A. FEROX DANA BAY STORMWATER UPGRADE REPORT

**PROCUREMENT PLAN NUMBER
TDR245/2021/2022**

REF NO.: 10082001

| REPORT DESCRIPTION | CONCEPT AND DESIGN VIABILITY FOR STORMWATER UPGRADE AT A. FEROX, DANA BAY |

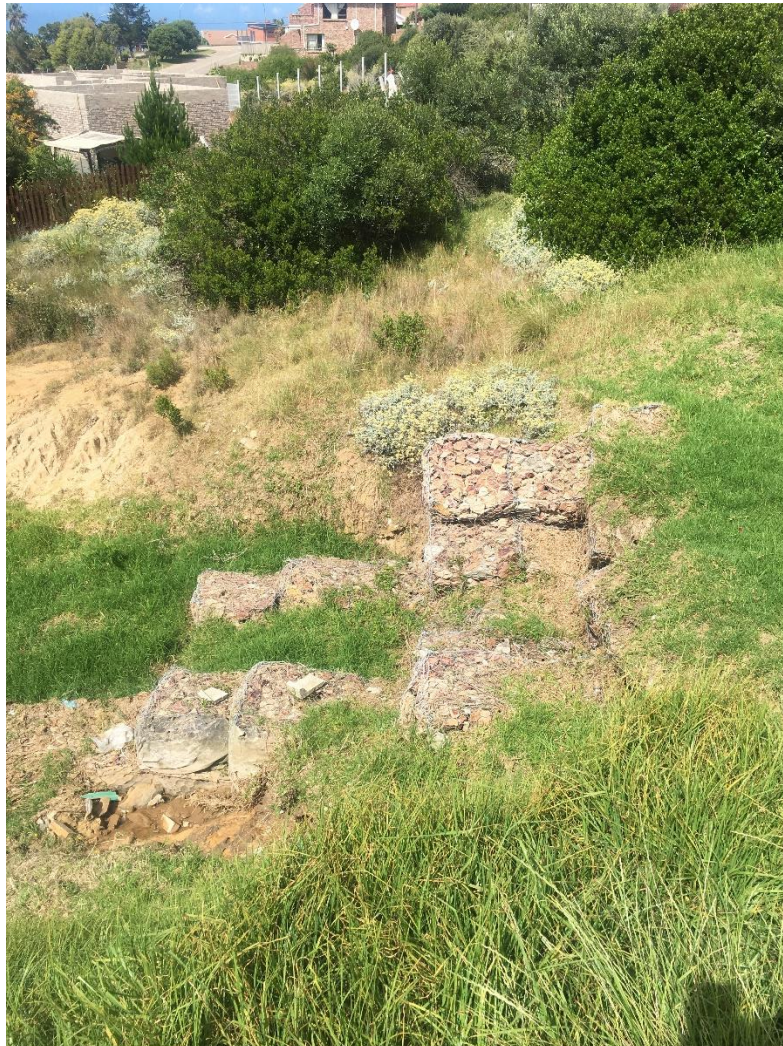
Two rectangular weir structures were identified on site. The Upstream Weir was found to have completely failed having been pushed to the side by the energy of the flow of the runoff. (Figure 2.) As a result, there is no control point for the upstream flow and therefore providing no protection for downstream flow and the watercourse embankments.

Figure 2: Failed upstream gabion weir structure.

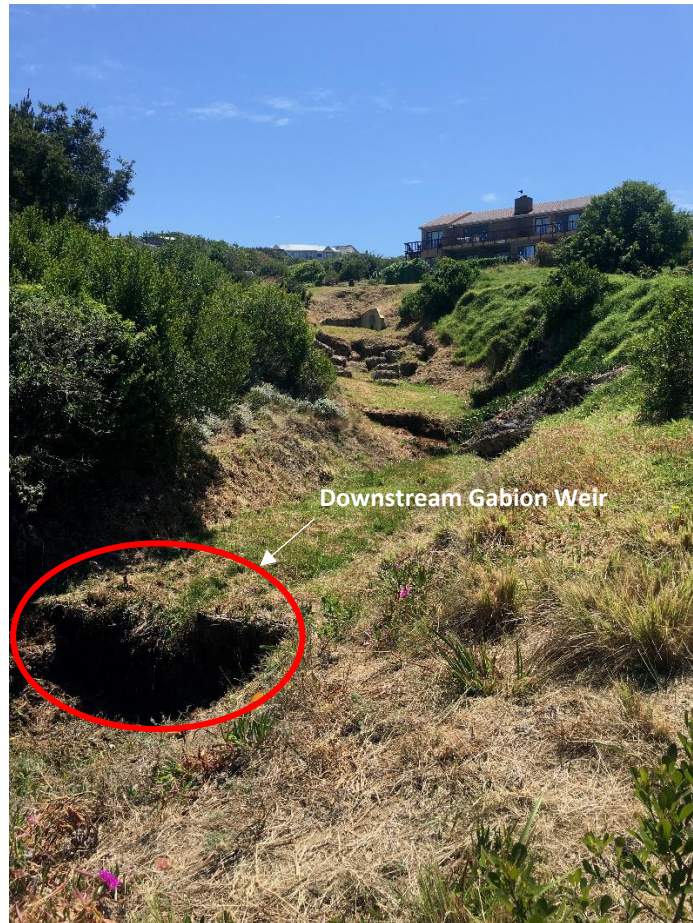
The condition of the Downstream Weir indicated a partial failure due to silt build up and overgrowth of vegetation. This renders the structure semi-functional and unable to fully manage the capacity of the upstream flow. (Figure 3.)

Figure 3: Partially failed downstream gabion weir structure.

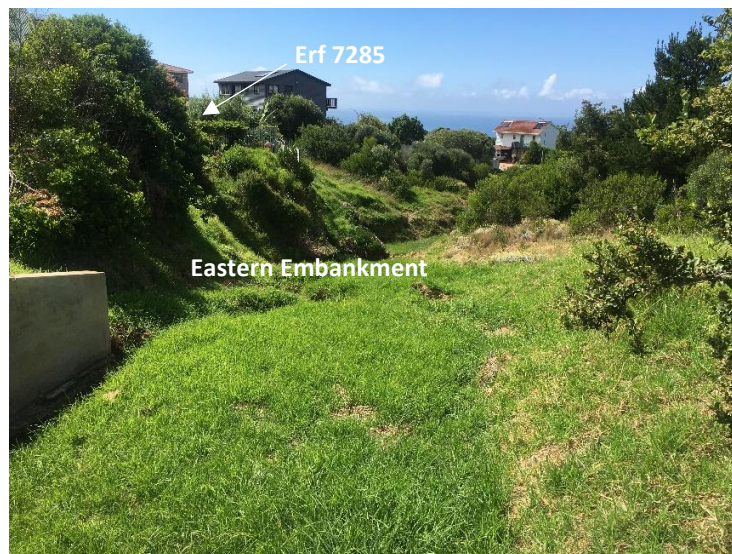
The condition of the Eastern Bank of the channel shows undercutting of the slope due to erosion. (Figure 4.) The undercutting has compromised the stability of the slope.

Figure 4: Eastern bank of watercourse undercut by erosion.

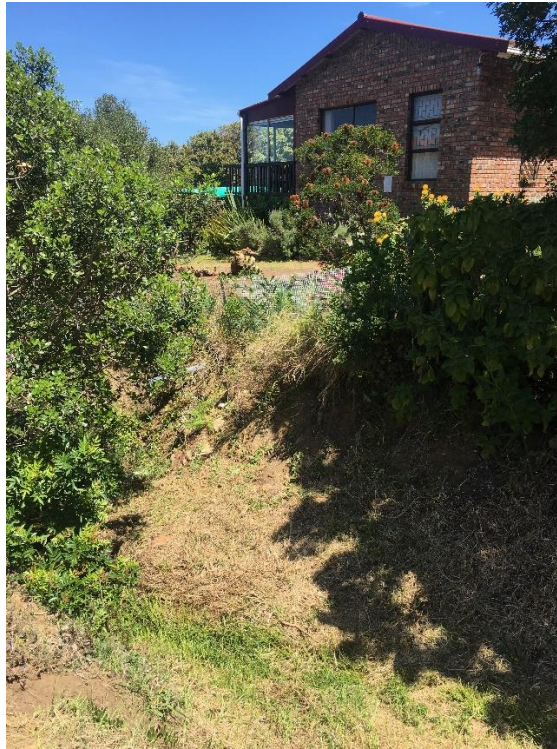
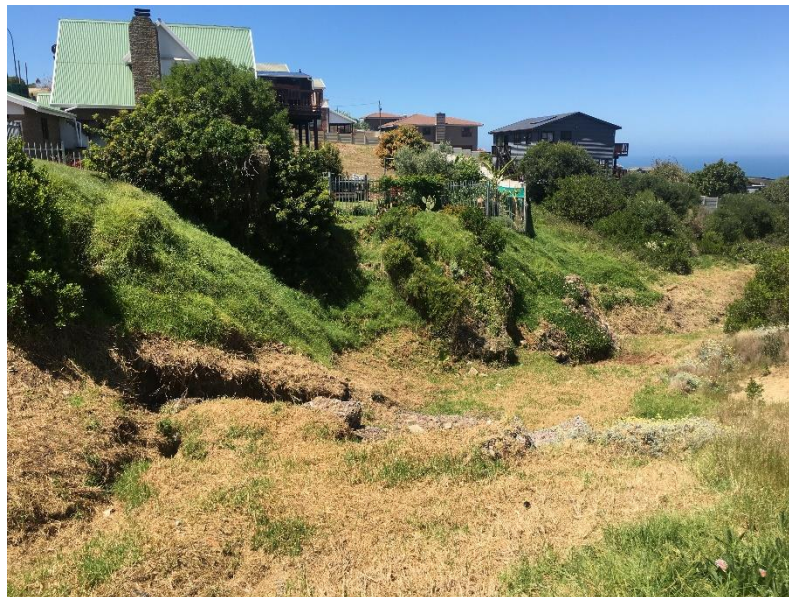
Due to undercutting by the flow, the condition of the Eastern Bank of the channel presents a threat of active slope failure due to erosion. (Figure 5.) This poses a threat to the property of erf 7285 and residents have taken to using their own means to sure up the stability of the embankment by stacking tyres.

Figure 5: Slope erosion presents a threat to property adjacent to watercourse.

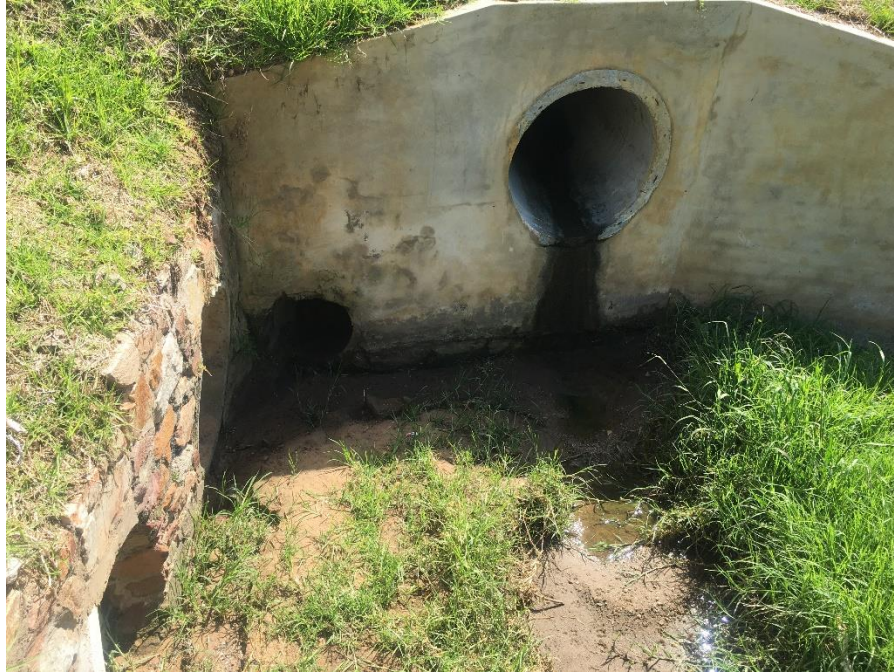
Evident in the condition of the watercourse and contribution to the non-functionality of the gabion weir structures is the lack of maintenance. Overgrowth of vegetation and the build-up of silt has reduced the stormwater management performance of the control structures. (Figure 6.)

Figure 6: Lack of maintenance resulting in silt build-up and vegetation overgrowth.

Overgrowth of vegetation and the build-up of silt has reduced the stormwater management performance of the control structures. This is due to a clear lack of regular maintenance. The gabion weir structured also suffered from not having a regular maintenance or being rehabilitated when signs of structural failure began to emerge.

and, therefore, reduce clogging and blockages. However, regular debris removal will need to take place together with cutting and removal of vegetation and overgrowth.

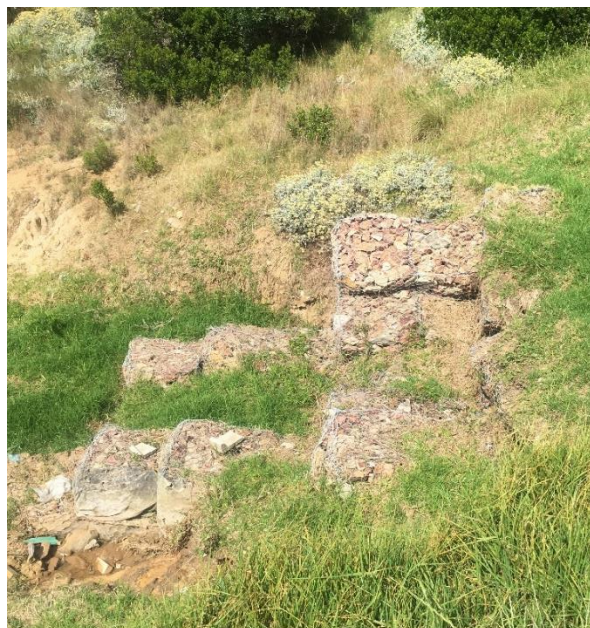
The reason for the failure of the existing gabion weirs is due to their lack of ability to manage high velocity and volumes of flows. Silt build-up over time and lack of routine maintenance was also the cause of displacement of the weirs. Hence this design consideration was ruled out. See Figure 4.

Figure 4: Failed displaced weir structure, A. Ferox.
