Appendix C: Site Photographs

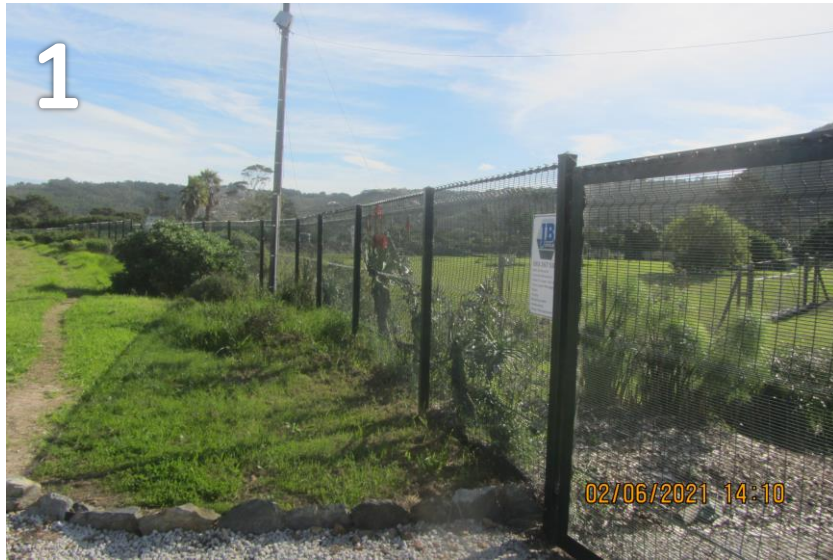
Photo 1: External fencing. Photo 2: Newly completed access road. Photo 3: Parking area and internal fence. Photo 4: Northern portion of the erf

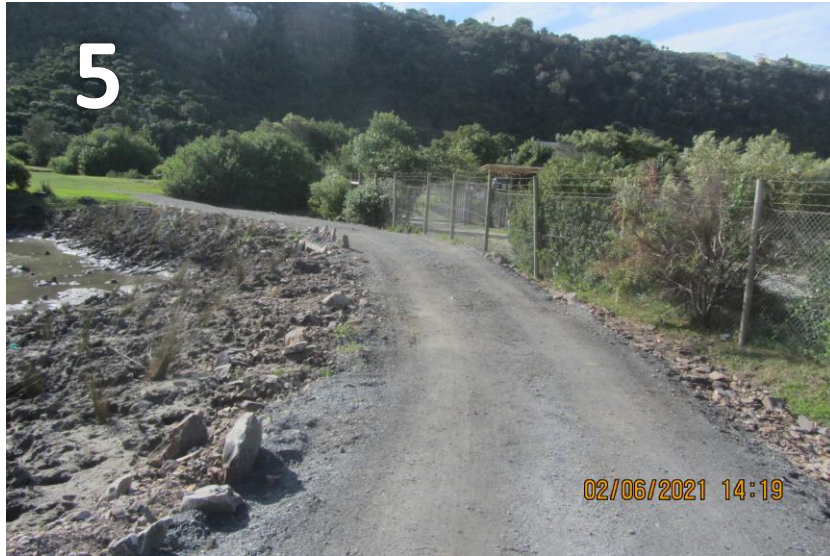
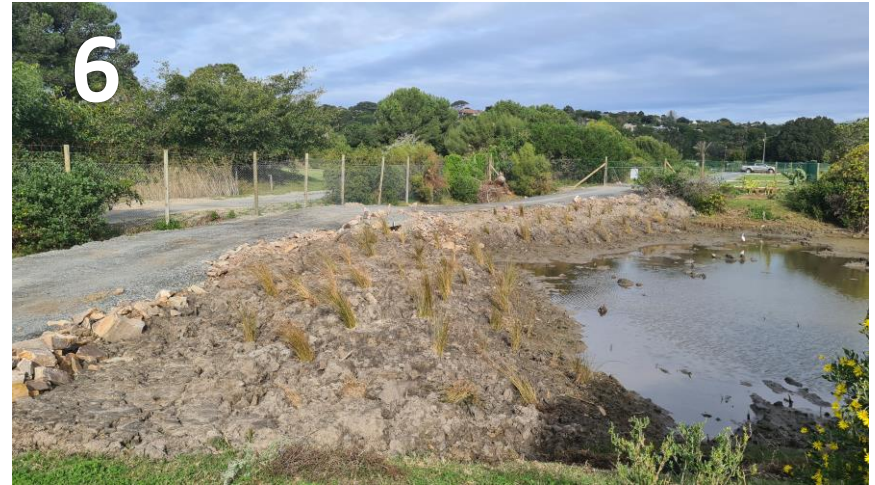
Photo 5 & 6: Completed access road over tidal channel. Photo 7: Culvert with access control, shows height of water moving through at high tide. Photo 8: Exposed mudflats of the tidal channel showing improved water quality and habitat.

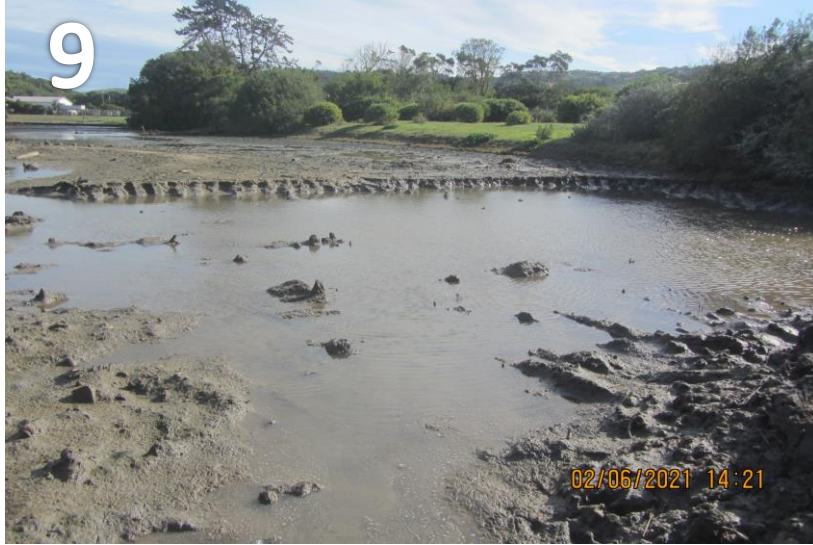
Photo 9: Exposed mudflats of tidal channel at low tide. Photo 10: Thicket on the northern portion of the erf. Photo 11: South view of the southern portion of the erf with old dam in foreground. Photo 12: Northern portion of the erf
