## Appendix D: Site Photographs

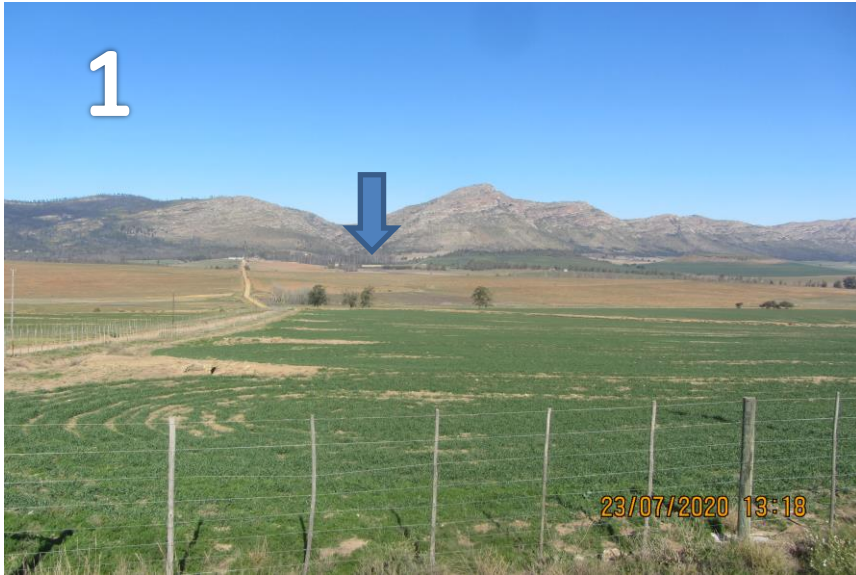
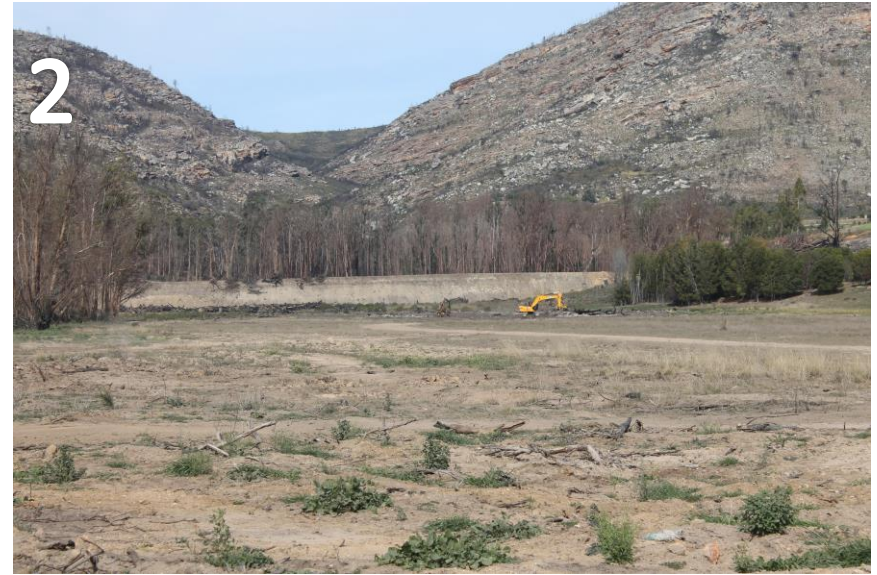
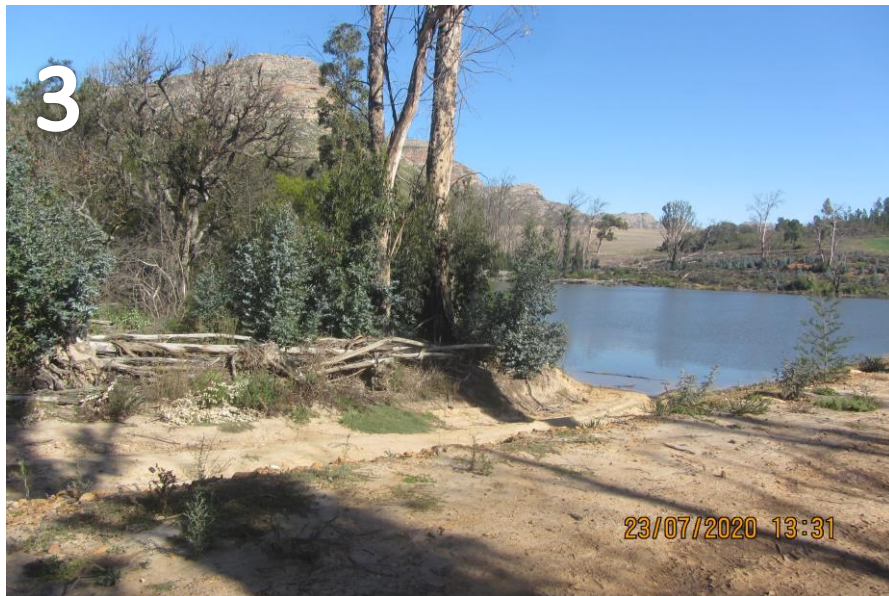
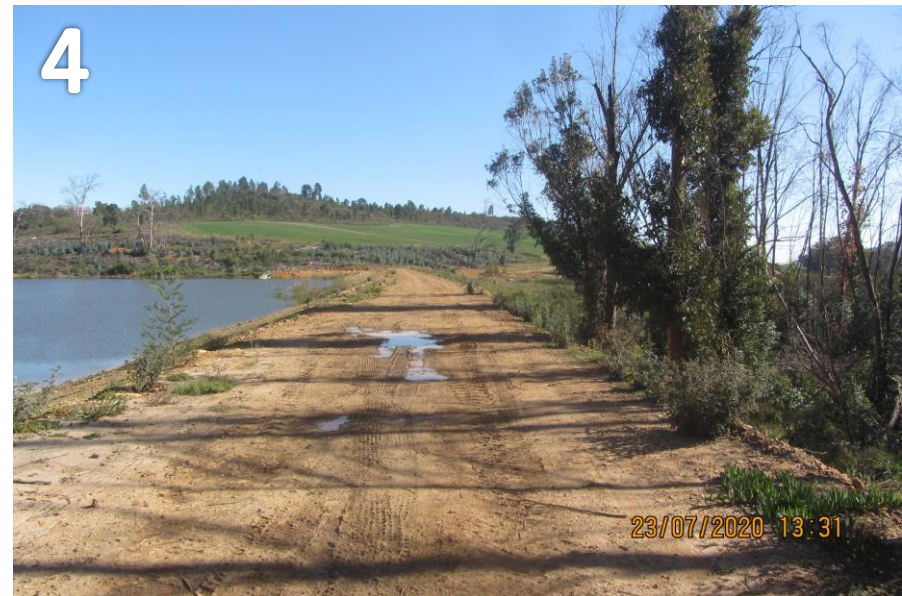
Photo 1 – dam view from the N9. Photo 2 shows clearance activities in 2019. Photos 3 & 4 view the dam from the eastern side.

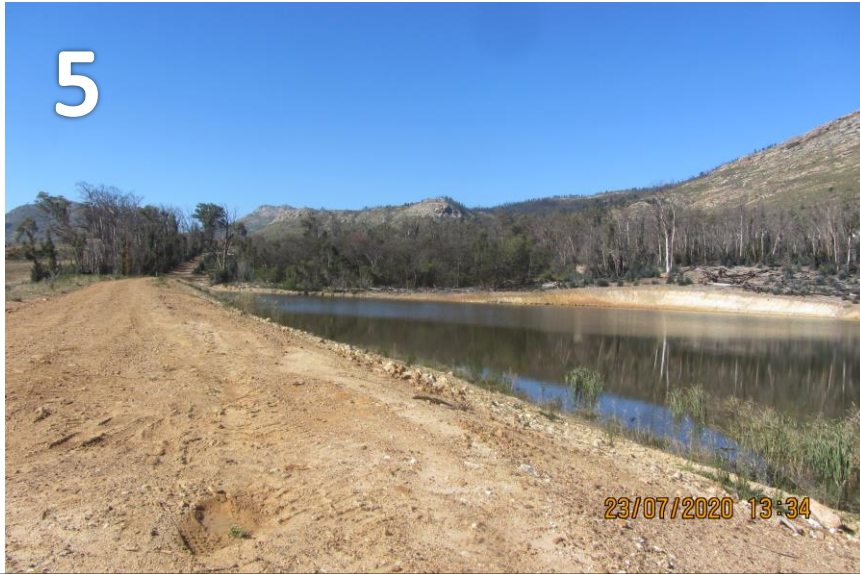
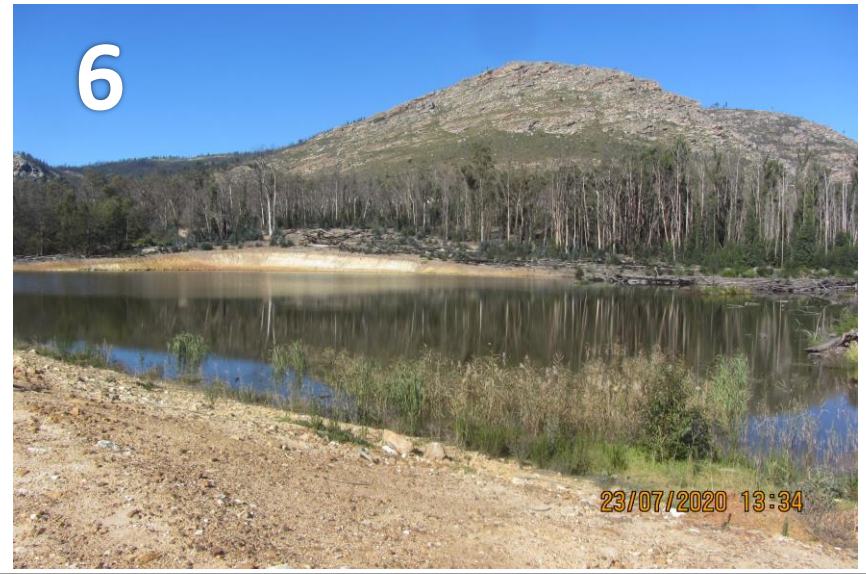
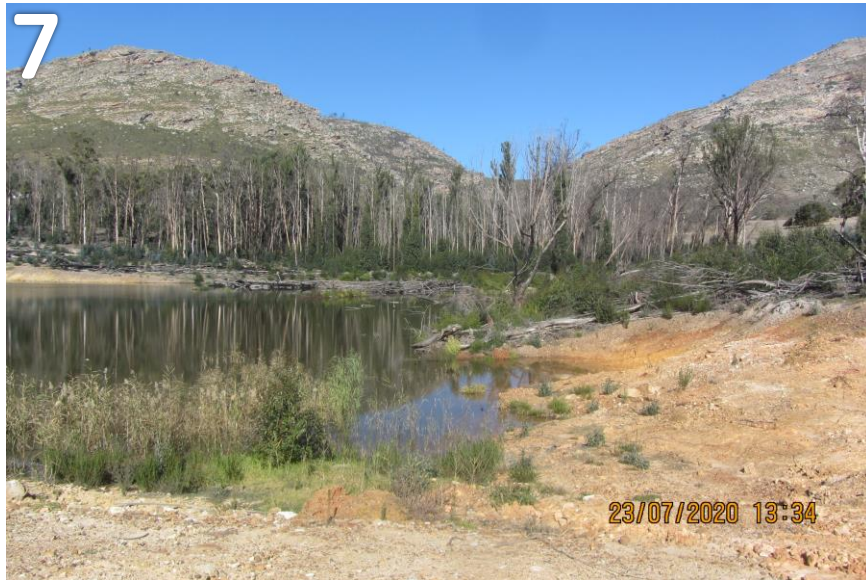
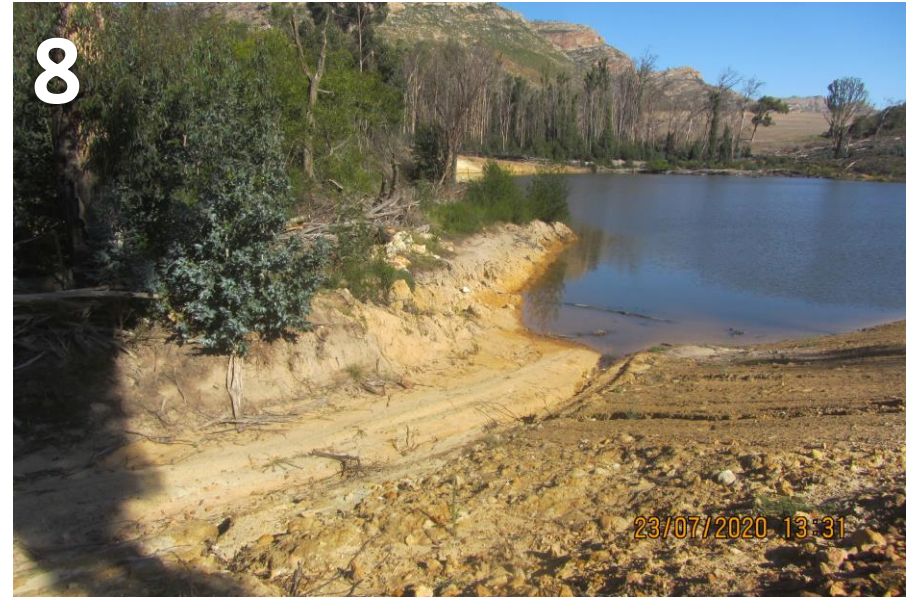
View from the western side of the wall of the dam. (Photos 5, 6 & 7). Note bluegum infestation upstream. Photo 8 shows the current spillway.

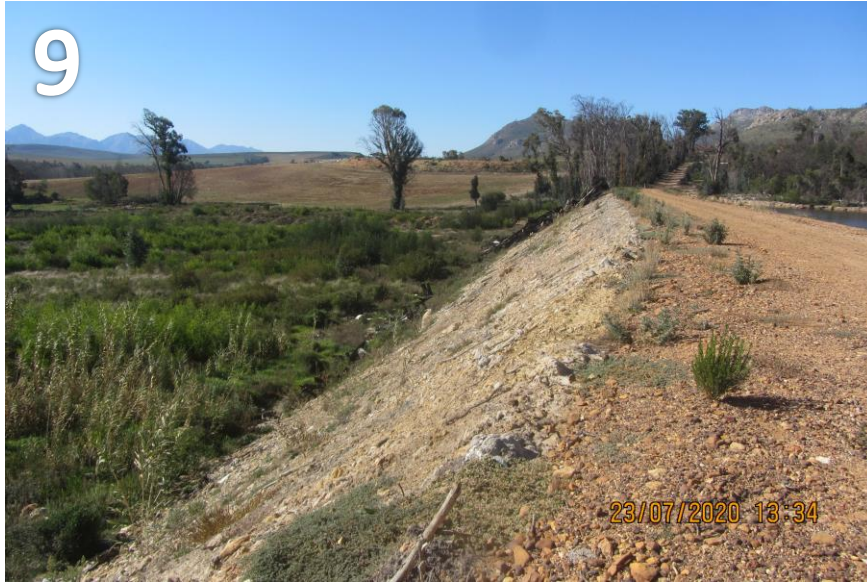
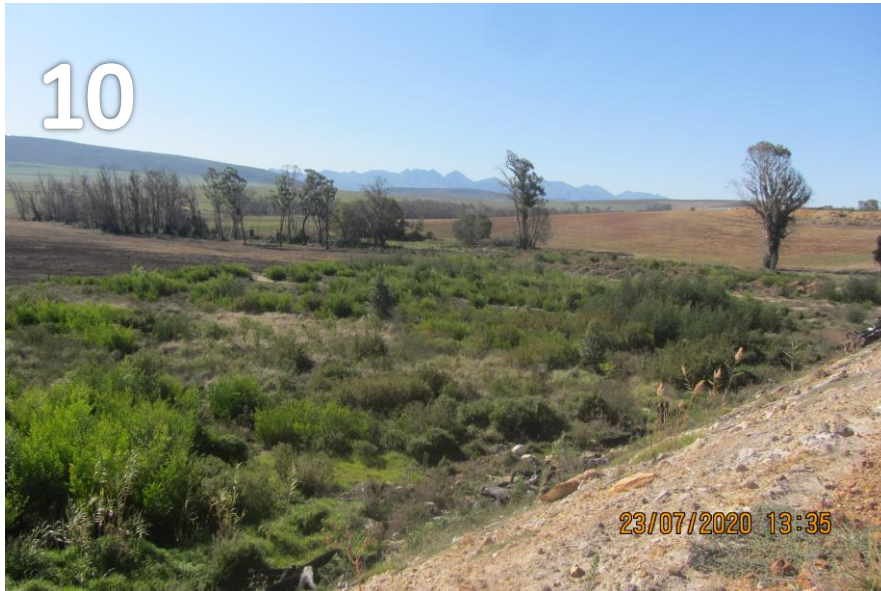
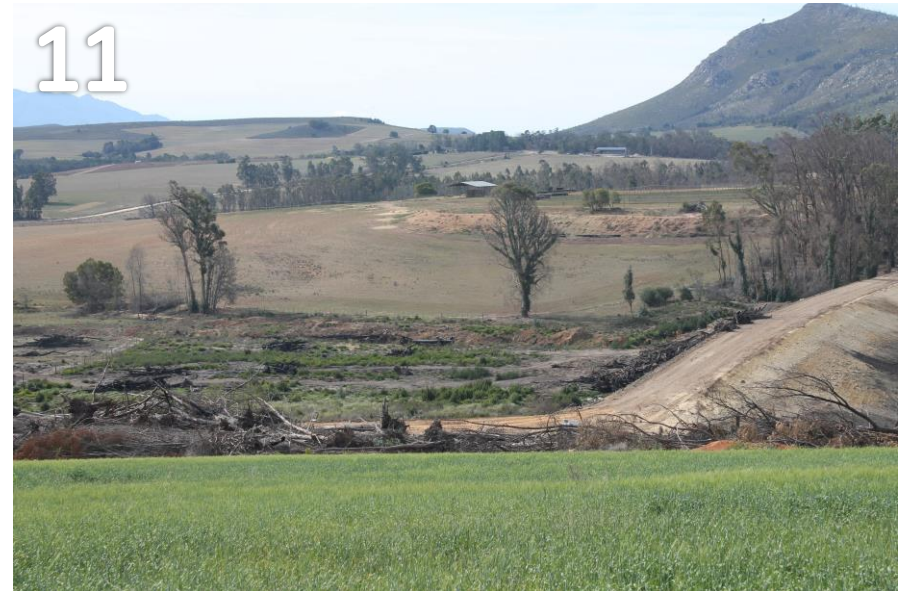
View of the dam wall (Photo 9 & 10).  
Photo 10 shows the area downstream of the wall in 202, with the comparison for 2019 during the clearing operations. Note the regrowth in the riparian area.
