Photographs Taken of Fence to be Replaced:

A Series of photographs were taken of where the existing fence is located with and without river flow:

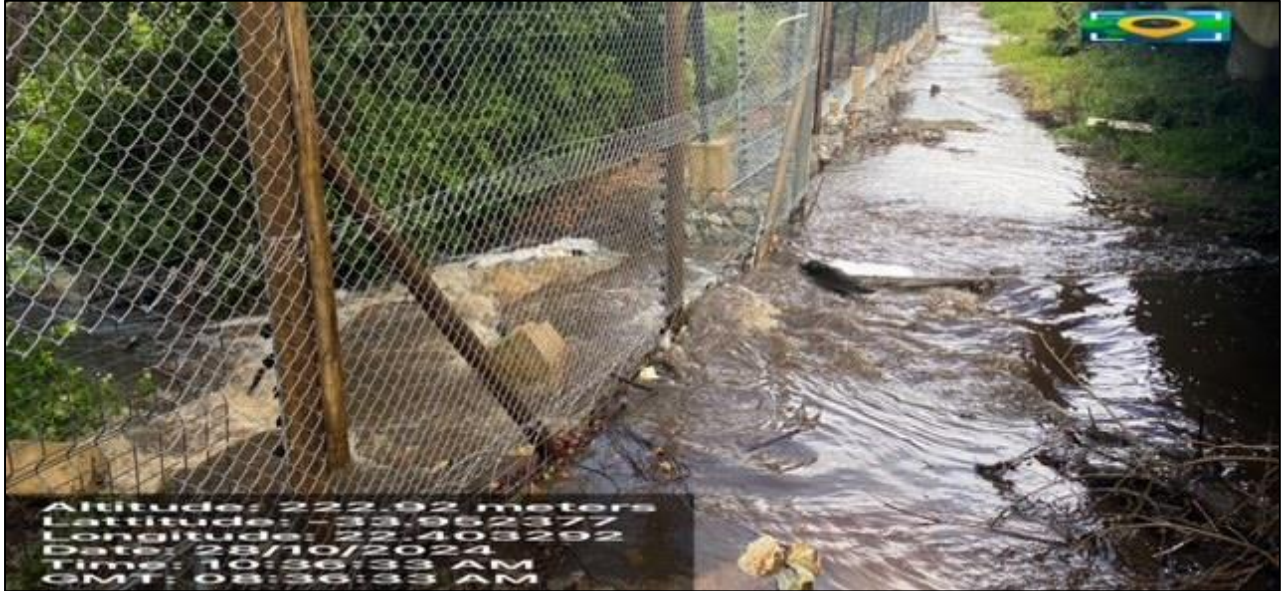
Figure 1: Portion of the fence erected on existing gabions/reno mattresses.

Pictures above were taken from the R404 Montagu Road bridge during a period of harsh rainfall. Foundation of the fence is shown to be submerged under the river water as seen in figures 1 & 2. It can clearly be seen from *figure 3* that the fence above is to be repaired and maintained. Hence a new sustainable fence design has been proposed by the proponent/owner.

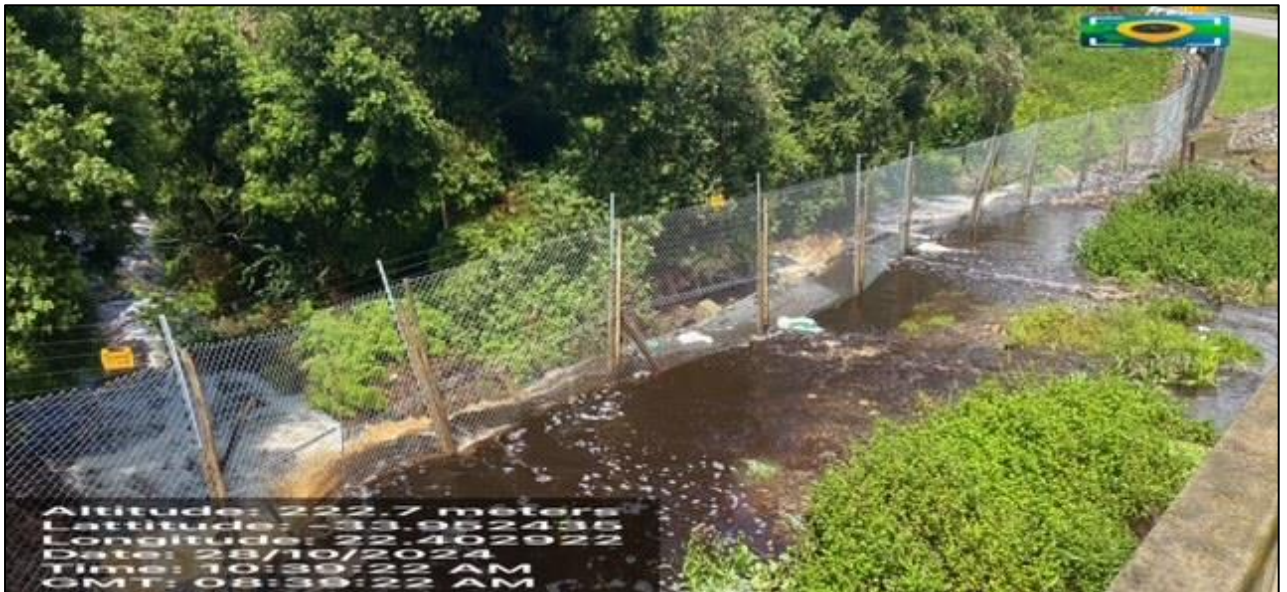
Figure 2: Portion of the fence where existing footings are covered during flow (view taken from bridge).

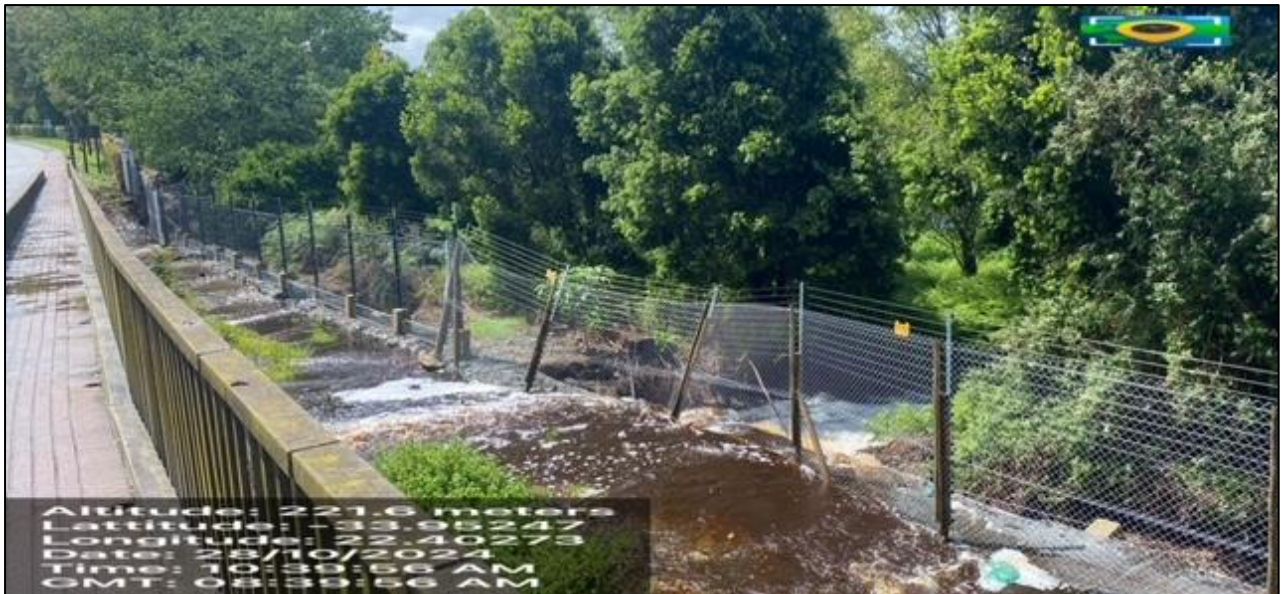
Figure 3: Portion of the failing fence damaged by waterflow (existing gabions/reno mattresses below water level during high flow).

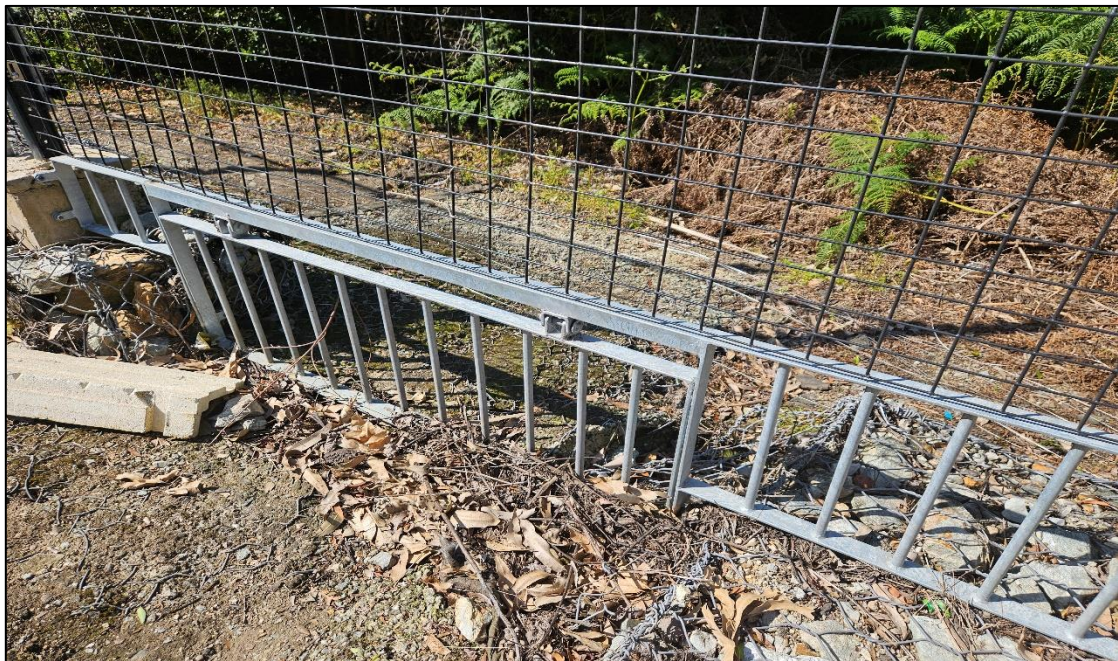
Figure 4: Existing Fence with unsustainable movable bottom section that is too narrow.

Pictures in Figures 4 & 5 were taken on a drier day to showcase the exposed gabion/ reno mattress structures currently imbedded into the bed/banks of the watercourse. These structures are to be removed and replaced in according to the Engineering Design to allow an improved fence/security system that will be less prone to damage/repairs.

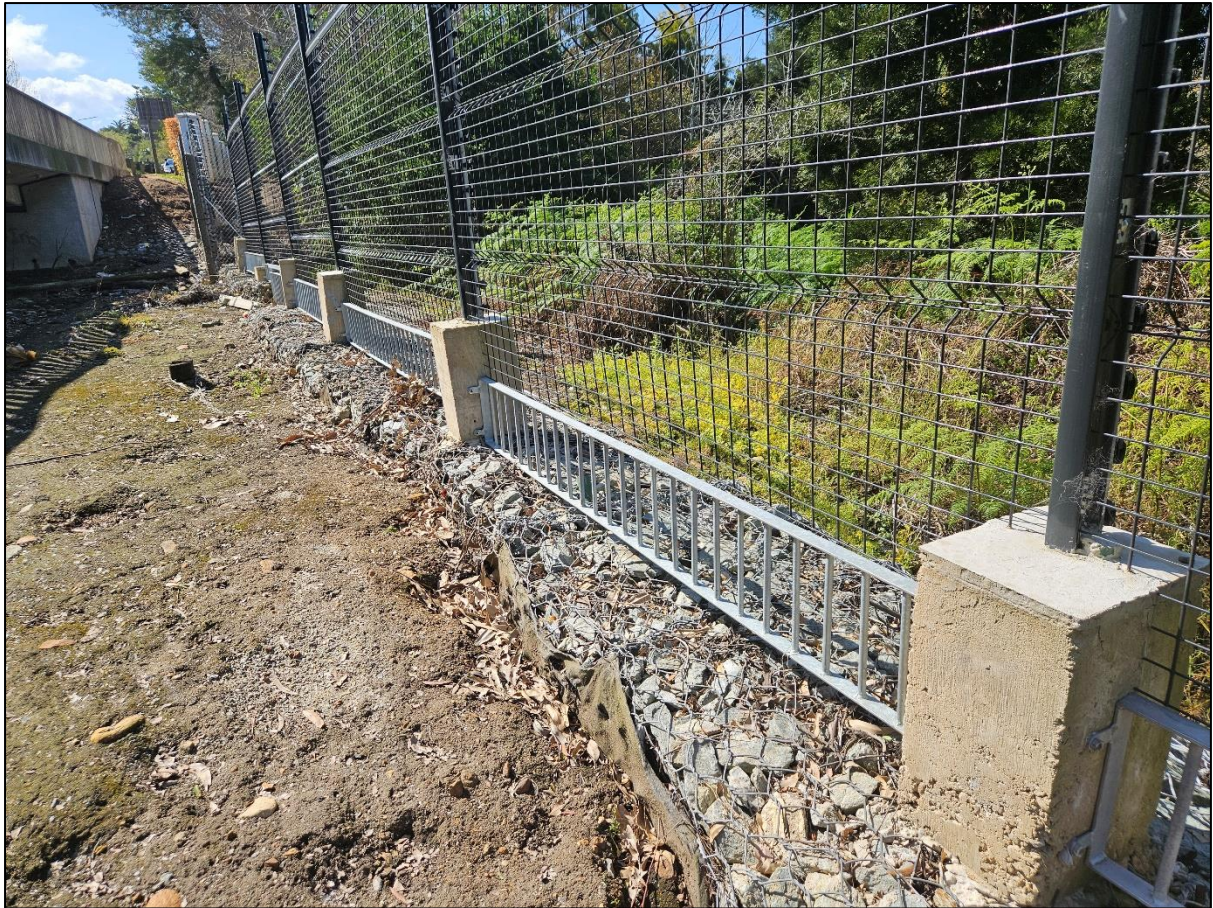
Figure 5: Exposed Gabions/Reno Mattresses and foundation of existing fence to be removed and replaced according to engineering design.
