**RESIDENTIAL DEVELOPMENT ON THE REMAINDER
OF PORTION 60 OF THE FARM PLATTEBOSCH NO.
485, STILL BAY, WESTERN CAPE
EA REF: 16/3/3/5/D5/19/0001/22**

**PHASE 1 CONSTRUCTION
ECO REPORT
FOR SEPTEMBER 2024**

**(Submitted 4 October 2024 as the ECO could
not access the site during September 2024)**

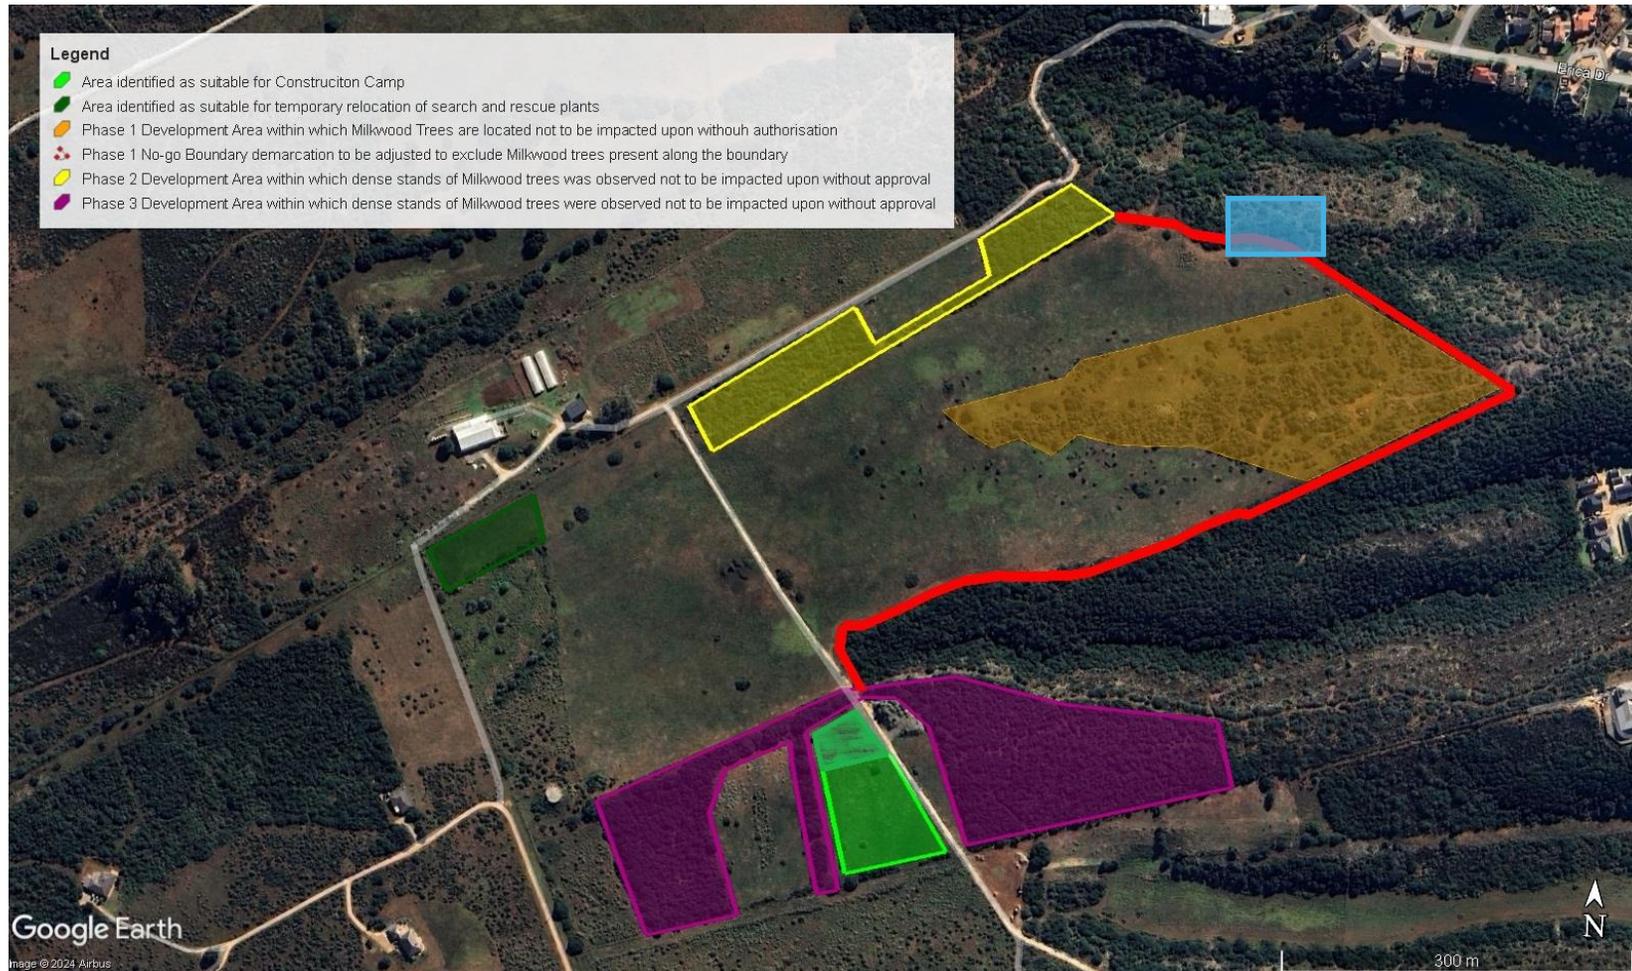
Map 1: July 2024 ECO map for indicating areas where Milkwood trees were observed and to be avoided; proposed construction camp placement; proposed search and rescue plants temporary placement. No machinery clearance are allowed within the dense stands of Milkwood Trees as identified within Phase 2 and Phase 3 areas. **The blue square on the map above shows where encroachment into the no-go area has occurred, as per the recommendations no-go demarcation must be immediately reinstated as per original demarcation done by the land surveyor and the impacted no-go area must be rehabilitated**

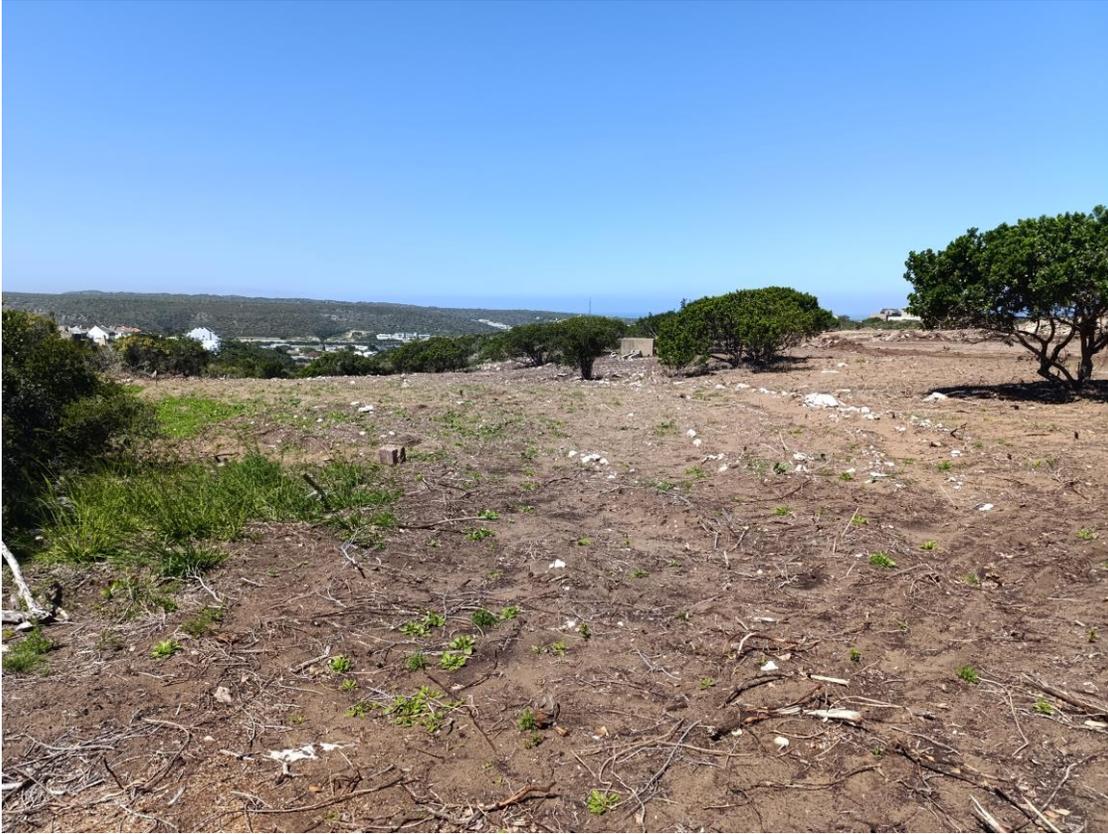
Finding No.	Area of activity	ECO Findings and Recommendations
S1	No-go boundaries and protected Milkwood trees within and	During July ECO site inspection, it was found that the boundaries of the no-go areas were correctly demarcated, however during the ECO site inspections conducted on 29 August 2024 and 3 October 2024 it was found that no-go demarcation points is no longer clearly visible and is not distinguishable from the demarcation being

Photo 1: Encroachment within no-go area to be demarcated for rehabilitation (photo taken 03 October 2024).

<p>along no-go boundaries</p>	<p>used for services layouts i.e. pipeline and roads. Some of the no-go demarcation points were moved and encroachments have occurred into the no-go areas.</p> <p>It is recommended that all no-go boundaries demarcation be immediately restored according to the no-go boundaries that was determined by the land surveyor and confirmed as correct during the July ECO inspection before site clearance commenced. The pegs used for no-go boundaries demarcation must also be clearly distinguishable from the pegs used for services infrastructure layout pegs. No developments, site clearance or road or service infrastructure developments may take place within the no-go areas without approval from the Department that these developments can occur within the scope of the Environmental Authorisation.</p> <p>Encroachments that have occurred within the no-go area must be demarcated for rehabilitation.</p> <p>Refer to the map below.</p> <p>During the ECO inspection on 3 October 2024 this requirements to be rectified immediately was also discussed with the site manager Mr Evan Vermaak.</p>

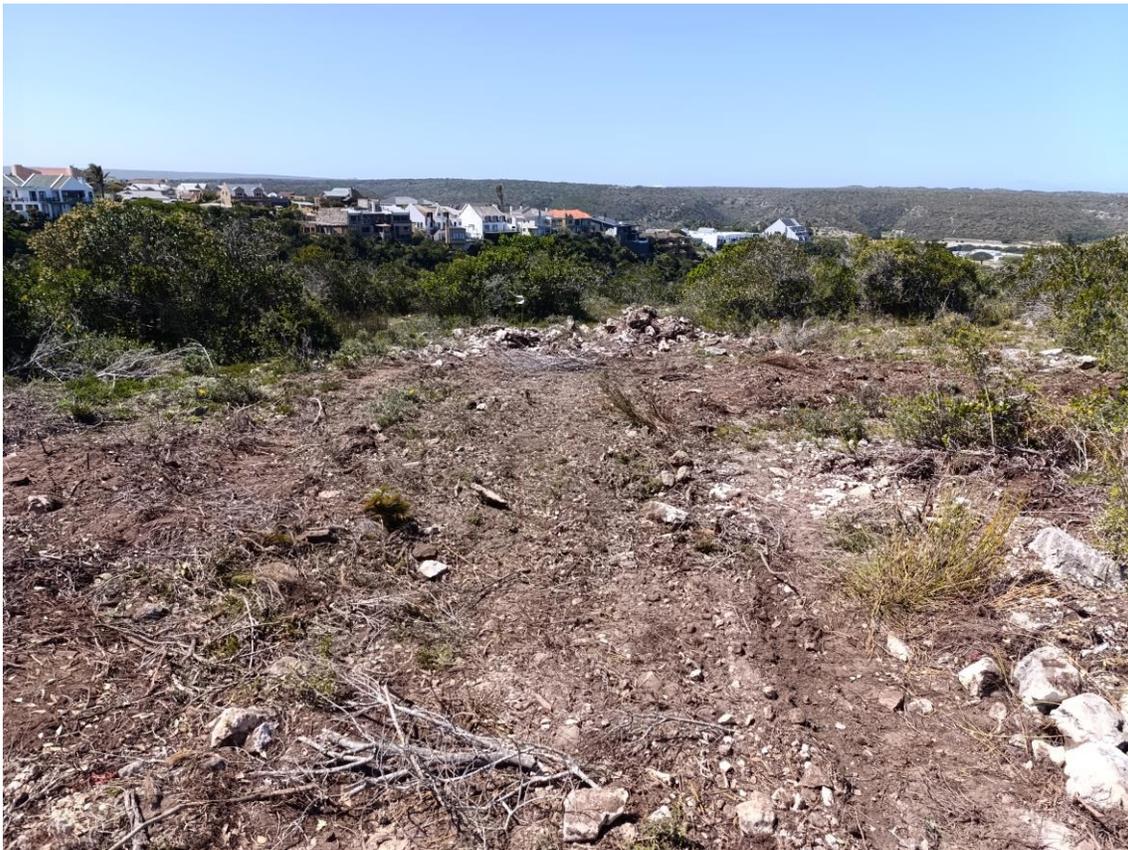
Photo 2: Encroachment within no-go area to be demarcated for rehabilitation (photo taken 3 October 2024).

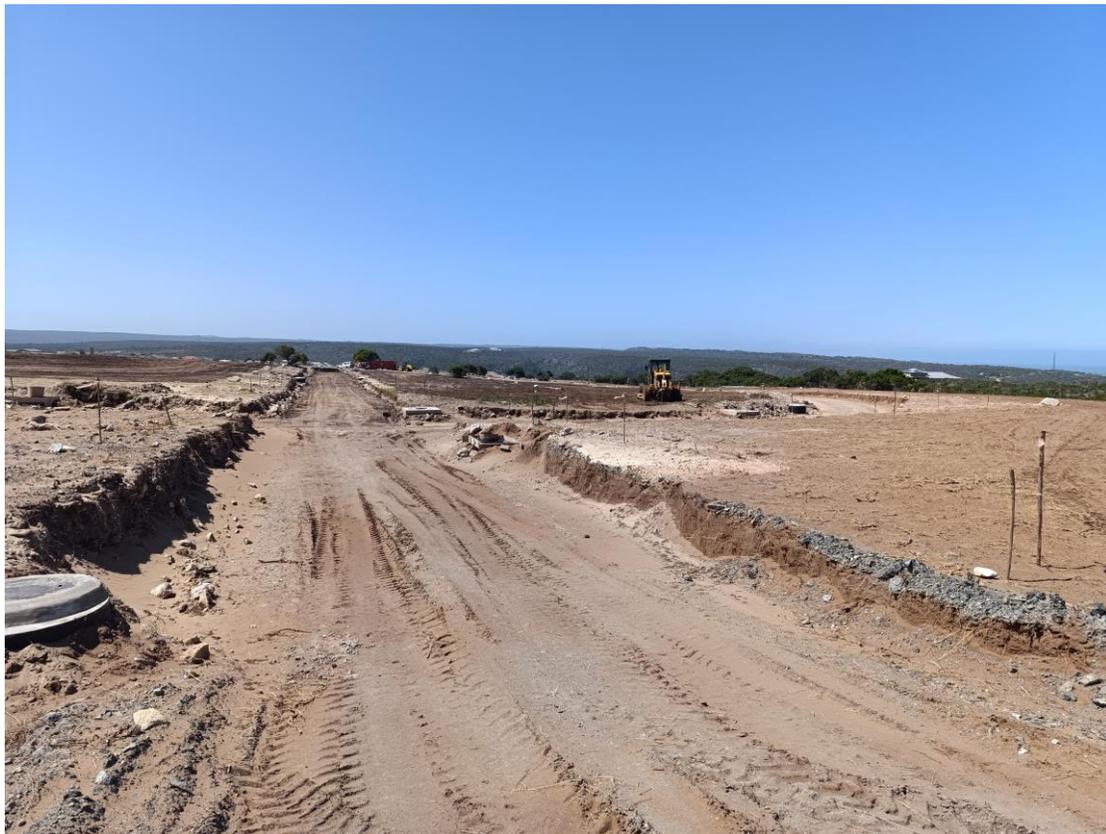
Photo 3: Phase 1 services construction progress (photo taken 3 October 2024).
