**RESIDENTIAL DEVELOPMENT ON THE REMAINDER  
OF PORTION 60 OF THE FARM PLATTEBOSCH NO.  
485, STILL BAY, WESTERN CAPE  
EA REF: 16/3/3/5/D5/19/0001/22**

**PHASE 1 CONSTRUCTION  
ECO REPORT  
FOR DECEMBER 2024  
(Submitted 11 December 2024)**

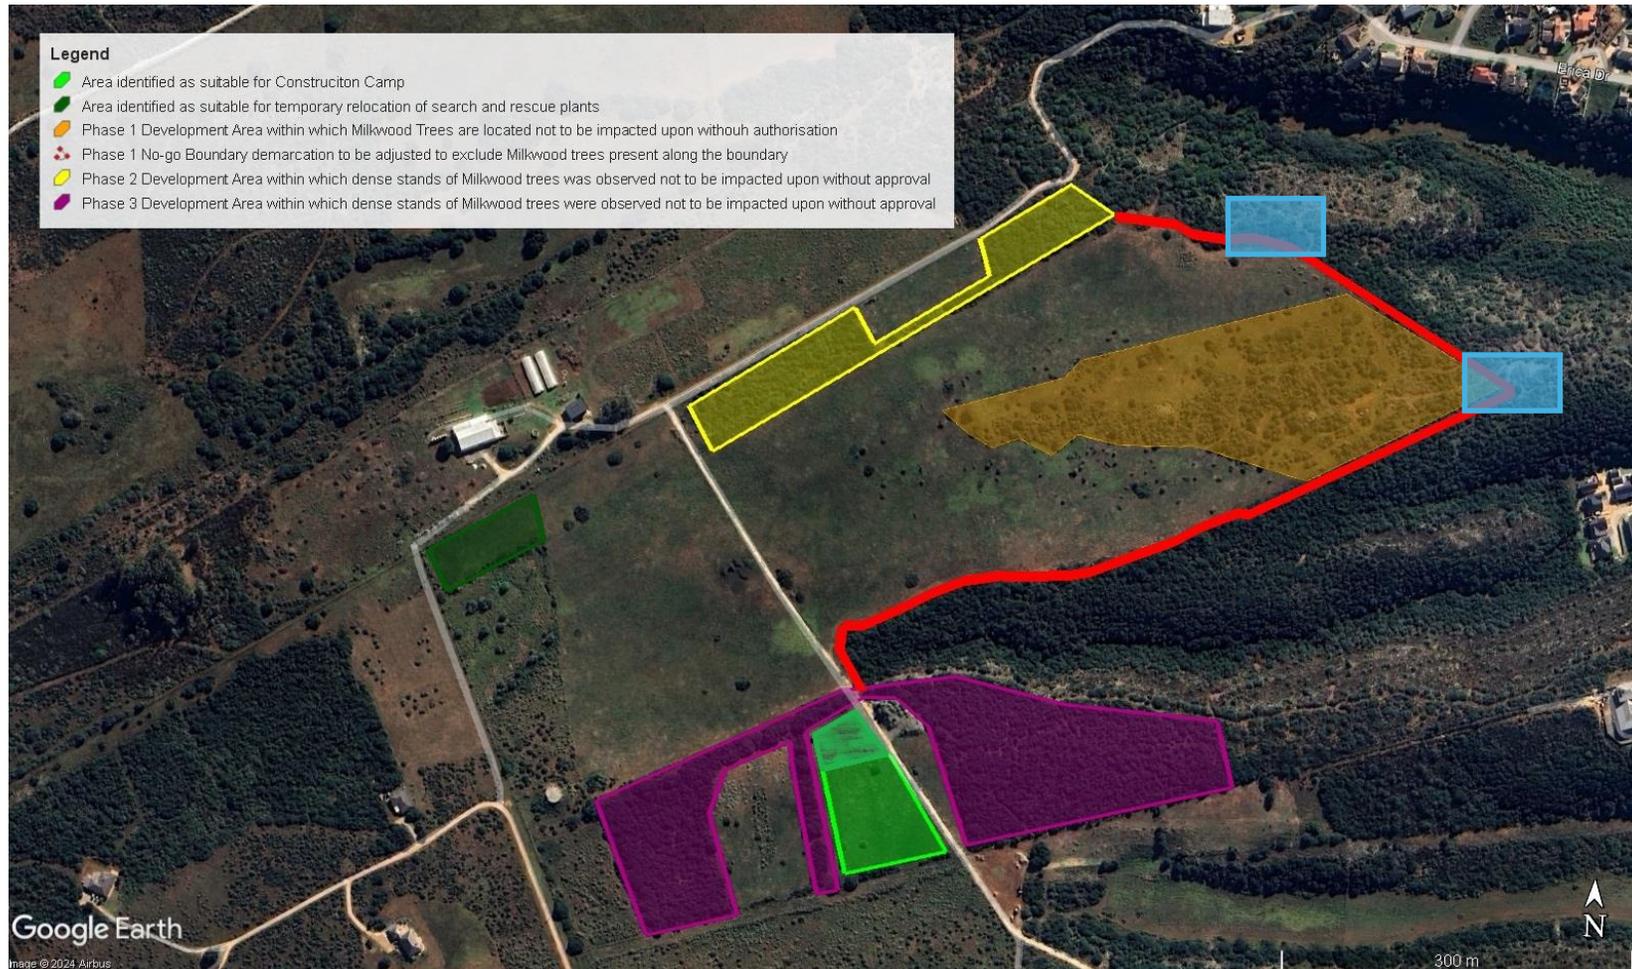
**Map 1:** July 2024 ECO map for indicating areas where Milkwood trees were observed and to be avoided; proposed construction camp placement; proposed search and rescue plants temporary placement. The ECO stated that no machinery clearance are allowed within the dense stands of Milkwood Trees as identified within Phase 2 and Phase 3 areas. The EA holder however continued to clear vegetation within Phase 2 development area with machinery and this has lead to damage to dense Milkwood trees. **The blue squares on the map above shows where encroachment into the no-go areas have occurred, as per the recommendations no-go demarcation must remain reinstated as per original demarcation done by the land surveyor and the impacted no-go area must be monitored for rehabilitated**

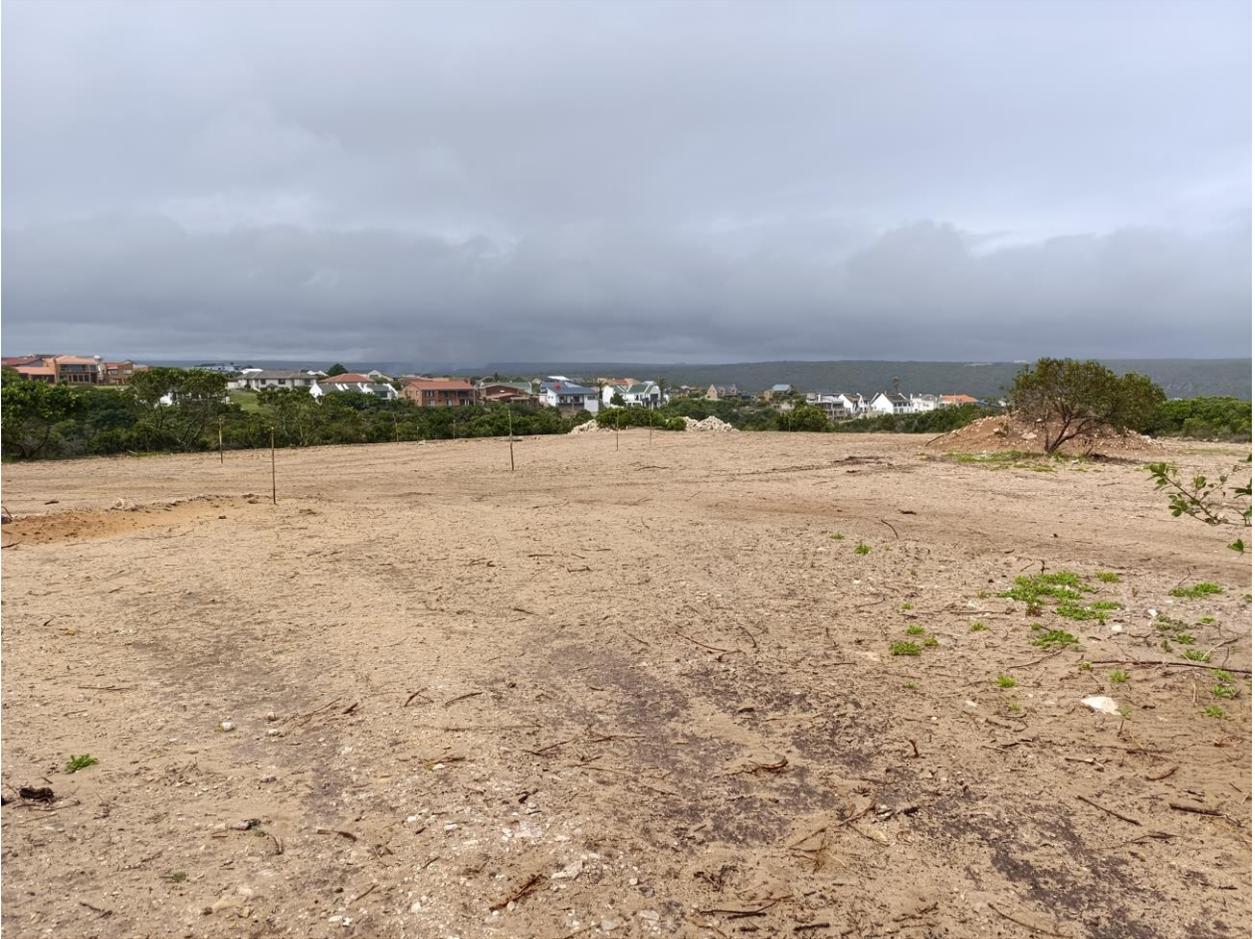
<b>Finding No.</b>	<b>Area of activity</b>	<b>ECO Findings and Recommendations</b>
D1 (Finding since Nov 2024)	No-go boundaries and protected Milkwood trees within and along no-	During the time of the December 2024 inspection, it was found that the original no-go boundaries have maintained. Demarcation must remain throughout construction phase and the ECO will monitor the rehabilitation progress of impacted no-go area edges and recommend indigenous vegetation planting if required.  Within the north-eastern corner no-go area encroachment stockpiles of lime rocks were observed which must be removed as

**Photo 1:** Lime stone stockpiles within no-go area still to be removed (photo taken 6 December 2024).

go boundaries	soon as possible. These rocks may not be dumped or placed within any of the no-go areas.
D2 (Finding since Sept 2024)	Milkwood trees within proposed development area	<p>A total of 26 Milkwood trees were counted by the ECO located within the Phase 1 development area. <b>NO MILKWOOD TREES MAY BE IMPACTED OR DAMAGED during any site clearance or construction activities without authorisation/permits.</b></p> <p>Extreme caution must be exercised during construction activities to ensure no impacts or damage to any protected Milkwood trees occurs.</p> <p><b>Phase 1 and partial Phase 2 development areas have been cleared all Milkwood trees located within the approved development area must be recorded by the land surveyor and indicated on the proposed development layout, this was proposed to be done before the December ECO site visit, but has not yet been done. Mapping of remaining Milkwood trees on layout within Phase 1 and 2 areas must be completed before the next ECO site visit scheduled for 28 Jan 2025 and map must be provided to the ECO before the scheduled site visit.</b> The layout map indicating the locations of the recorded Milkwood trees must be provided to the ECO before 6 December 2024 so that the ECO can check the map for correctness when conducting the next site visit. Thereafter this layout must be presented to the relevant official at the DFFE and applications for removal, relocation or pruning must be applied for and obtained from the relevant authority before any of these Milkwood trees may be impacted upon. As far as possible these trees must be accommodated on the layout within the proposed erven.</p> <p>During the July ECO report the following was recorded - <i>Dense stands of Milkwood trees were also observed within Phase 2 and Phase 3 remaining indigenous vegetation areas and when these areas are being cleared the shrubs around the Milkwood trees must be carefully cleared by hand not to damage any Milkwood trees and all Milkwood trees must be recorded and where removal or impacts on these trees cannot be avoided applications for removal, relocation or pruning must be applied for and obtained from the relevant authority before any of these Milkwood trees may be impacted upon.</i> During the ECO inspection conducted on 29 August 2024 it was observed that clearance activities has</p>

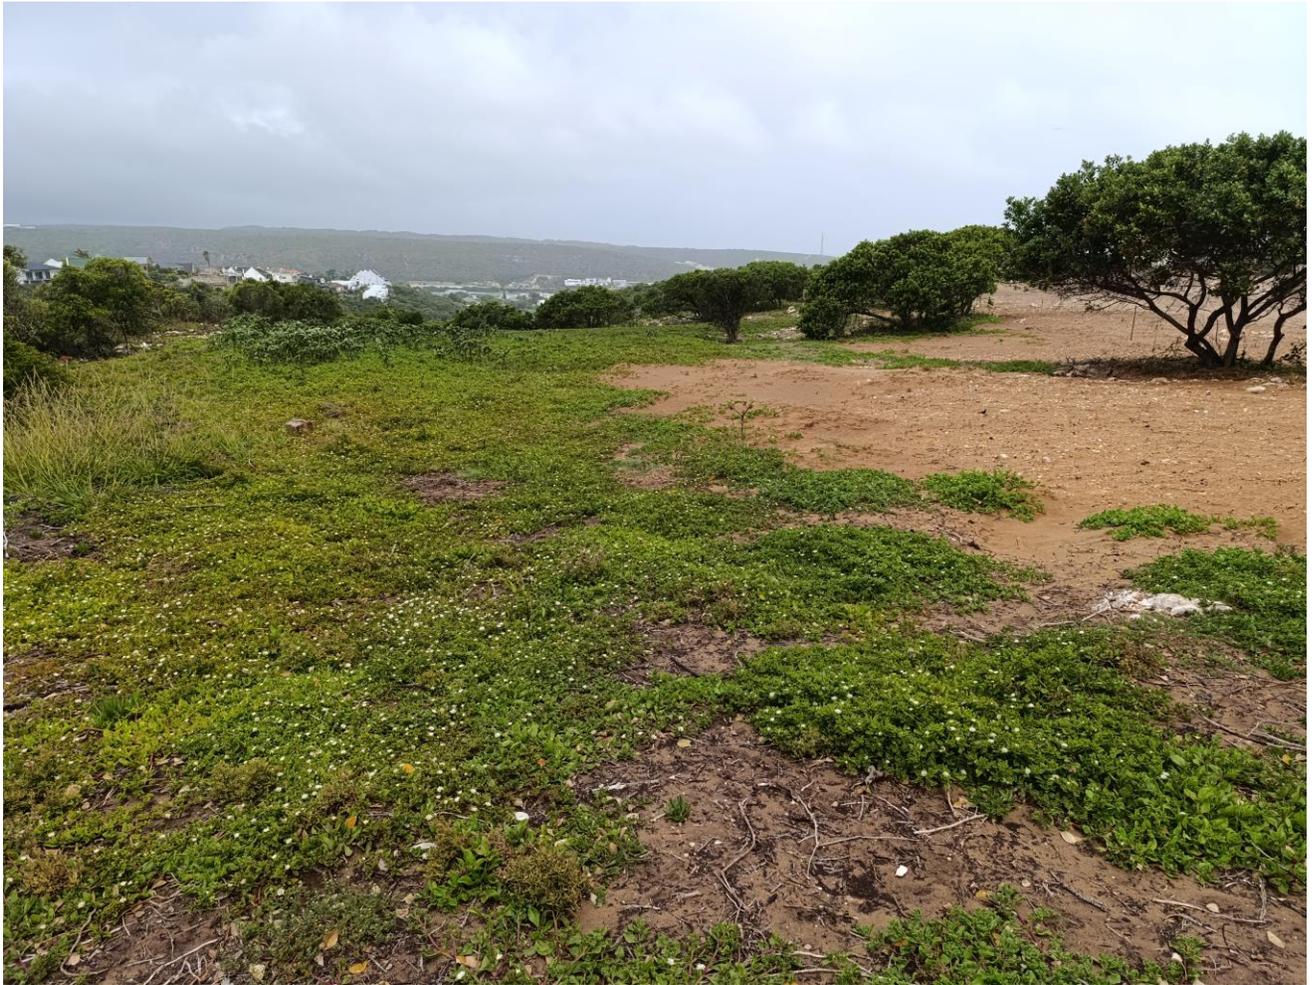
**Photo 2:** Rehabilitation progress of impacted no-go area (photo taken 6 December 2024).

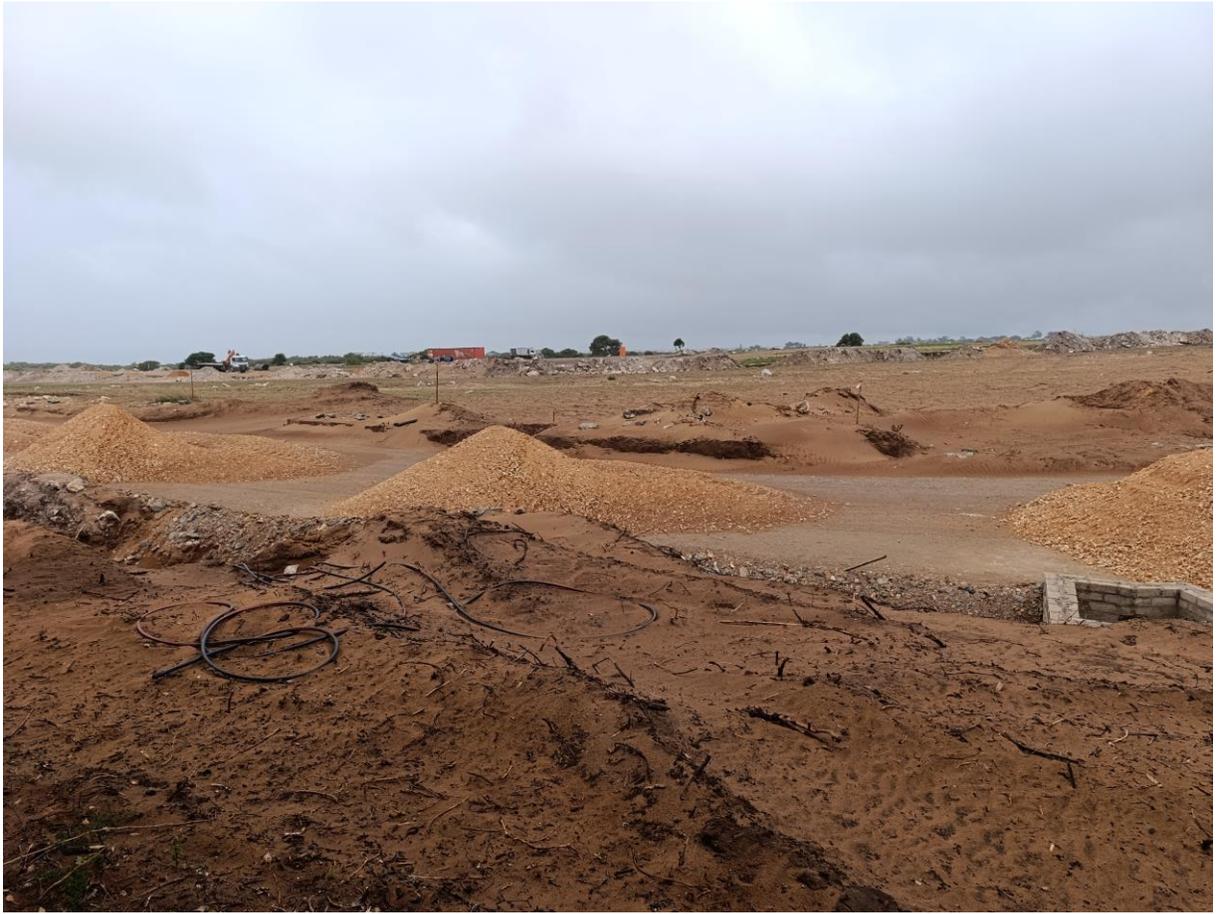
**Photo 3:** Phase 1 civil services construction progress (photo taken 6 December 2024).
