PHOTO KEY DIAGRAM

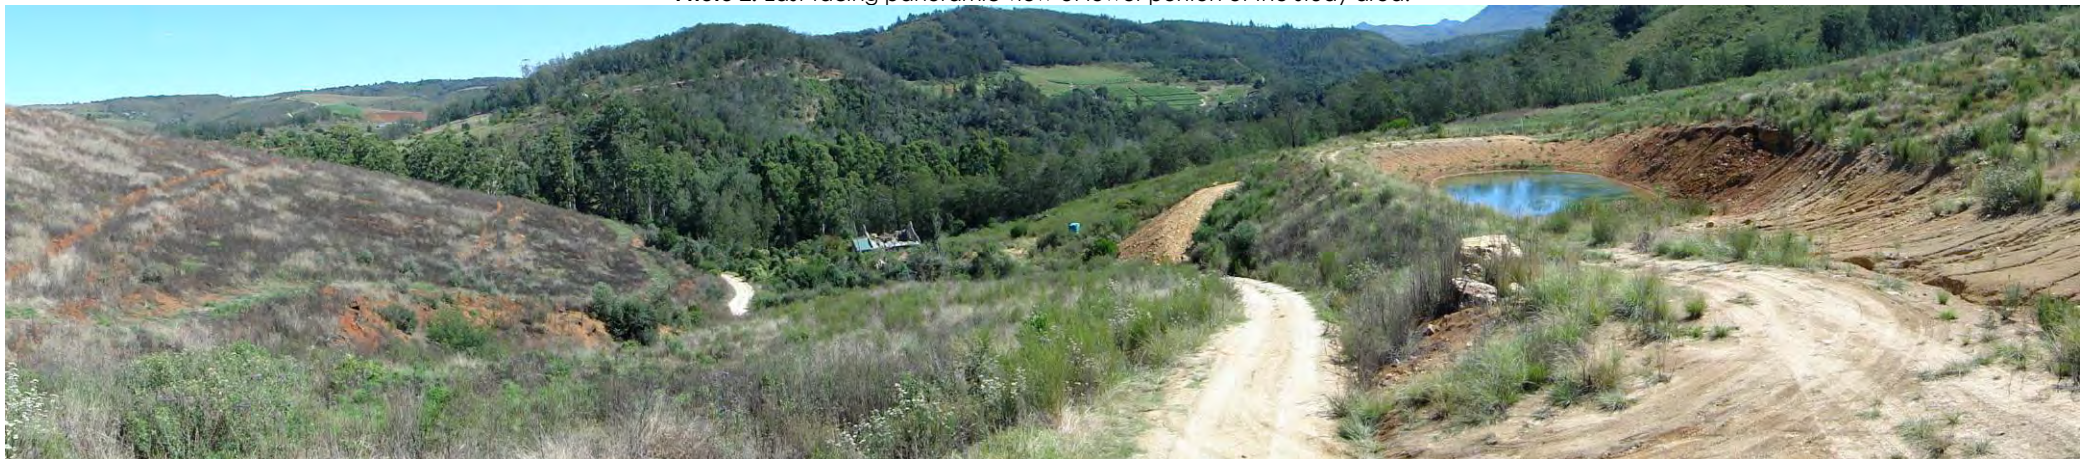
Photo 3: Southwest facing view across new dam and fire-damaged historic structure at lower end of the study area.

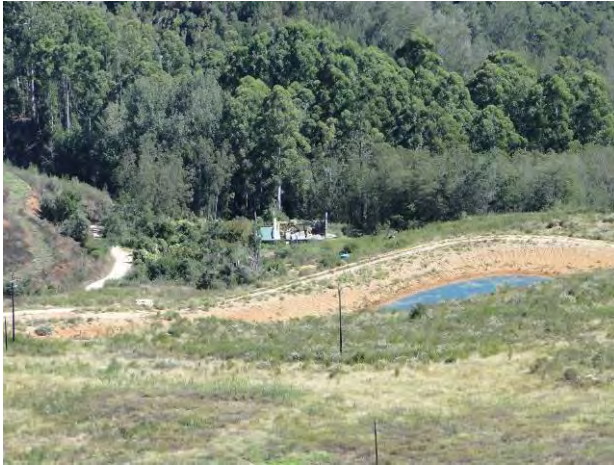
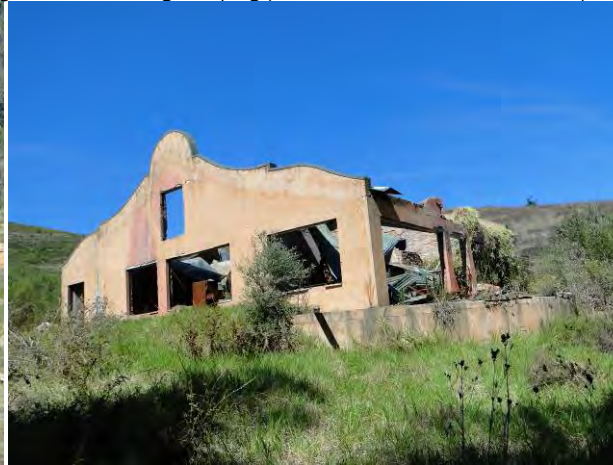
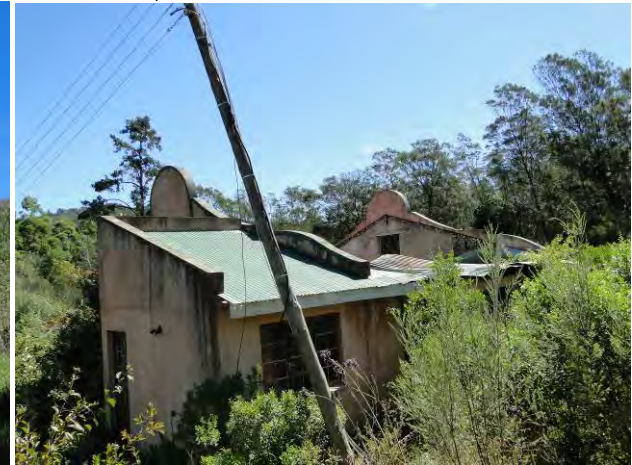
Photos 8-10 (left-to-right): New dam and fire-damaged historic building; Close-up views of south and north-facing elevations of same historic building.
