APPENDIX D - SITE PHOTOGRAPHS

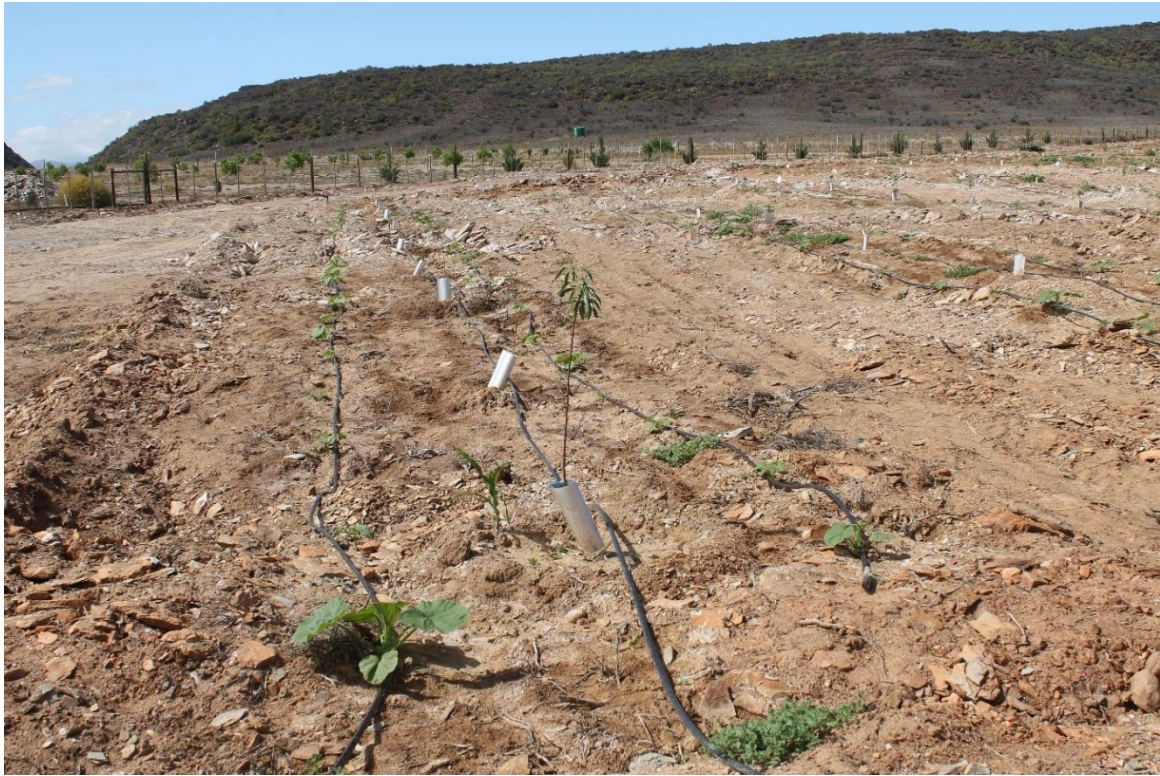
Figure 1: The cultivated area just after commencement of activities.

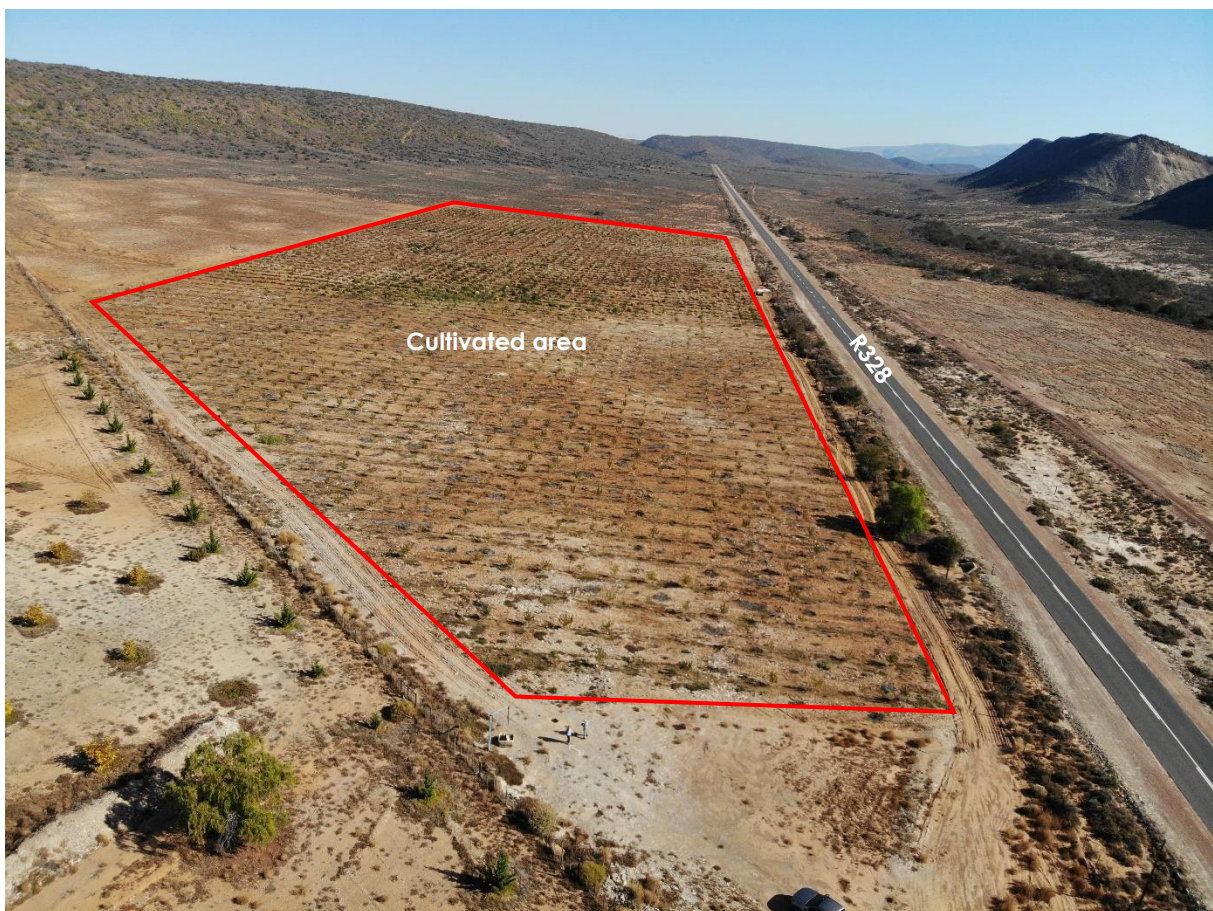
Figure 2: View of the 13 ha cultivated area (red polygon) that commenced without authorisation consisting of 7ha planted and 6ha ripped.

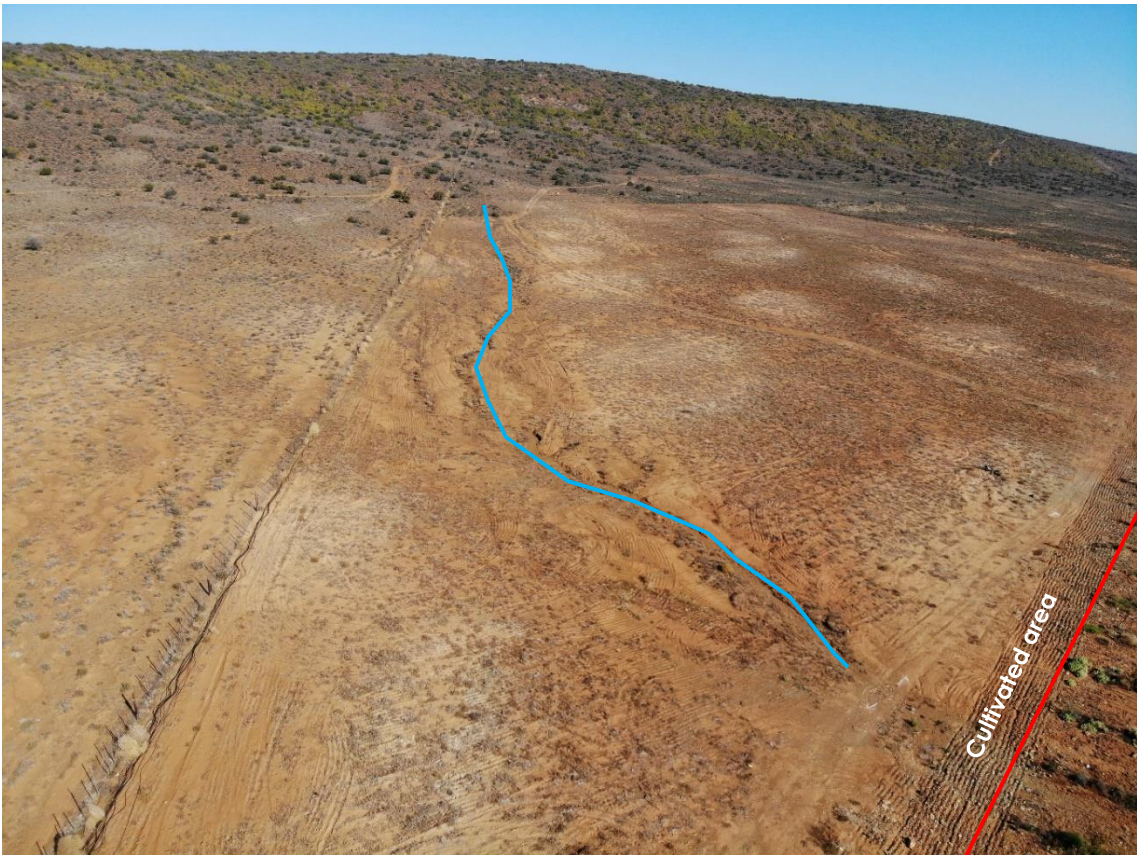
Figure 3: View of the drainage line (blue line) running through the ripped area entering the planted
Zhending in the cultivated area.

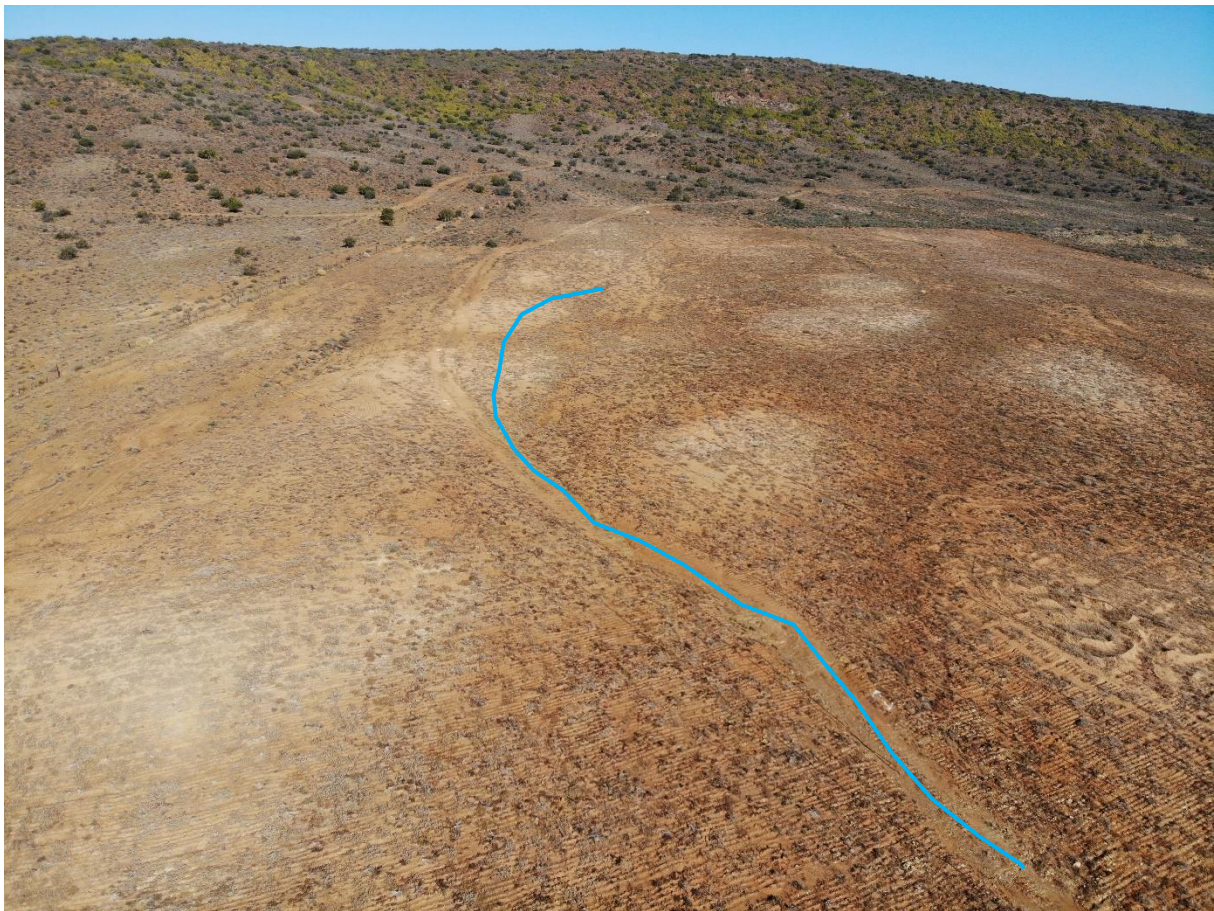
Figure 4: View of a drainage line (wash area) [blue line] into the proposed cultivated area.

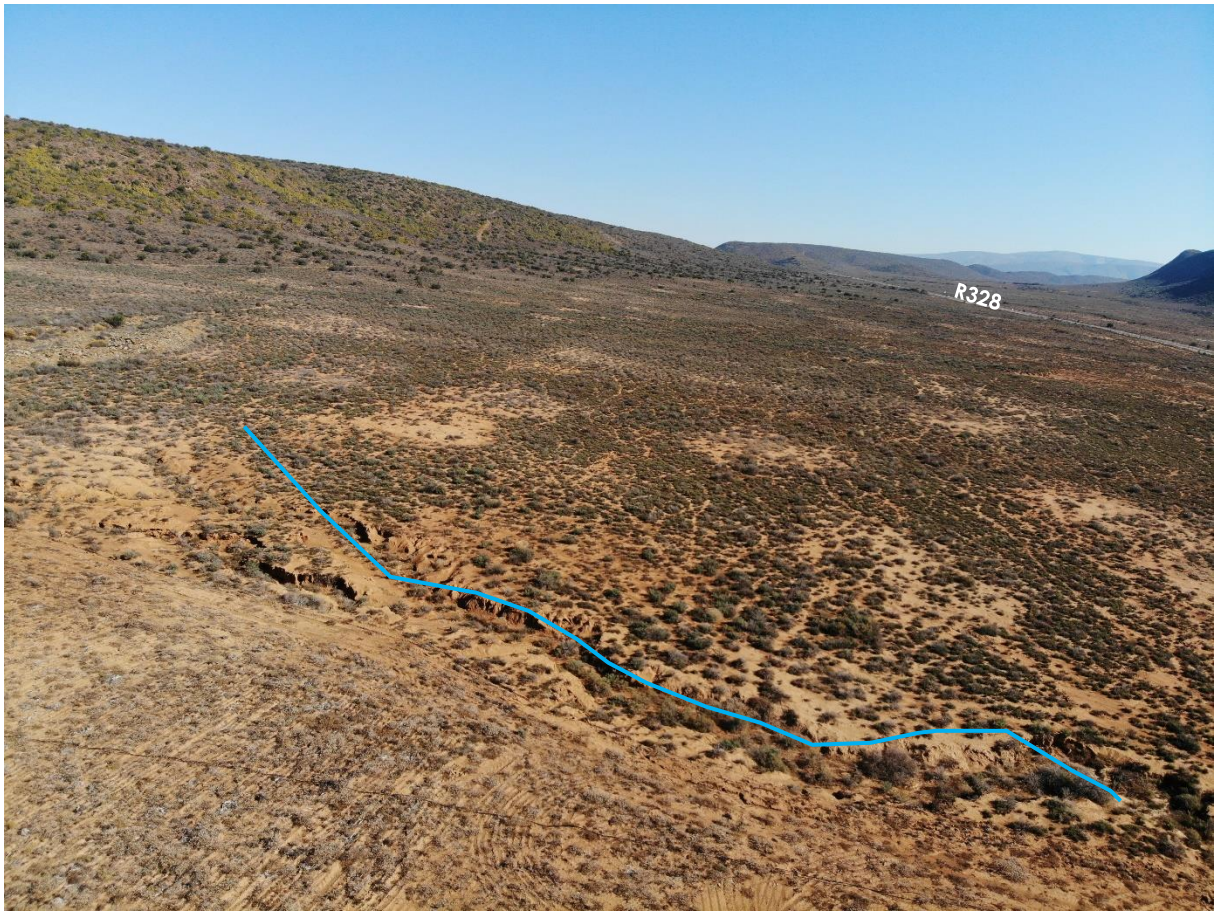
Figure 5: View of the most western drainage line within the proposed cultivation area creating the western boundary of the proposed cultivation area. Indigenous vegetation in the background but not of high sensitivity.

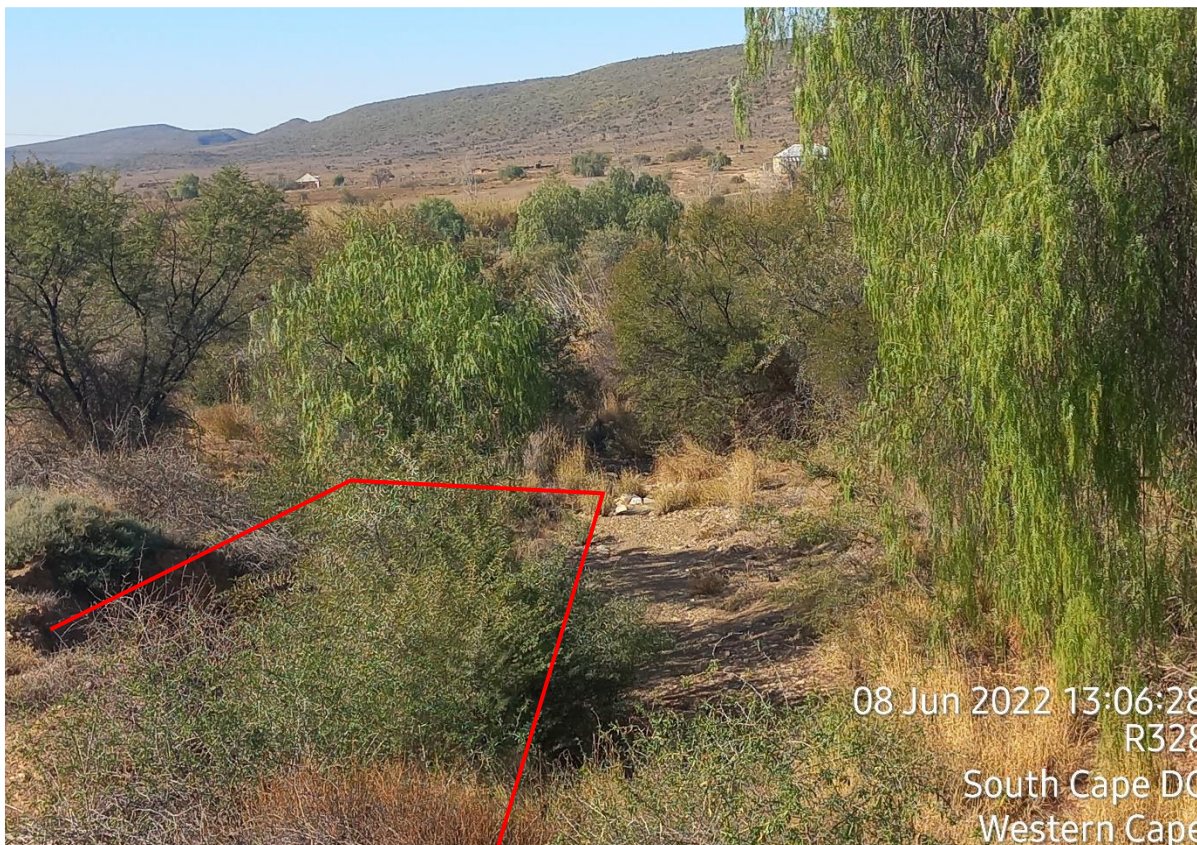
Figure 67: View of the area after the pipeline was constructed. the image shows the regrowth of vegetation within the disturbed area. The red polygon is where the northern bank was disturbed.
