Coastal Assessment

ARCH ROCK RESORT, FARM PORTION 5 OF 296
KEURBOOMSTRAND

Coastal Engineer's Report

December 2021

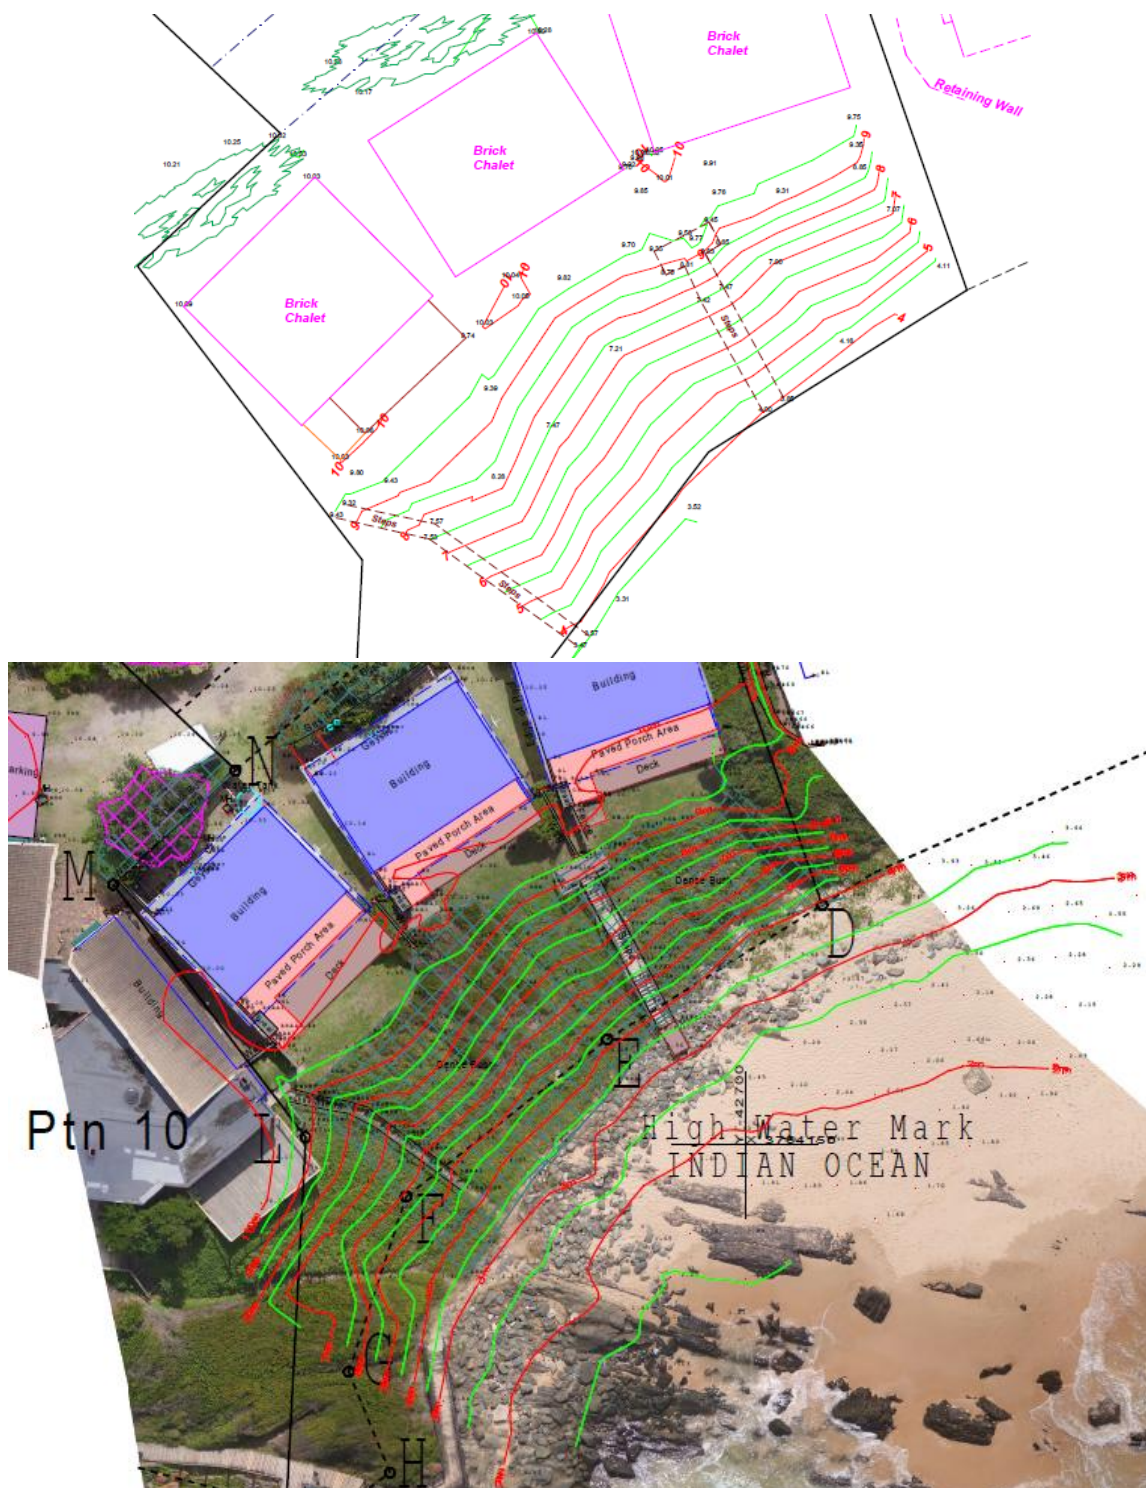
The contour levels on the seaward side of the property above mean sea level (MSL) are shown in Figure 4 (extracted from the provided surveyor's drawings). *There is a general fall (1.2%) across the site from the north to the south, with a steep slope (42% or 1:2.4) on the south down towards the beach (deVilliers&Hulme, Aug 2020).*

Figure 4: Extracts of site plans showing topographical levels (above MSL) on the seaward (southern) boundary (top: Beacon Survey, December 2019; bottom: VPM surveys, September 2020). See the original plans for full resolution.

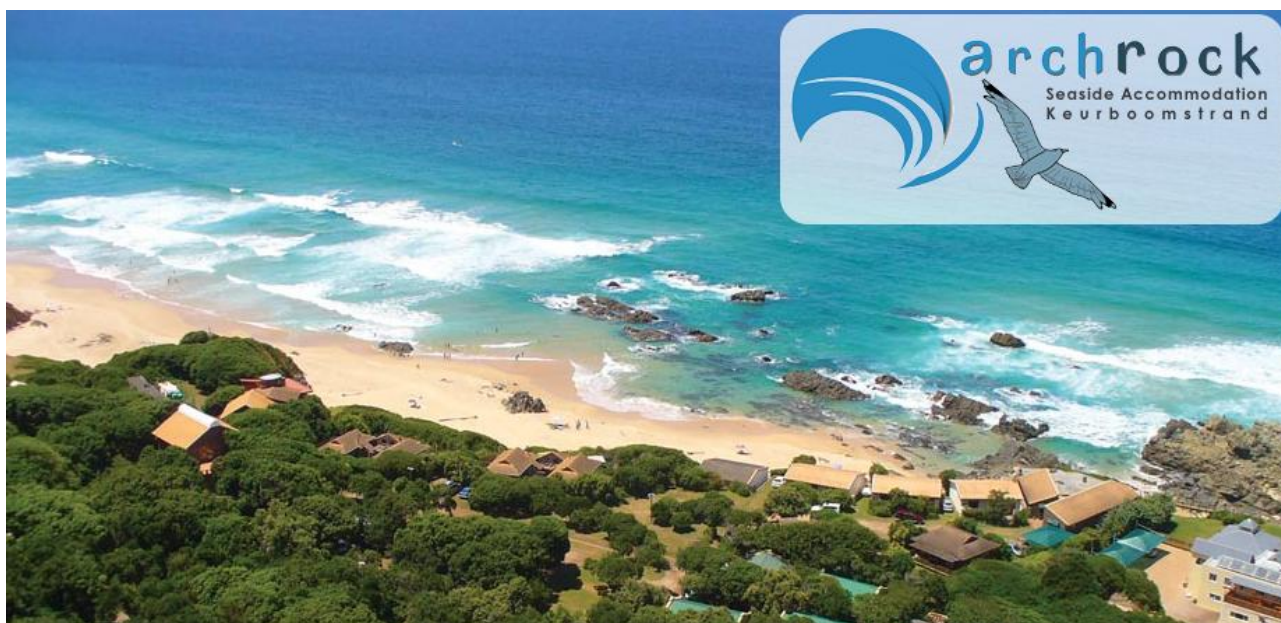
The nearshore bathymetry is shown in the Figure 5 below. The foreshore here has a moderate slope of about 1:30. A nearshore rocky reef offers some protection from wave attack (see Figure 6).

Figure 6: Photograph of the shoreline (archrock.co.za). A rocky reef provides some protection from wave attack and helps to retain sand on the beach in front of the property.

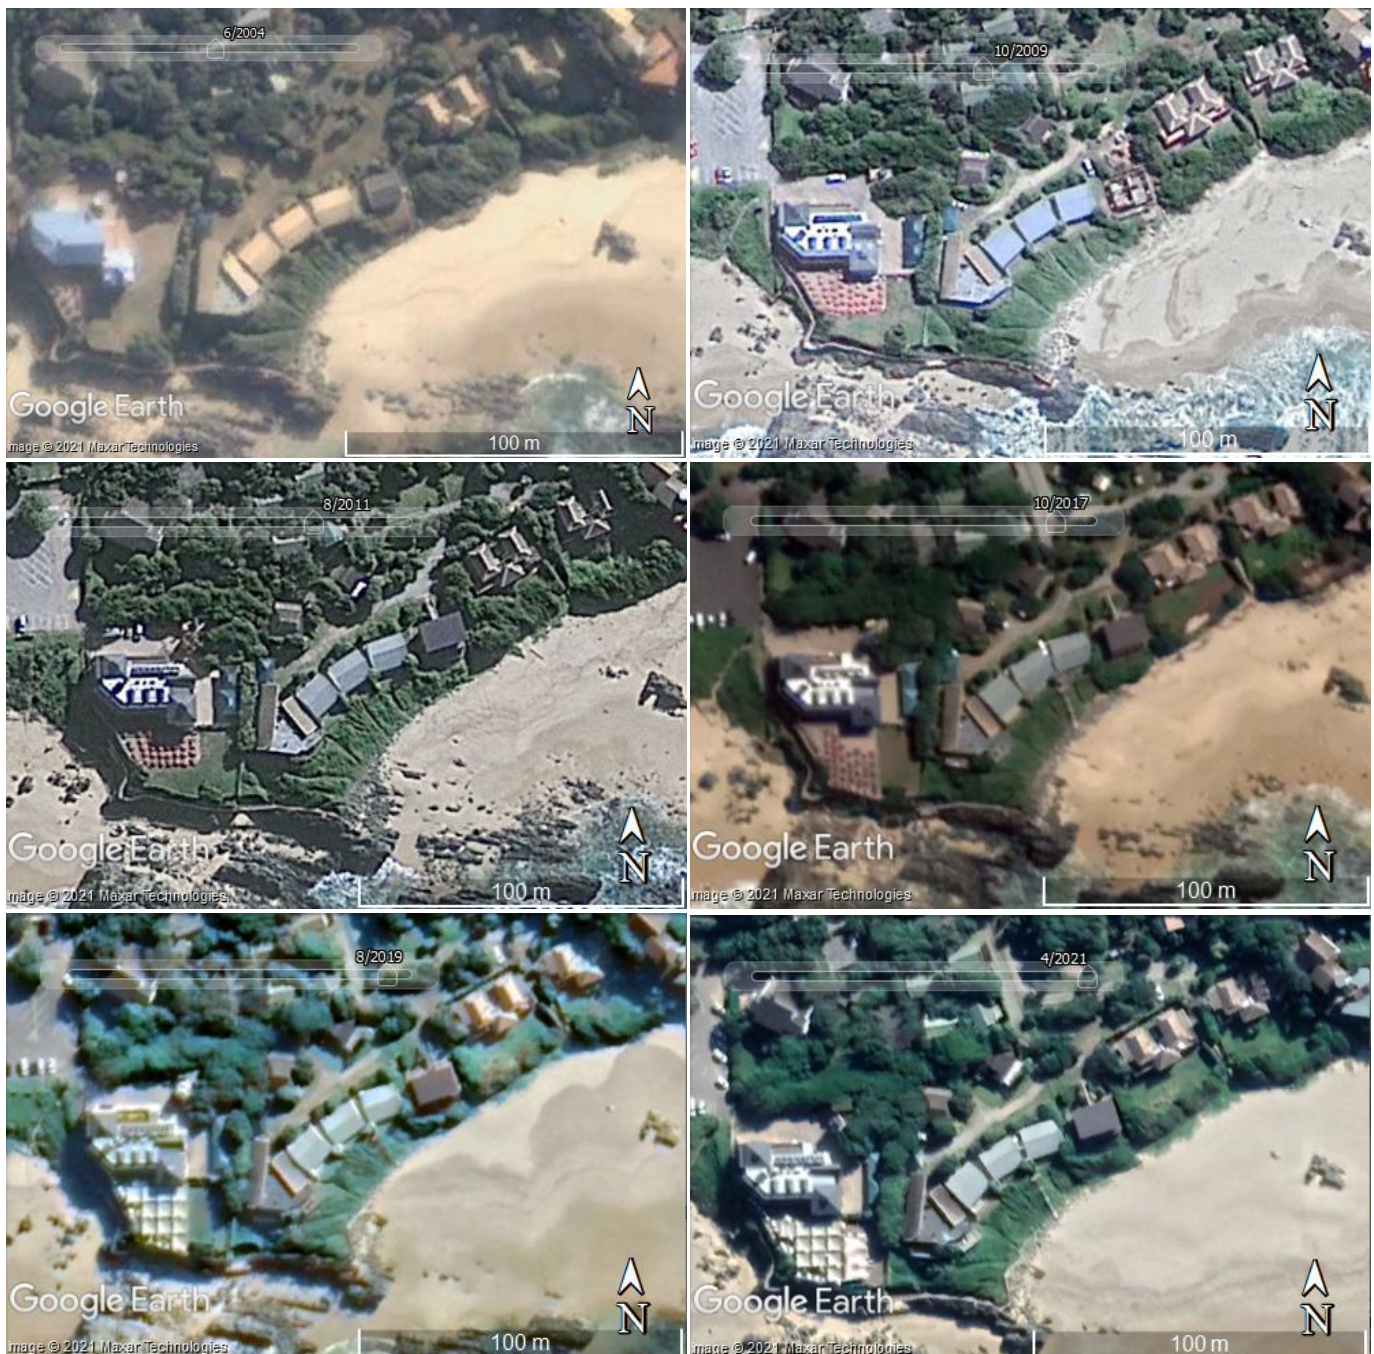
The beach sand erodes and accretes intermittently over time and appears to be “dynamically stable” over the past 17 years (the period of available historical satellite imagery of sufficient resolution). The vegetation line appears to have remained stable over this period and the density of vegetation on the steep seaward slope (natural erosion protection) appears to have improved following replacement of the older beach access pathways with an elevated wooden staircase (see Figure 9). The effects of climate change (including sea level rise and increased storm intensity) can nonetheless be expected to pose increasing risk to the beachfront properties in this area.

Figure 8: Selected satellite images of Keurboomstrand Beach between 2004 and 2021 (Google Earth)

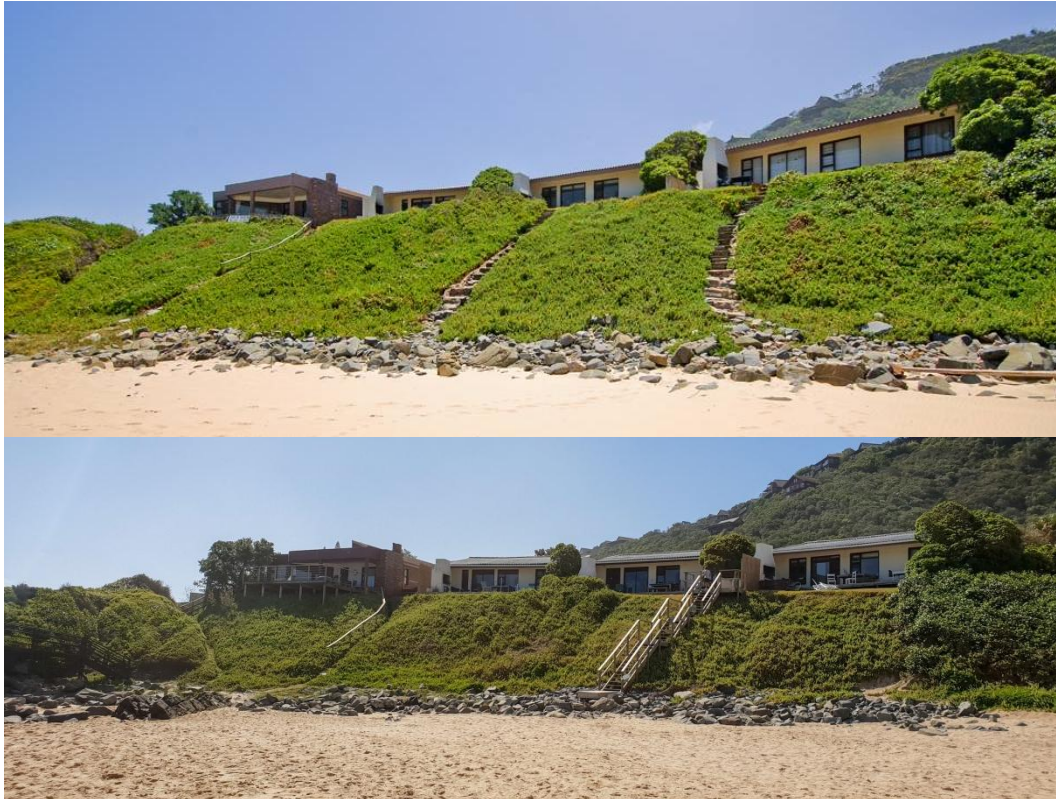
Figure 9: The vegetation density on the seaward slope appears to have improved following replacement of the older beach access pathways (top, archrock.co.za) with an elevated wooden staircase (bottom, twitter.com @Arch_Resort)

The vegetation covering the steep beachfront slope offers considerable erosion protection. Care should be taken to limit damage to this vegetation during construction activities and future use. A specialist dune vegetation assessment and management plan is recommended to ensure that suitable indigenous species are present to provide optimum bank stabilisation. Beach access pathways should not allow vegetation trampling / disturbance as these create vulnerable zones which can compromise the stability of larger sections of slope during a large storm event. As noted above, replacement of the older access paths with an elevated wooden stairway several years back appears to have already gone a long way to improving the natural erosion protection.

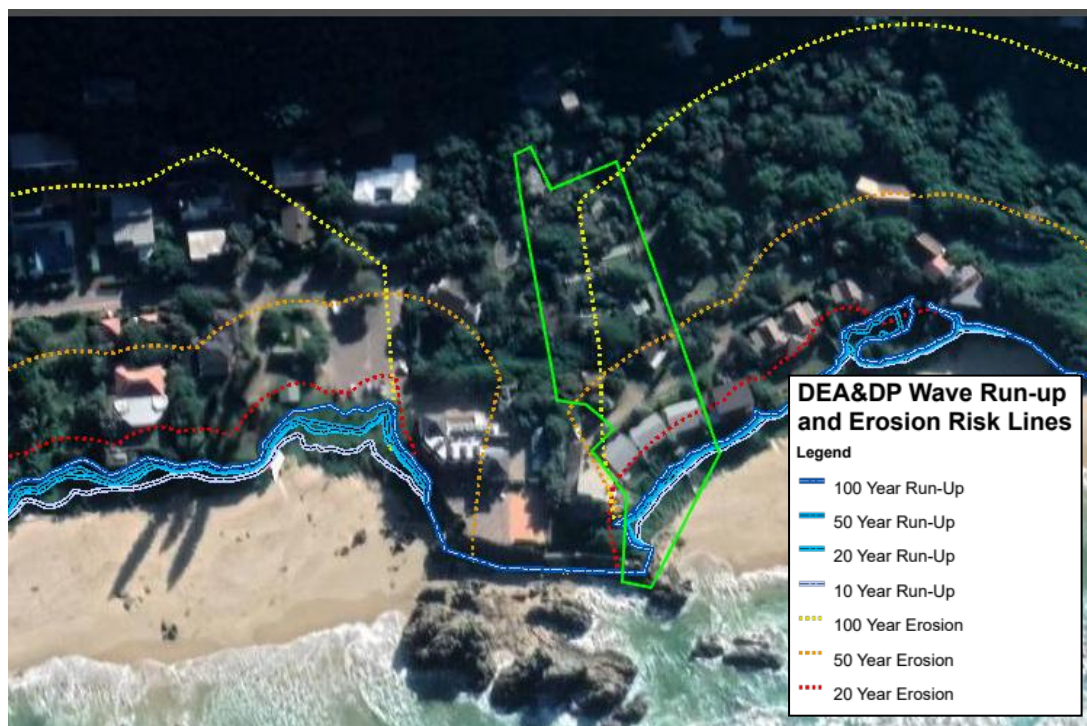
Figure 10: DEA&DP Eden District wave run-up and erosion risk lines at Keurboomstrand

The DEA&DP erosion risk lines (Figure 10) indicate that significant parts of the property may be at high risk of coastal erosion in the near future. However recent historical trends at the site, which is protected to some extent by the presence of a nearshore rocky reef, indicate **relatively low coastal erosion risk at present**. We therefore believe that the erosion risk lines shown in Figure 10 over-estimate the local erosion risk at this property (Farm Portion 5 of 296, Keurboomstrand). **Nonetheless, the effects of climate change will pose increasing risk in the future and coastal erosion is a concern for this property**. The beachfront units are considered to be possibly at risk of damage due to coastal erosion. The proposed geotechnical investigations (recommended prior to detail design) will shed further light on the extent of the erosion risk.
