## Appendix C: Site Photographs

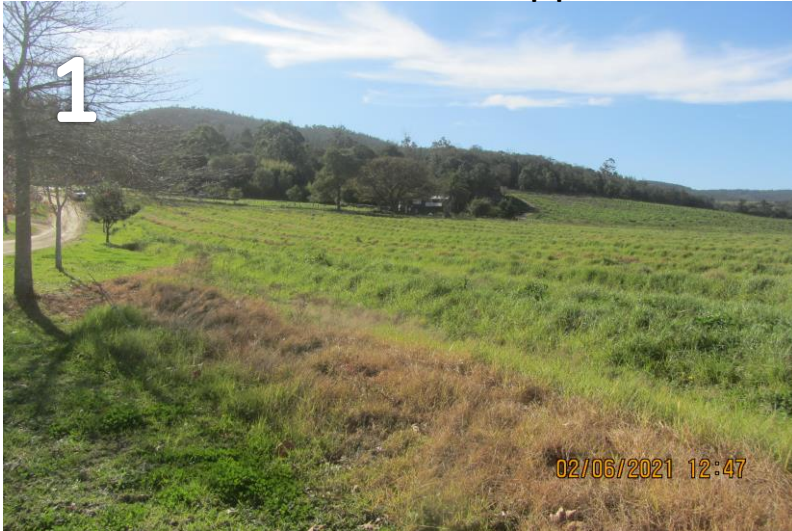
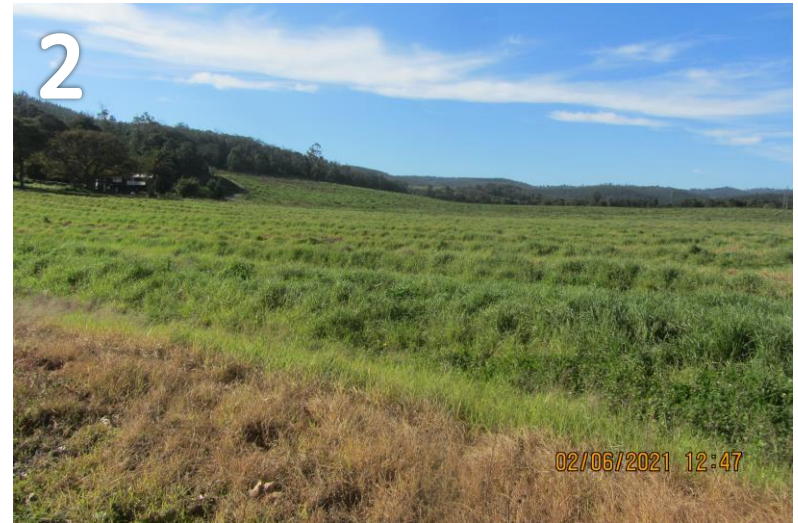
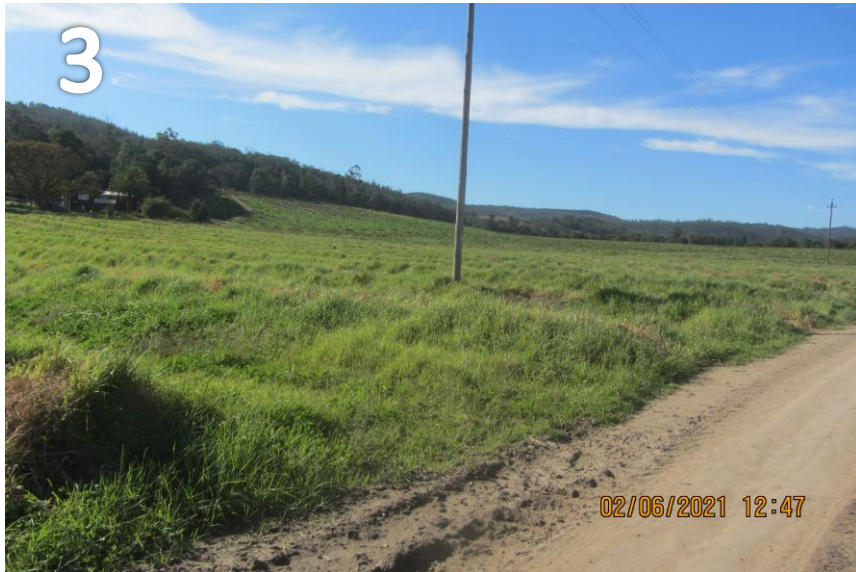
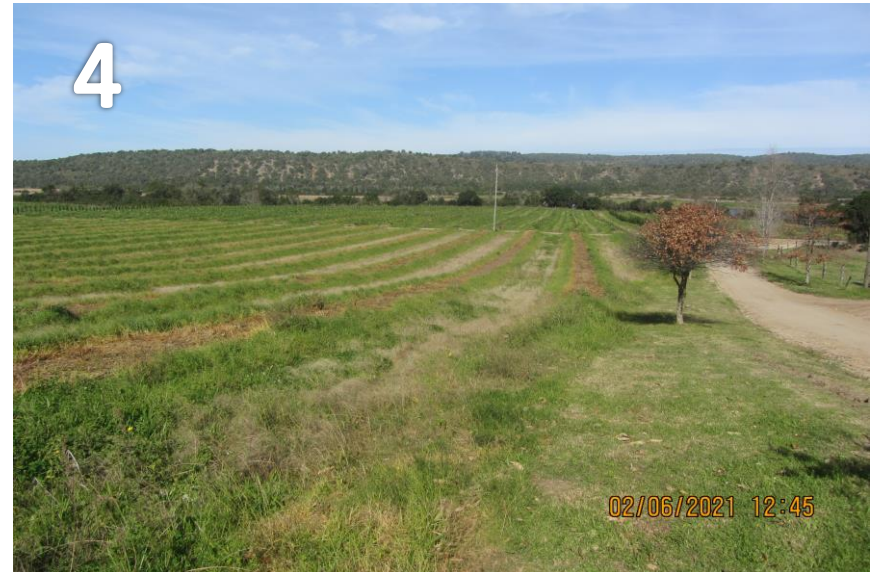
Photos 1 – 4 show the area that is being proposed for the development of the new off stream dam. The area has been extensively utilised for crop growing over many decades and has been chosen as it is one of the very few places on the farm with suitable dam building material available.

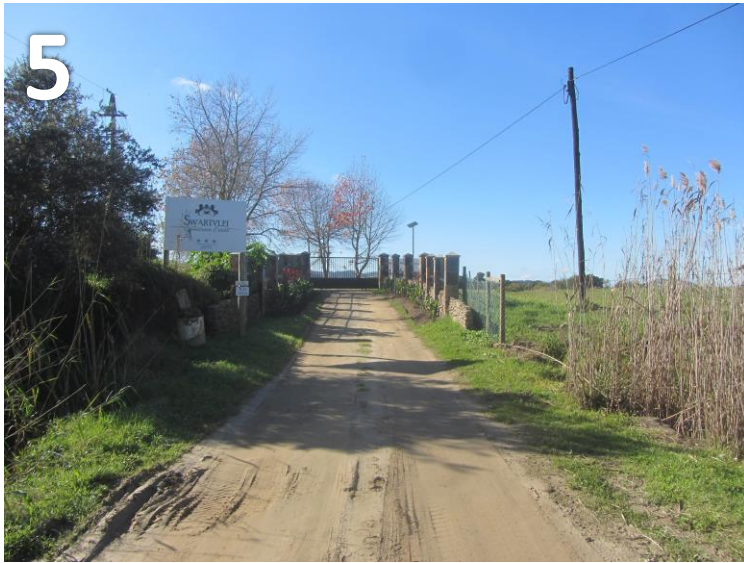
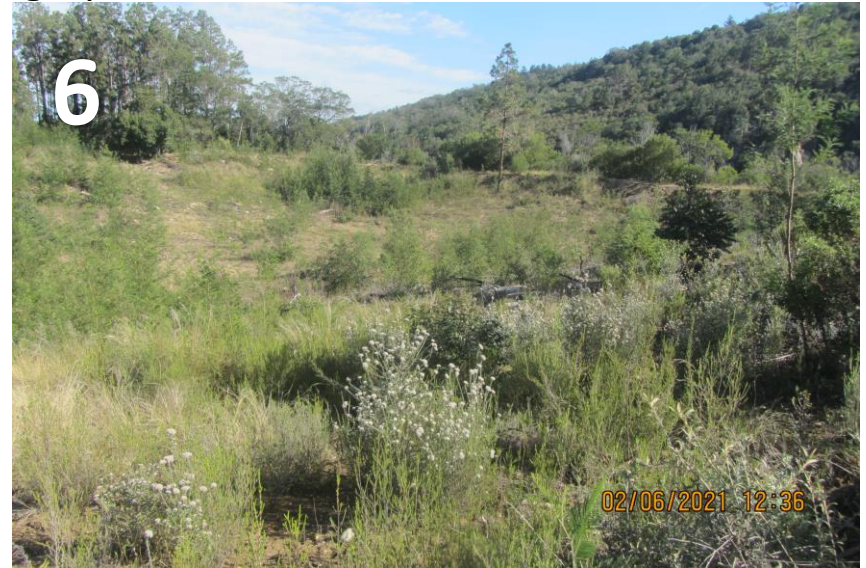
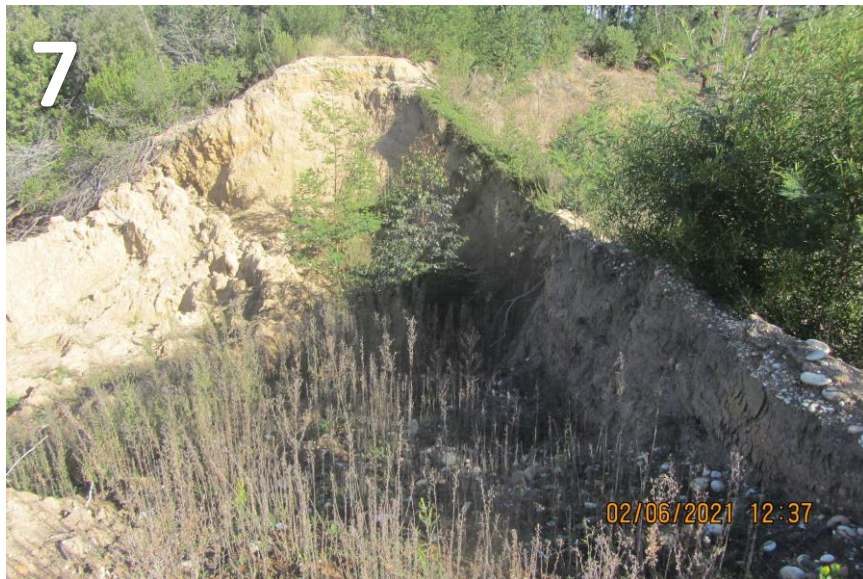
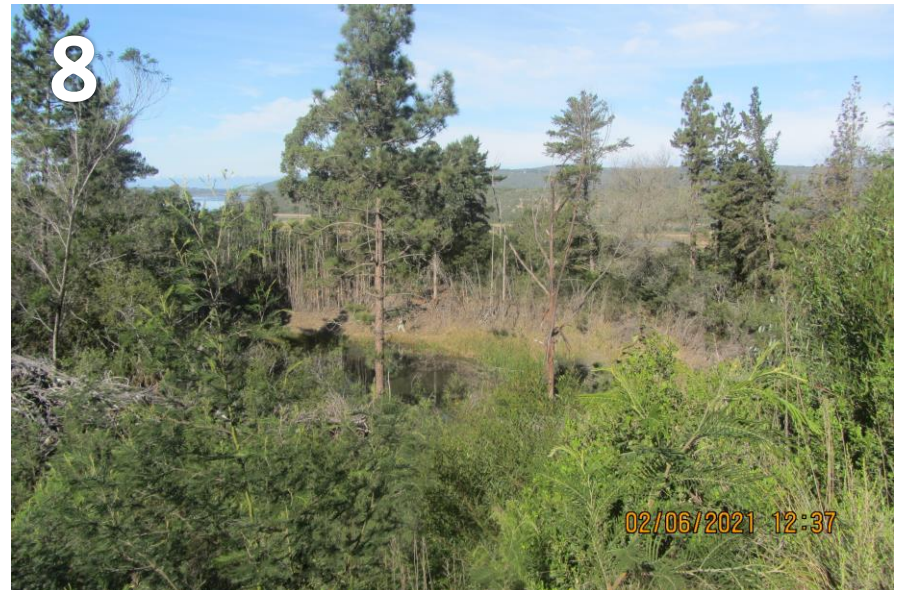
Photo 5 shows the entrance to the property. Photo 6 shows one of the old dams, with Photo 7 showing the failure of the dam wall. Note the type of material that would have led to the failure. Photo 8 shows the 2<sup>nd</sup> of the dams which will be replaced by the new dam.

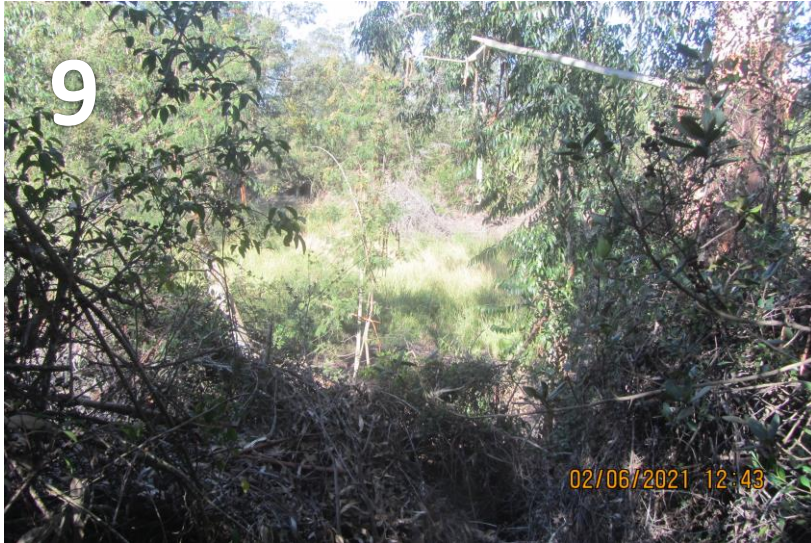
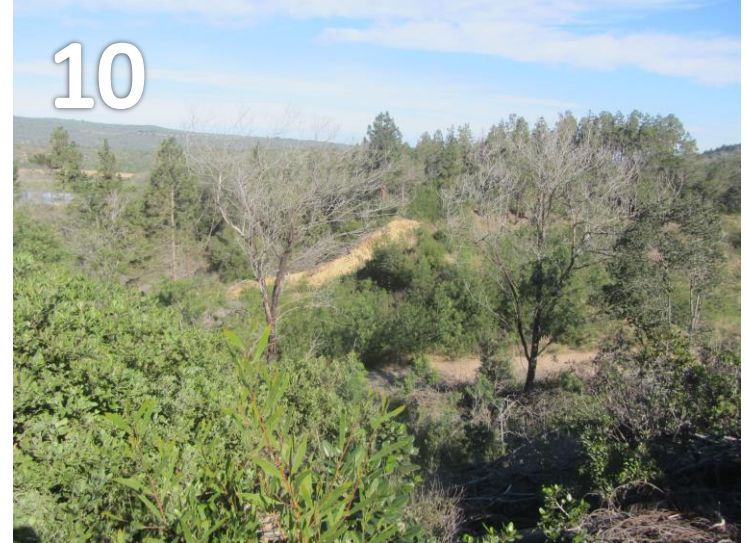
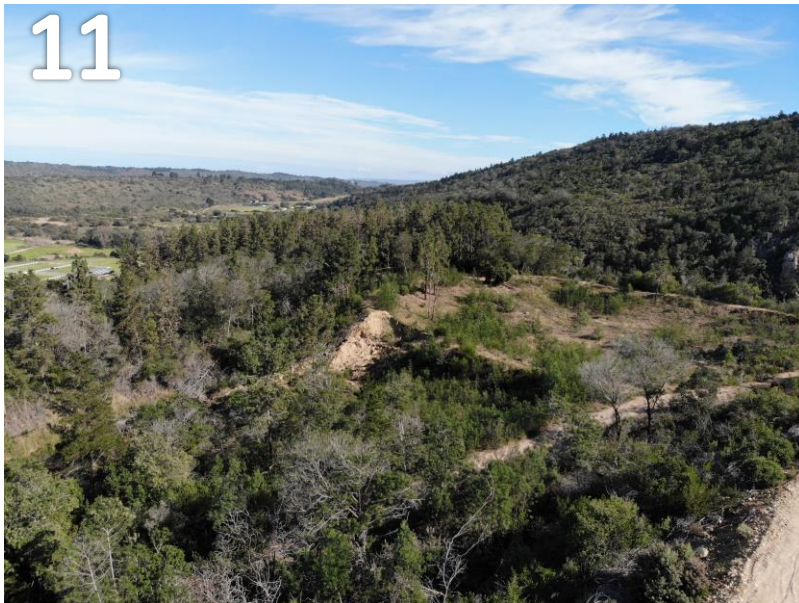
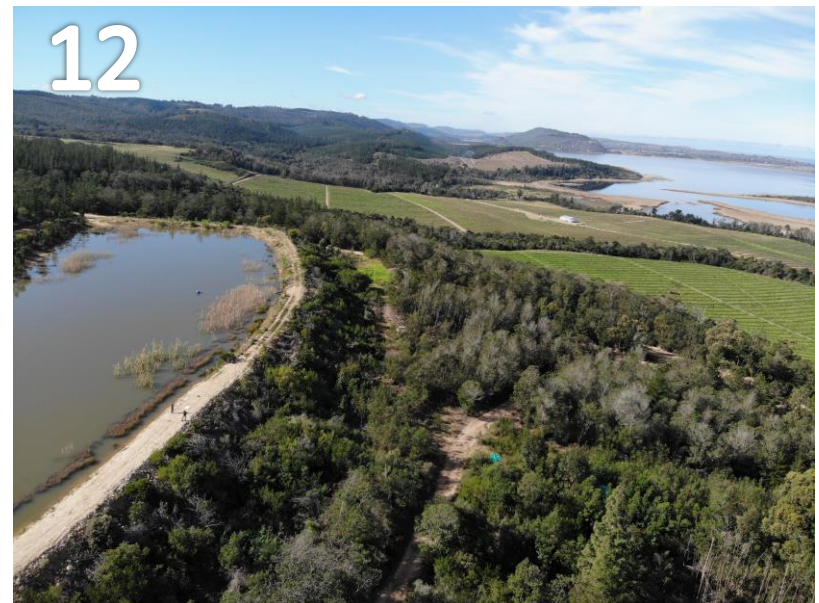
Photo 9 shows the 3<sup>rd</sup> of the dams to be replaced. Note in all photos the levels of alien invasive infestation that must be managed. Photo 12 shows the remaining dam from which water in the new dam will be obtained via gravity feed.

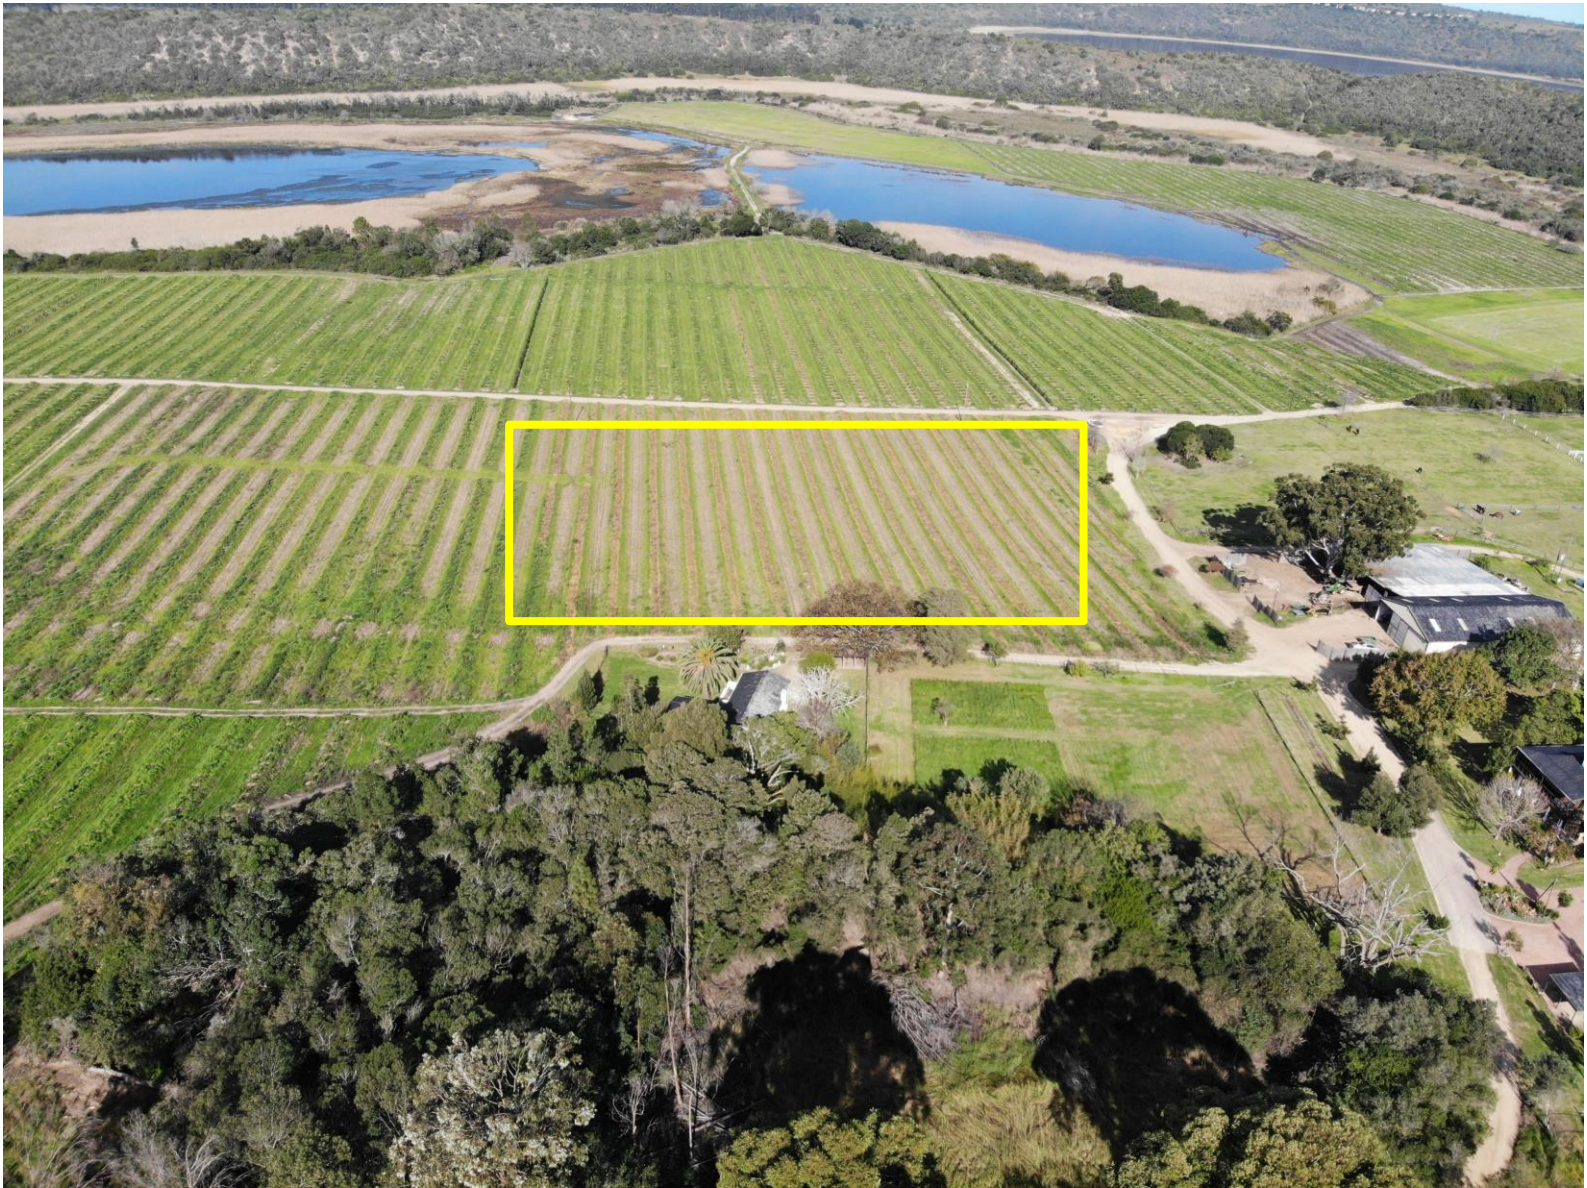
14

Aerial image showing the approximate location of the new storage dam on the existing agricultural lands.
