**HERITAGE IMPACT ASSESSMENT:  
PROPOSED SUNVELD SOLAR ENERGY FACILITY ON  
DOORNFONTEIN A 118 AND KRUISPAD 120, PIKETBERG  
MAGISTERIAL DISTRICT, WESTERN CAPE**

Required under Section 38(8) of the National Heritage Resources Act (No. 25 of 1999)

HWC Case No.: HWC23091509MS0918

Sunveld PV Solar Energy Facility

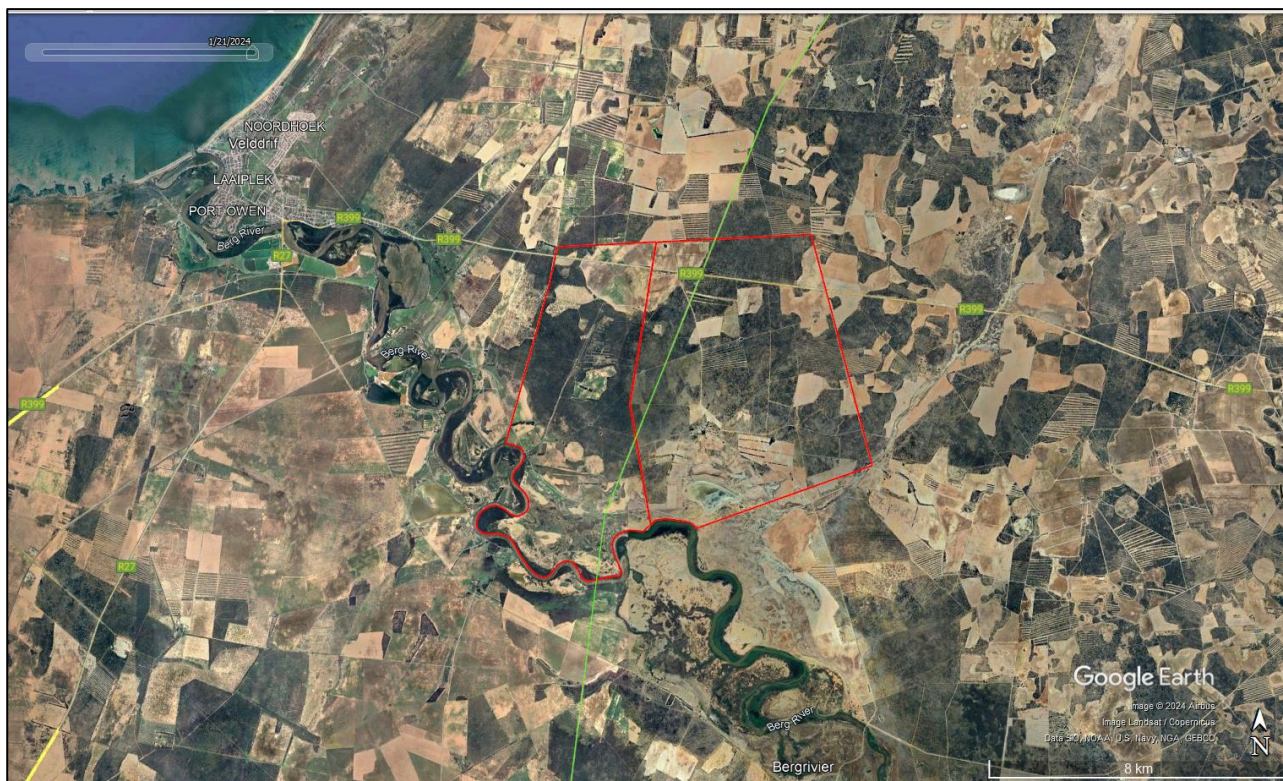
**Figure 4:** Aerial view of the study area (red polygons = affected farms) showing the landscape context and position of the existing Eskom HV powerline (green line).

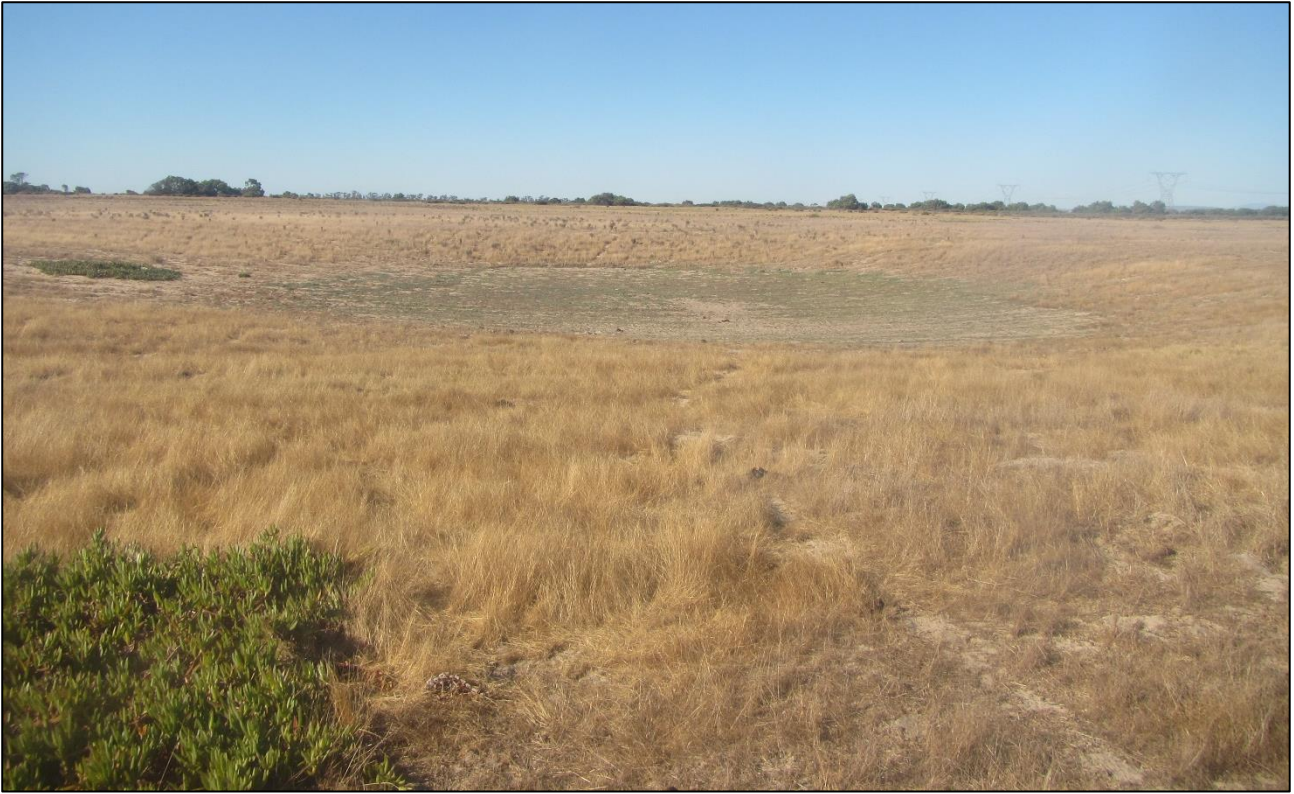
**Figure 11:** Looking west across a small endorheic pan in the north-eastern part of the study area (January 2024).

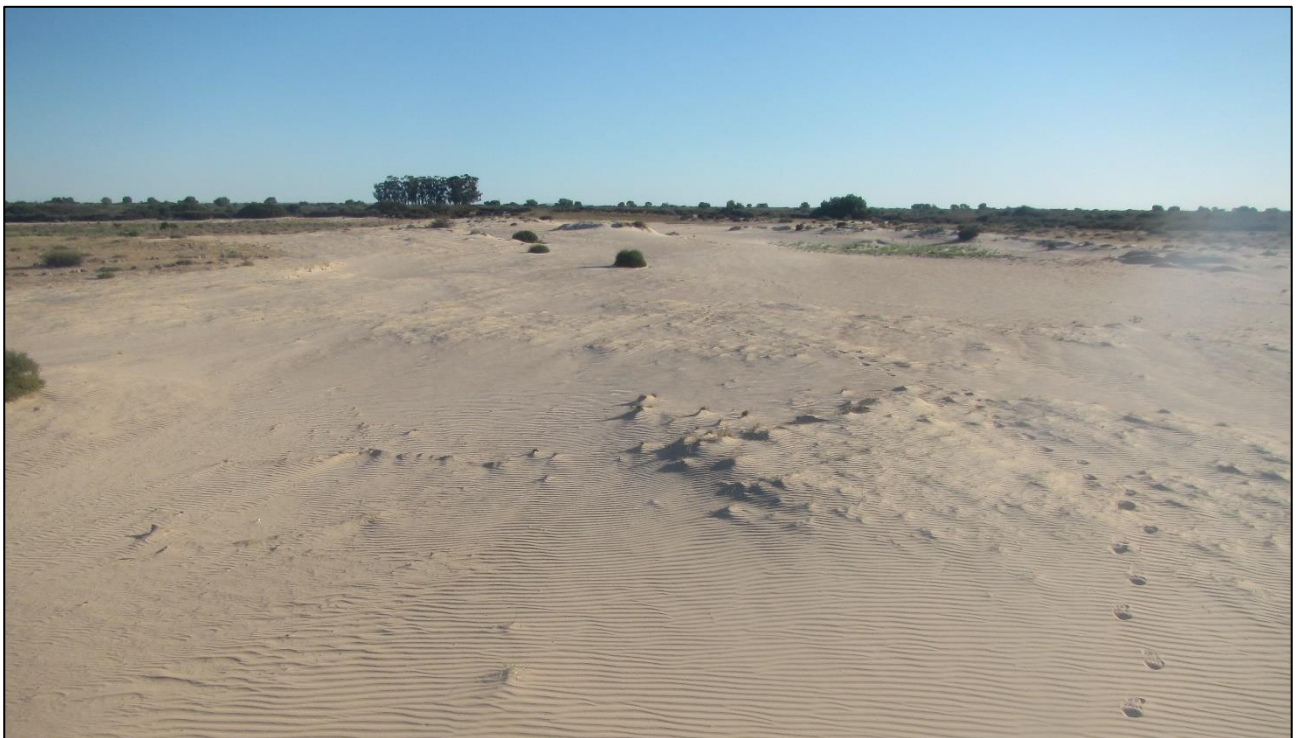
**Figure 14:** An area of deflating and mobile dune sand in an old arable land in the eastern part of the study area (January 2024).

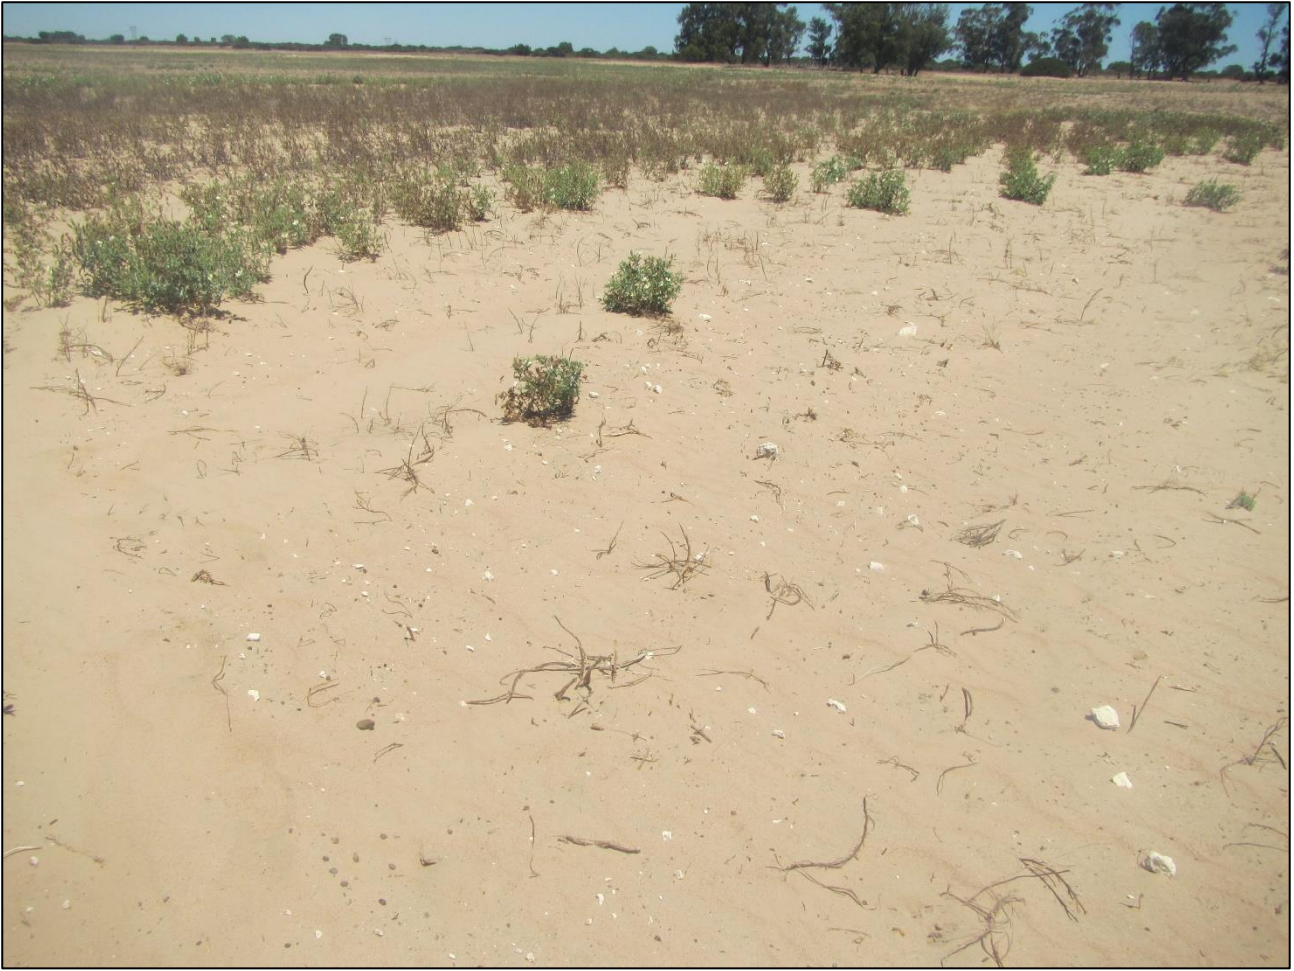
**Figure 15:** View towards the west in the centre of the study area, south of the R399, with calcrete fragments on the surface (January 2024).

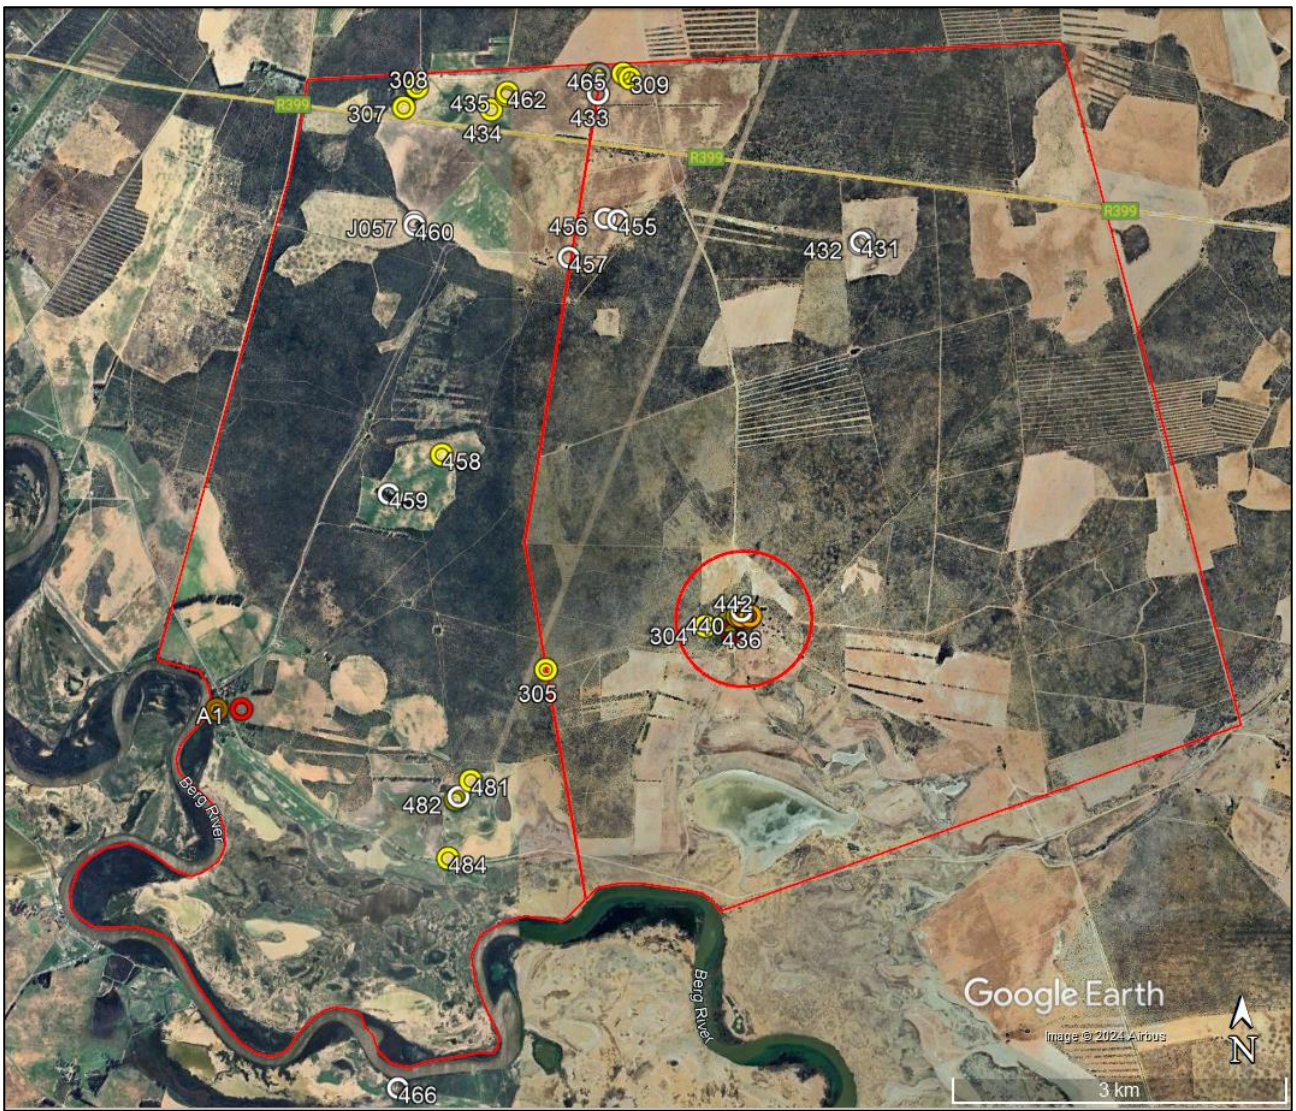
**Figure 16:** Aerial view of the study area (farm portions in red) showing the locations of the recorded sites by grade. Red = Grade IIIB, orange = Grade IIIC, yellow = Grade IIIC, white = NCW.

This section describes the heritage resources recorded in the study area during the course of the project. A full illustrated list is provided in Appendix 2, and the mapping is shown in Figures 16 to 21.

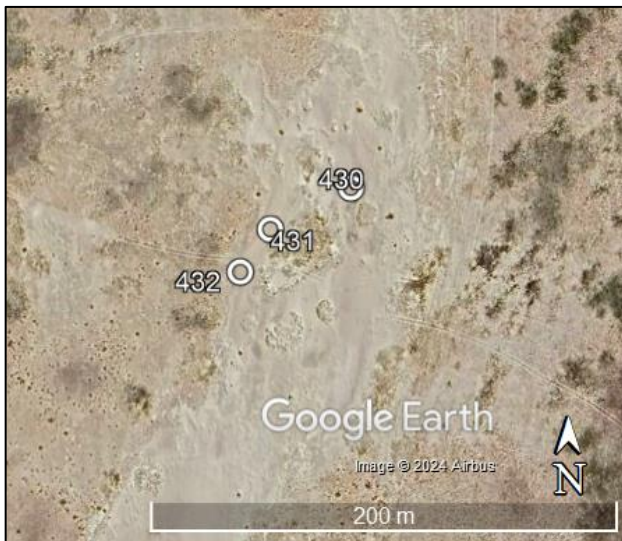
**Figure 18:** Enlargement of Figure 16.

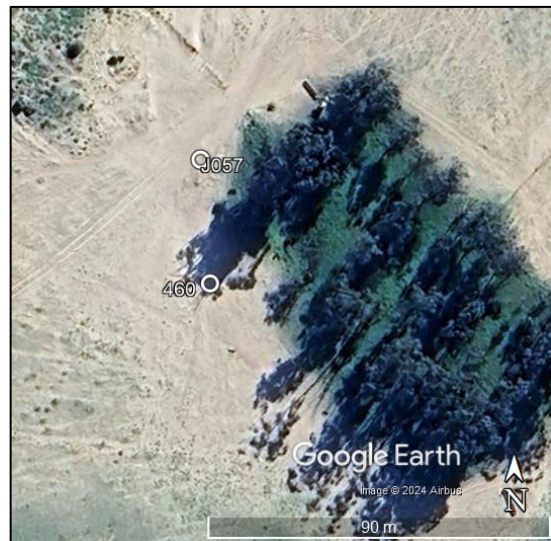
**Figure 19:** Enlargement of Figure 16.

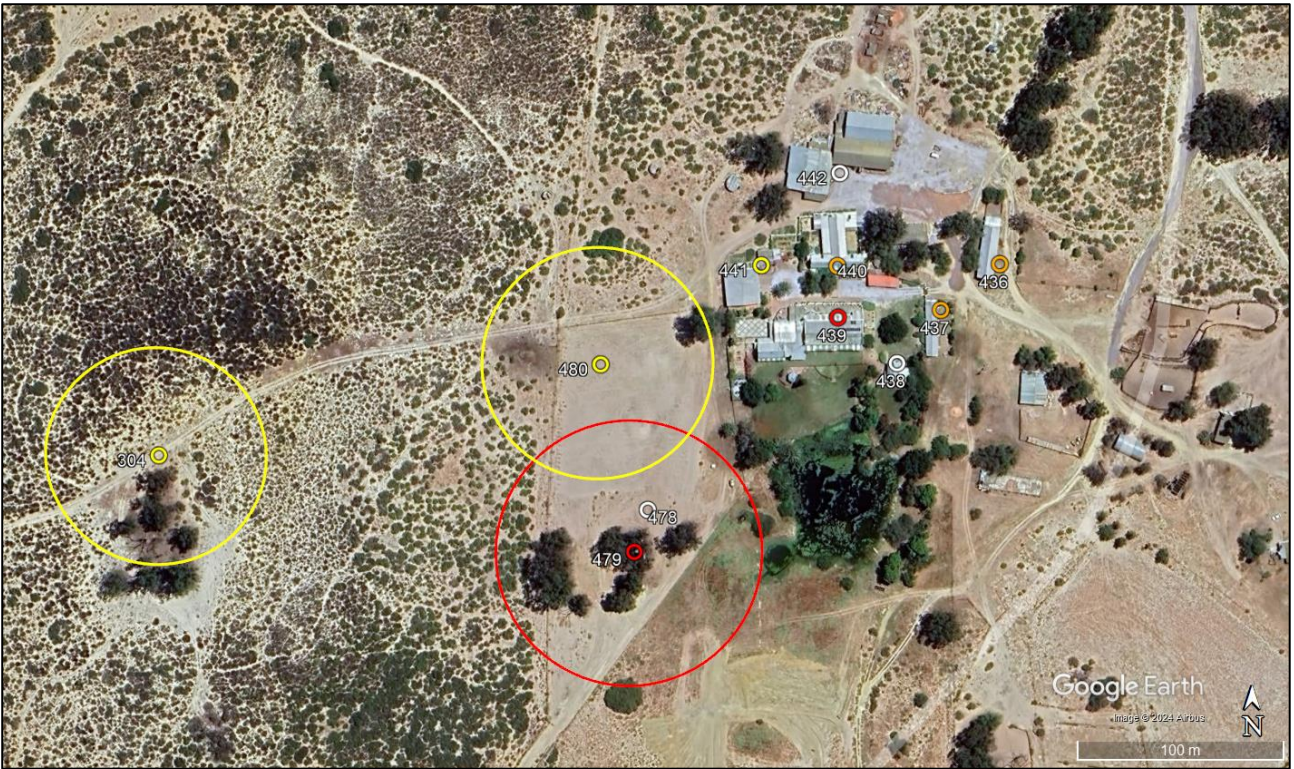
Figure 20: Enlargement of Figure 16.

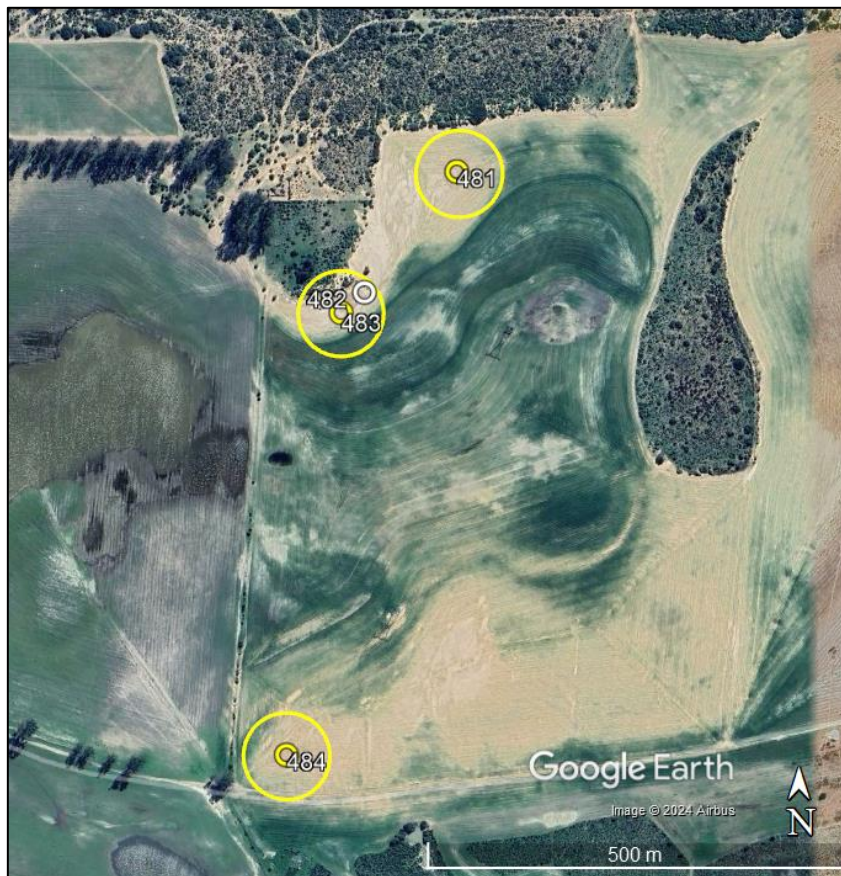
Figure 21: Enlargement of Figure 16.

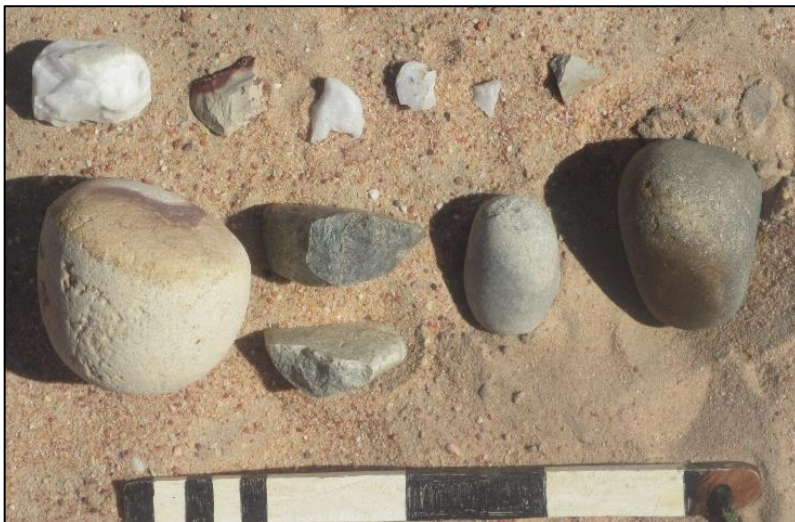
**Figure 24:** Stone artefacts from waypoint 434. Scale in 1 cm and 5 cm intervals.

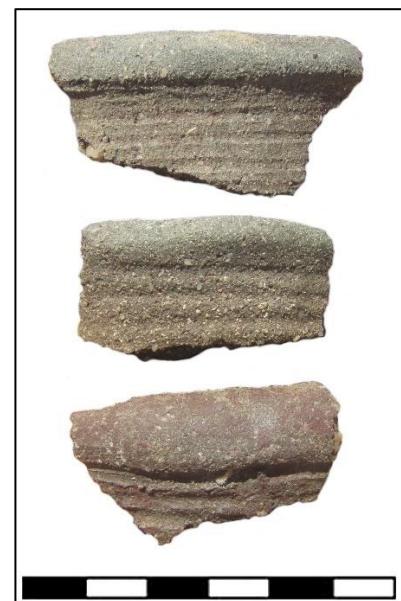
**Figure 25:** Decorated pottery from waypoint 483. Scale in cm.

from a single pot that must have once been buried in a dune there and which has become exposed and subsequently broken up. Three rim sherds with the same decoration were seen (Figure 25). The sites within the study area are generally of low significance but, being in an area from which no samples have ever been taken, they are still seen as important. A key element of these sites is their presence in ploughed lands. Such sites no doubt exist elsewhere too but cannot be found as the surface is not deflated. When ploughed fields lie fallow those artefacts that find themselves close to the surface will become exposed. Many more artefacts will be present beneath the surface. Ploughing will then rebury the artefacts until another fallow season allows some to be exposed. For this reason, sites can be present during one survey and 'gone' during another. As a result of this phenomenon, it is likely that many sites would be destroyed by development in areas that have avoided the visible archaeology and makes sampling of some scatters even more important.

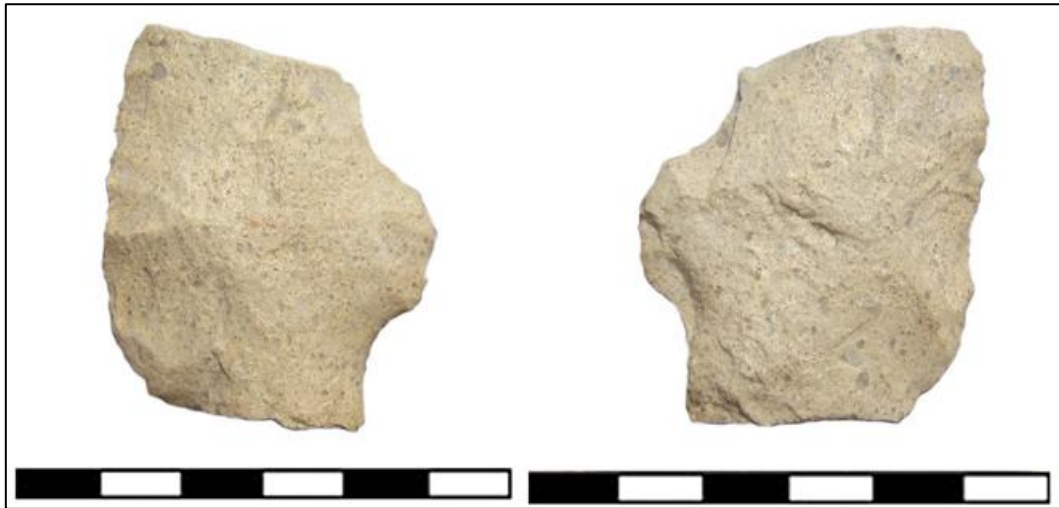
**Figure 26:** *Opposite faces of the fragment of Still Bay bifacial point. Scales in cm.*

Older material was found in only one place and this was on the edge of the Berg River floodplain very close to the pottery noted above. At this point some stone artefacts were associated with an exposure of fossil shell. While most of the artefacts were adiaagnostic, one was a mid-section of a bifacial point of the sort commonly ascribed to the Still Bay period of the MSA. The fragment appears to have come from an unfinished artefacts, perhaps discarded when it broke during manufacture.

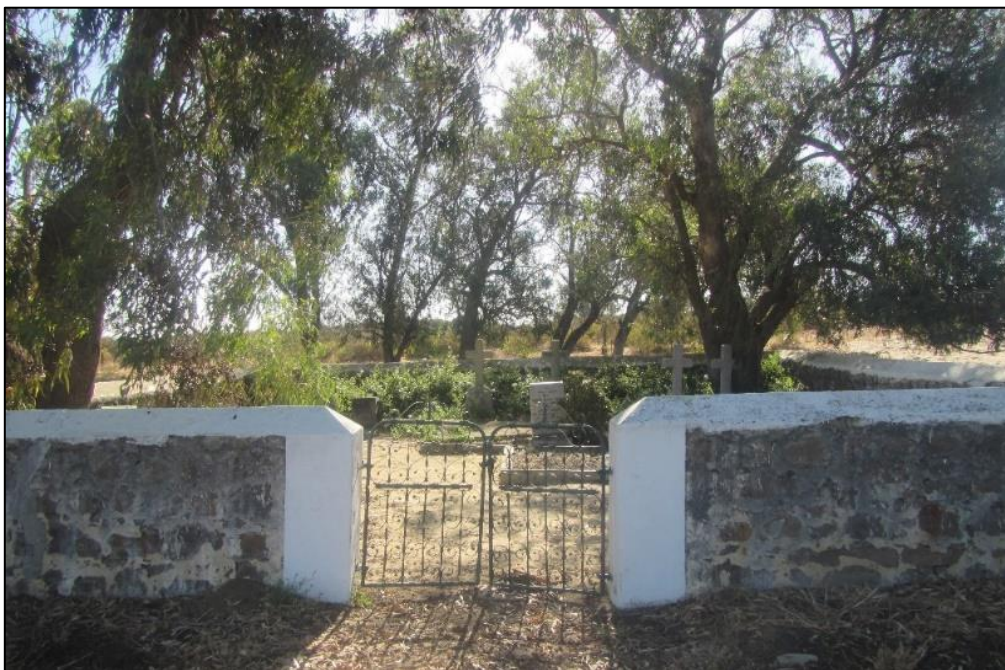
No isolated graves were found but the Melck family graveyard was recorded on the western side of the farmhouse (waypoint 479). The graveyard has a stone wall and contains nine graves with dates of death extending from 1918 to 2018 (Figure 27). According to a farm labourer, there is a workers' graveyard on the eastern side of the farmstead. It was not located during the surveys but is far from the development study area. From aerial photography a graveyard was also identified on Kruispad, but far away from the development area (Waypoint A1).

**Figure 27:** *Melck family graveyard at waypoint 479.*

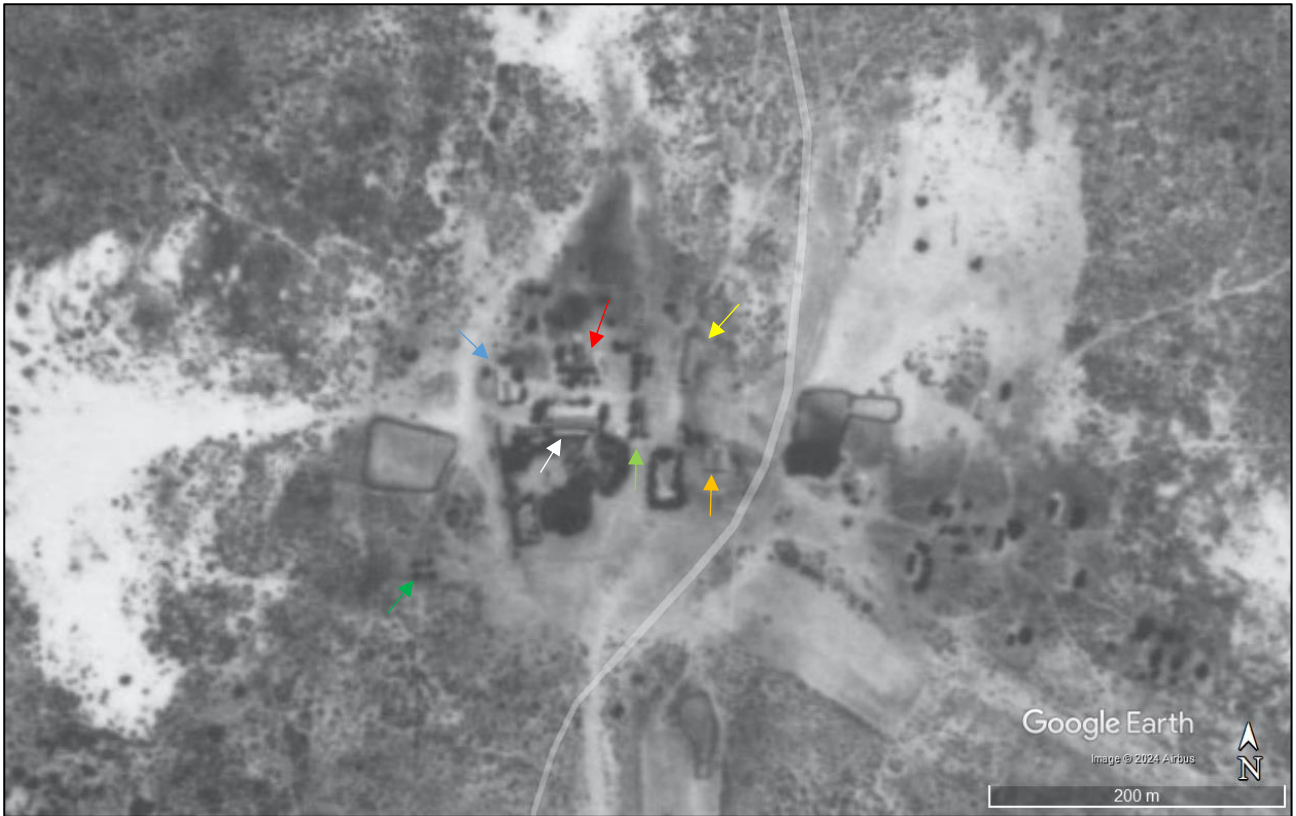
**Figure 30:** 1938 aerial photograph (126\_009\_50278) showing the Doornfontein farmstead. Dark green = graveyard (waypoint 479), blue = shed (waypoint 441), red = original farmhouse (waypoint 440), yellow = old barn (waypoint 436), orange = another outbuilding, light green = old barn (waypoint 437), white = current main house (waypoint 439).

The earliest aerial photography dates to 1938. Figure 30 shows the Doornfontein farmstead pretty much in its current configuration, although the small cottage southeast of the main house does not appear to have been present (according to the owner it was built in the 1950s) and the large sheds to the north of the farmstead were clearly absent. It also seems that all the labourers’ cottages spread out towards the southeast were already present, but one has evidently been demolished in recent years.

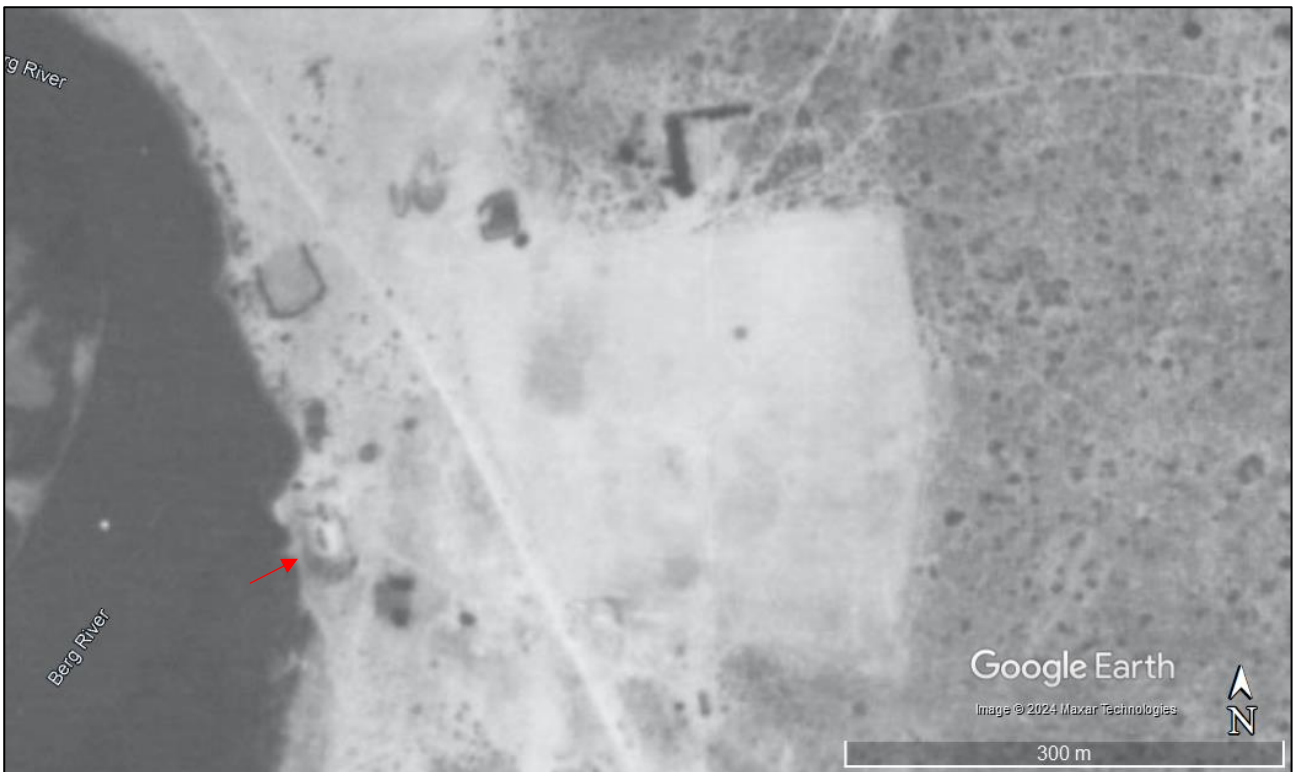
**Figure 31:** 1938 aerial photograph (126\_009\_50280) showing the Kruispad farmstead. The red arrow marks a house still present today.

Figure 31 shows the 1938 aerial view of the Kruispad farmstead. It is clear that the farmstead was very much undeveloped at that stage but at least one house (which still exists today) was present. A graveyard is visible on modern aerial photography 220 m east of the house but does not appear to have been present in 1938. It is clearly evident that, unlike Doornfontein, the Kruispad farmstead has largely developed since 1938. The 1960 aerial photograph, in fact, also shows relatively few structures. At both farmsteads it seems that the majority of the trees also postdate 1938.

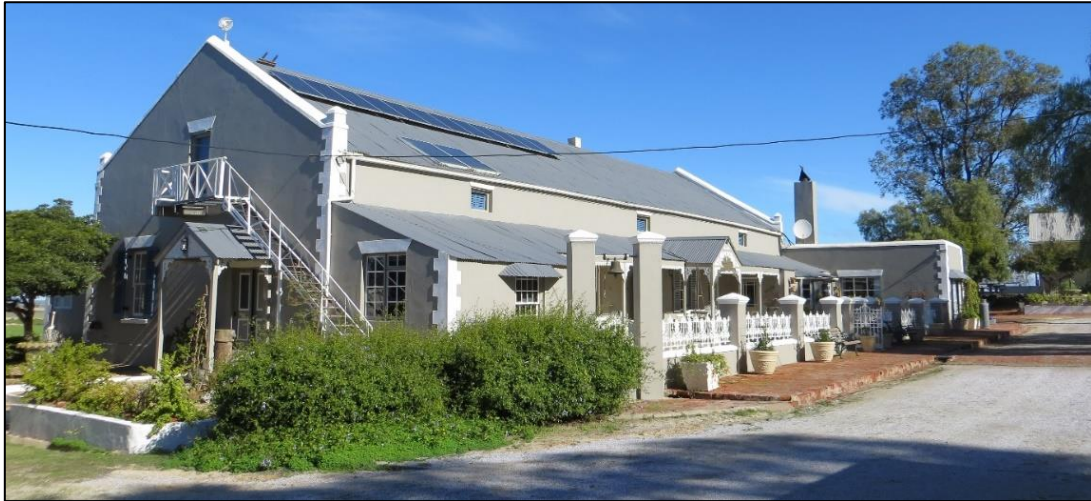
The site visit showed that historical sites are absent from the study area. All historical features noted in the desktop study are located well away from the development footprint. The Doornfontein farmstead was visited and recorded (waypoint 439) and is the most significant heritage resources in the study area. It has many historical structures, with the main farmhouse having been restored and renovated (Figure 33). It is unknown how much of the current appearance is modern, but the house seems to predate the Victorian period and was likely 'Victorianised' in the past with the recent renovations seeking to preserve that character. It faces south (downslope) towards the Berg River and a spring occurs in the garden on that side of the house. Just behind that house (i.e. to the north) is the older farmhouse (waypoint 440). This was once a T-shaped Cape Dutch house, but its gable collapsed and the repair followed the simplest route of removing the gable entirely (Figure 34). Additions and renovations have also been made to this house in recent years, especially on the north and west sides of the tail.

**Figure 33:** View of the north-eastern corner of the current main farmhouse on Doornfontein (waypoint 439).

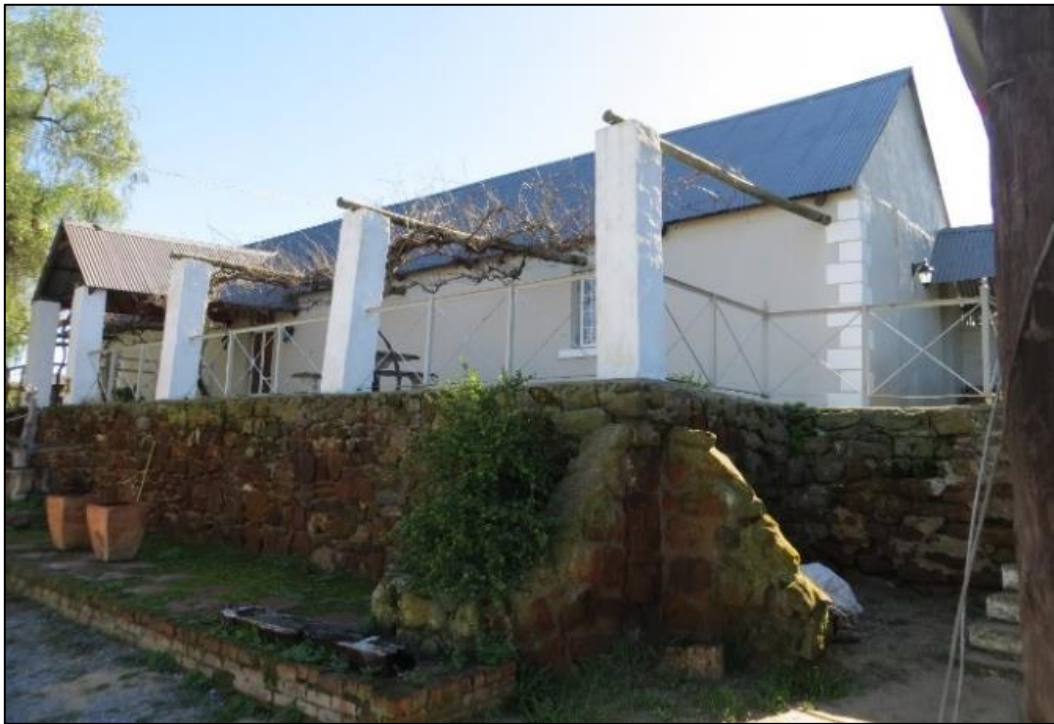
**Figure 34:** South-eastern corner of the older house on its large stone plinth (waypoint 440).

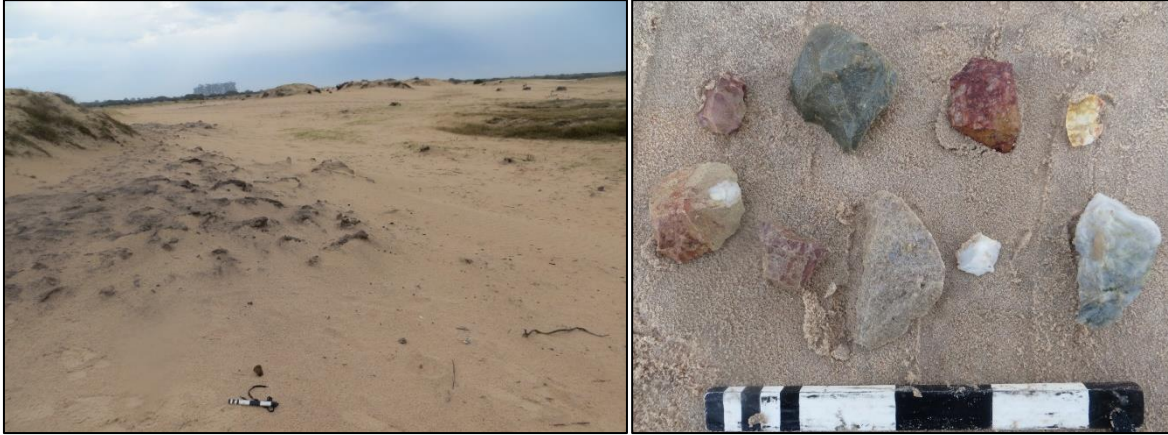
Waypoint	Location	Description	Grade
430	S32 48 20.9 E18 18 00.2	<p>Medium density 2x3m BGS in deflated area. Cores and flakes of quartz and silcrete. On revisiting this site 7.5 months later an ephemeral scatter of quartz, silcrete and 'other' flakes was seen along with one hammerstone.</p>

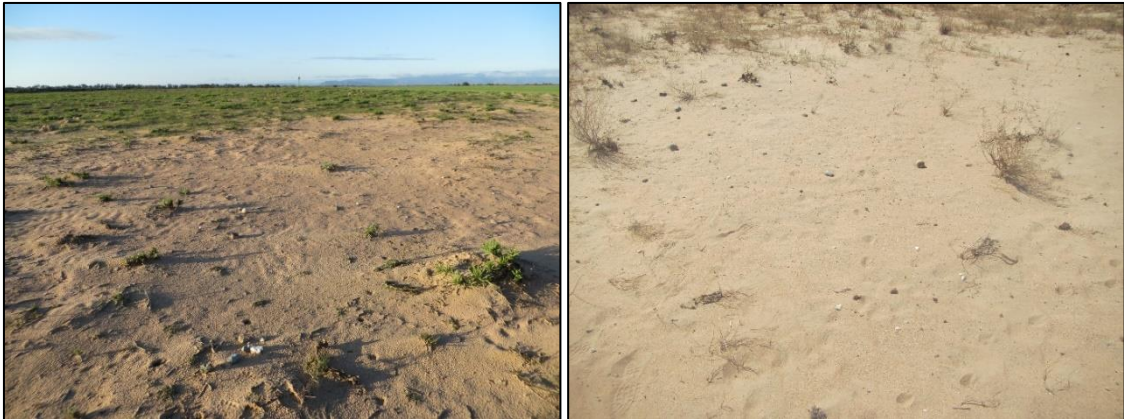
NCW
434	S32 47 43.2 E18 15 51.6	Medium density site in deflated, fallow area between two recently ploughed fields. 2 manuports, 5 hammer stones, two upper grind stones one upper grindstone/hammerstone, numerous flakes of quartz with minimal silcrete. Hammer stones and upper grindstones were of quartzite and other grey (probably metamorphic) rock. The main scatter is in an area of about 8 m by 8 m but there is light scatter around this area that extends up to 10-15 m from the core area.

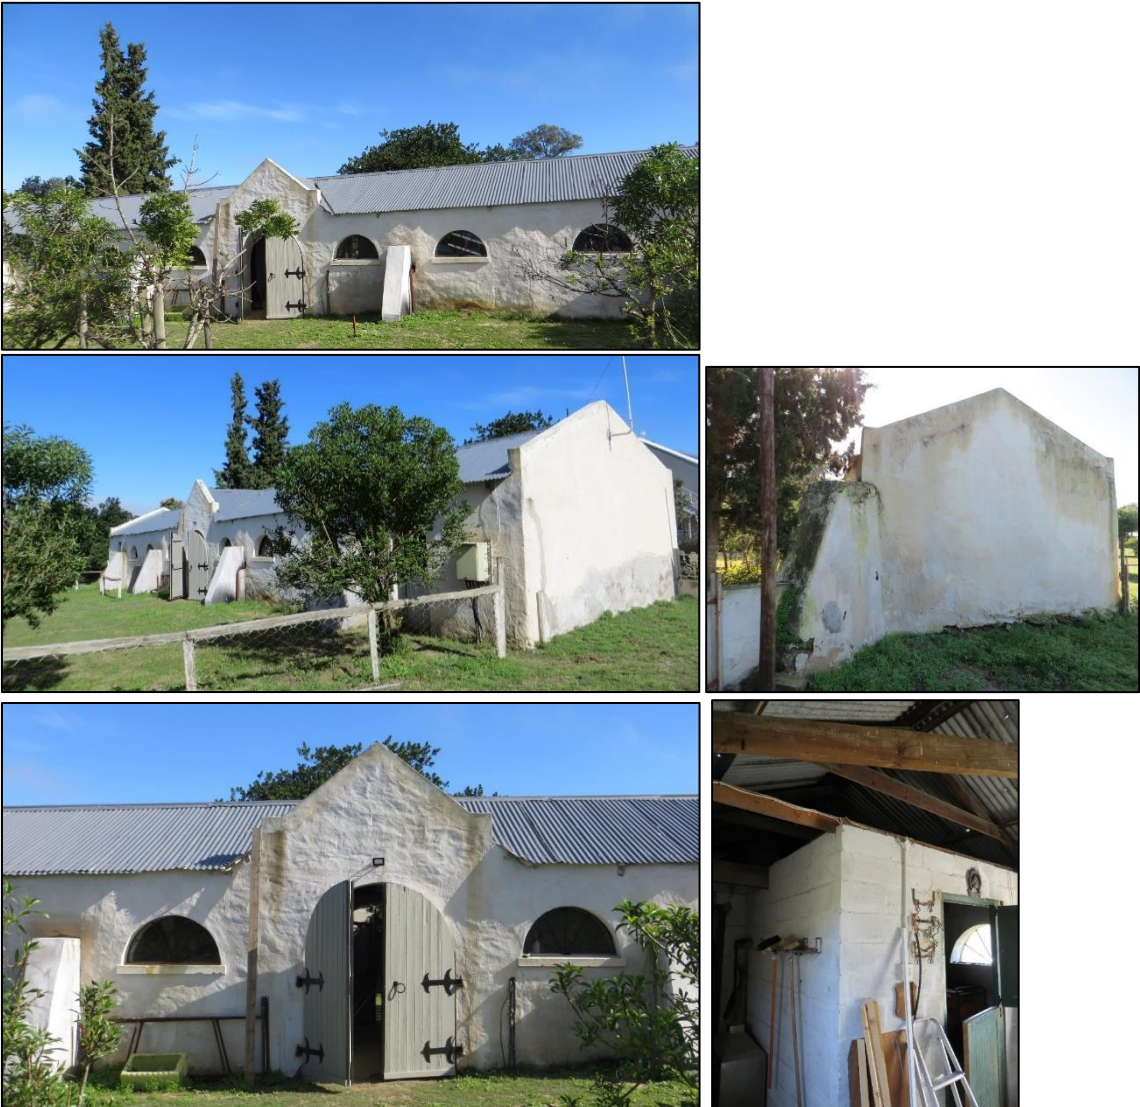
437	S32 50 10.5 E18 17 19.9	<p>Part of original farm buildings but fixed and repaired in subsequent years. Concrete cinderblocks inside. Part of Doornfontein farm complex (436-442) with complex is considered IIIA as a whole.</p>

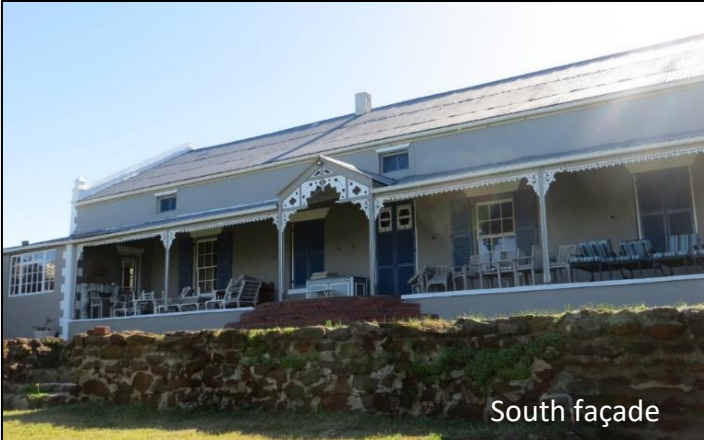
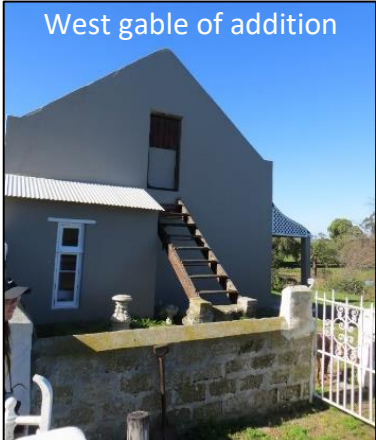
<p data-bbox="1025 592 1205 624">South façade</p> <p data-bbox="1301 204 1603 236">West gable of addition</p>	
440	S32 50 09.8 E18 17 18.0	<p data-bbox="539 651 1727 834">The original farmhouse built in the 1800s (according to farmer). Thick stone walls built on stone platform. Originally had a south-facing Cape Dutch gable which collapsed some years back and was not replaced. Oldest is the east-west section with the tail having been added. A further addition to the tail with a lower floor level has been added between 2004 and 2010.</p>

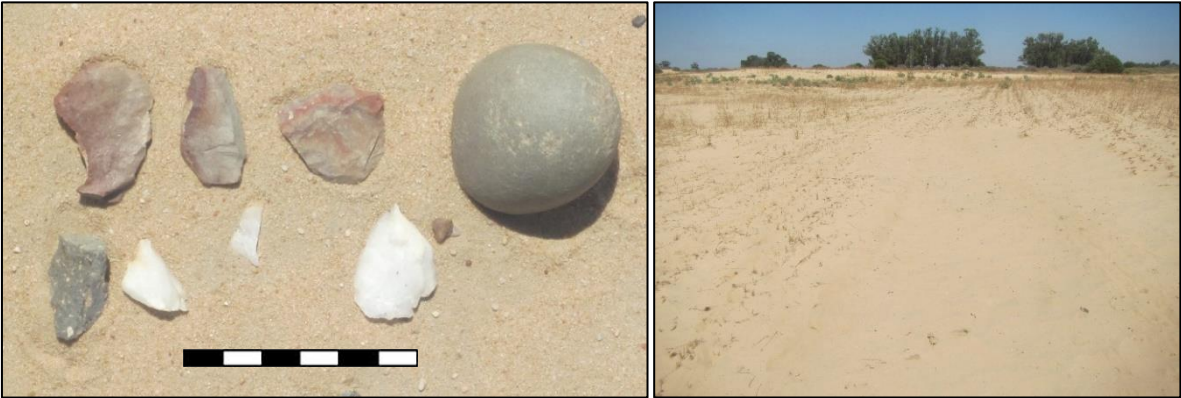
Waypoint	Location	Description	Grade
481	S32 50 57.6 E18 15 44.6	<p>A deflated area of a ploughed field on but very close to the edge of the Berg River floodplain showed about 20 LSA artefacts. Most were quartz but a few silcrete ones were also present along with one in quartz porphyry. There was also a broken hammerstone on a small quartzite cobble. There is a good chance that more artefacts are present beneath the surface.</p>

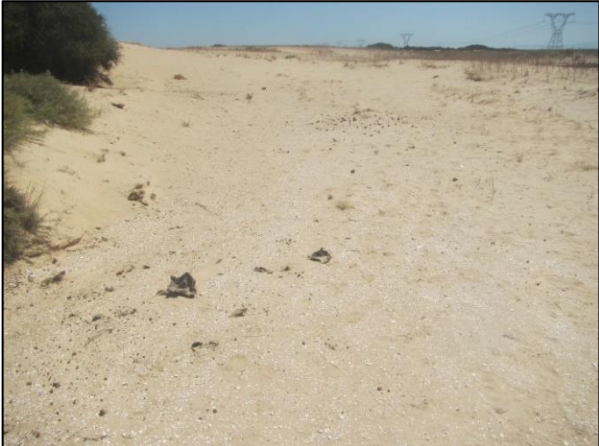
IIC
482	S32 51 02.3 E18 15 40.3	<p>At this location near the edge of the Berg River floodplain there was a scatter of fossil shell that included some extremely large wite mussels. Occasional MSA artefacts were also present including a medial fragment of what is almost certainly an unfinished Still Bay point. The origin of the material is unclear since the area is heavily deflated but the material is concentrated in one section only.</p>

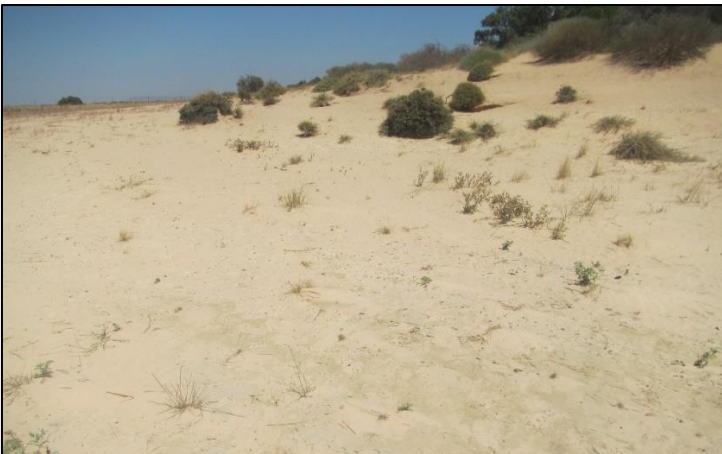
483	S32 51 03.1 E18 15 39.3	<p>This is another section of the heavily deflated area in which 482 was found. Here there was a dense scatter of perhaps 100 potsherds in a small area of about 3 m by 5 m. There were a few associated stone artefacts, and the entire site was only some 5 m by 10 m in extent. The pottery included three rim sherds with a 'thickened round' rim form and with horizontal incisions parallel to the lip. It seems likely that this was a whole pot in the recent past but that it has broken and degraded considerably since exposure by deflation. It may have been deposited in the sand dune which lies immediately north and which is eroding away under force of the southerly wind.</p>

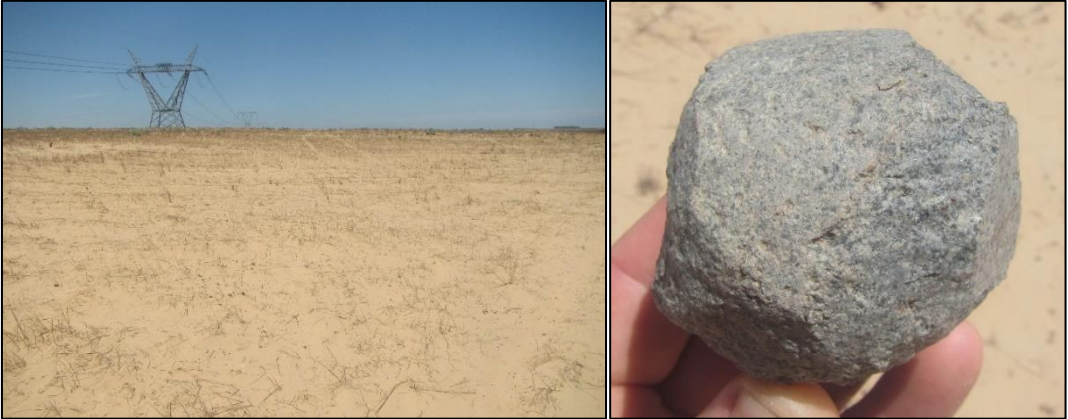
484	S32 51 20.1 E18 15 36.8	<p>A scatter of about 20 quartz artefacts was found in a deflated part of a ploughed field on the Berg River floodplain. Included an upper grindstone fragment. There was also an upper grindstone fragment. There is a good chance that more artefacts are present beneath the surface.</p>

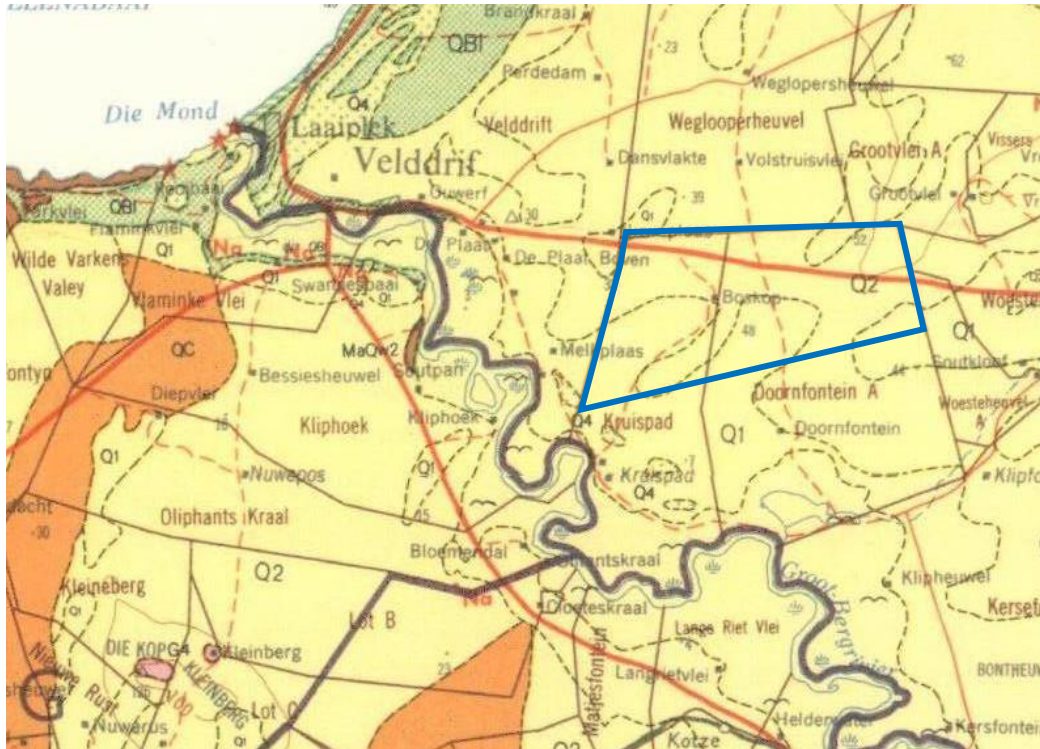
Figure 4. Location of the PV facility on 1: 250 000 geological series map (Anon 1973). Details as for Figure 3.

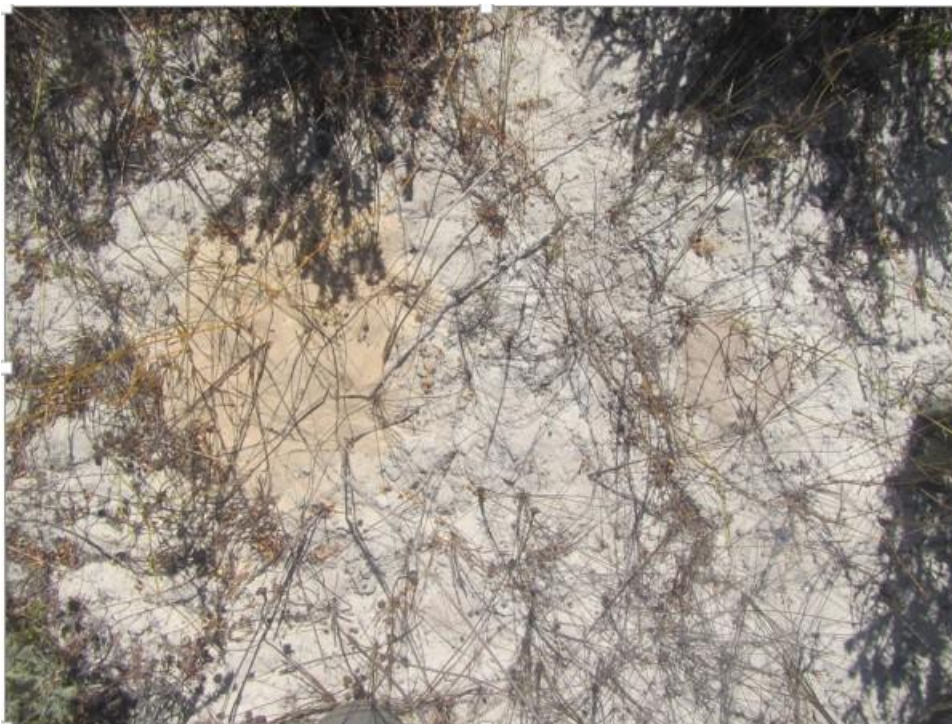
**Figure 7. JO Pale red sand exposure Langebaan or Springfontyn Formations.**

The following figures were recorded by JO during his archaeological survey. None fall within the PV footprint.

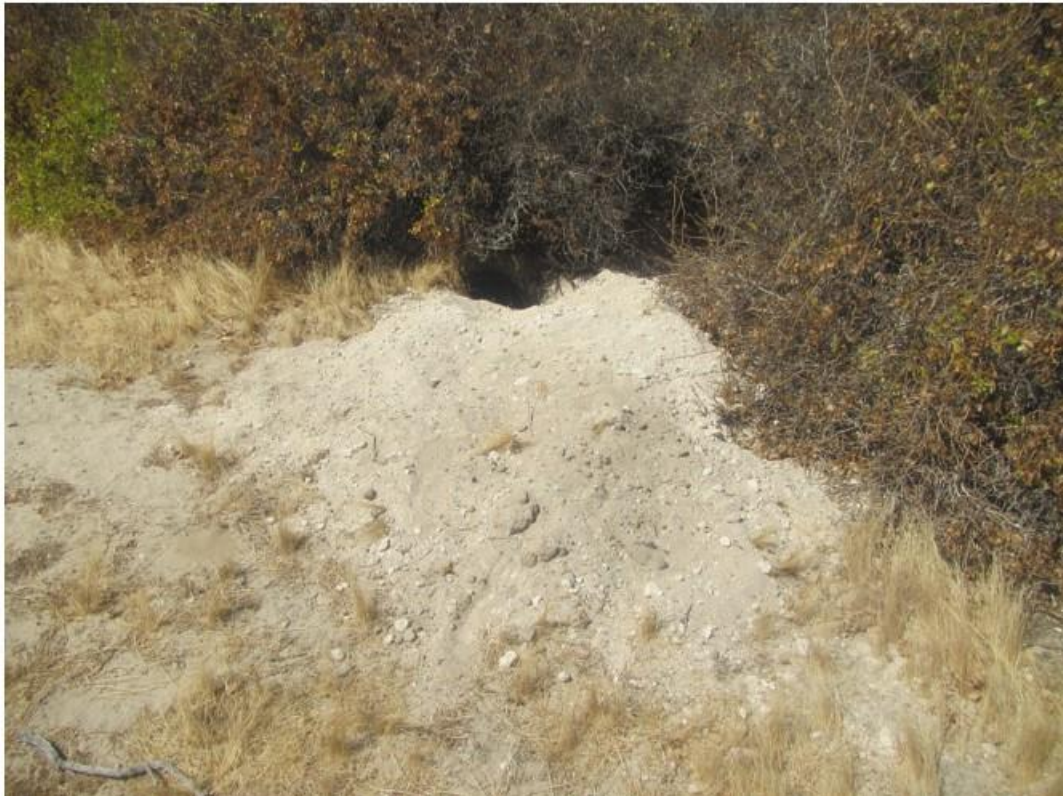
**Figure 8. JO white Langebaan Fm. sediment exposed by burrowing mammal.**
