**HERITAGE IMPACT ASSESSMENT:  
PROPOSED SUNVELD SOLAR ENERGY FACILITY ON  
DOORNFONTEIN A 118 AND KRUISPAD 120, PIKETBERG  
MAGISTERIAL DISTRICT, WESTERN CAPE**

Required under Section 38(8) of the National Heritage Resources Act (No. 25 of 1999)

HWC Case No.: HWC23091509MS0918

Sunveld PV Solar Energy Facility

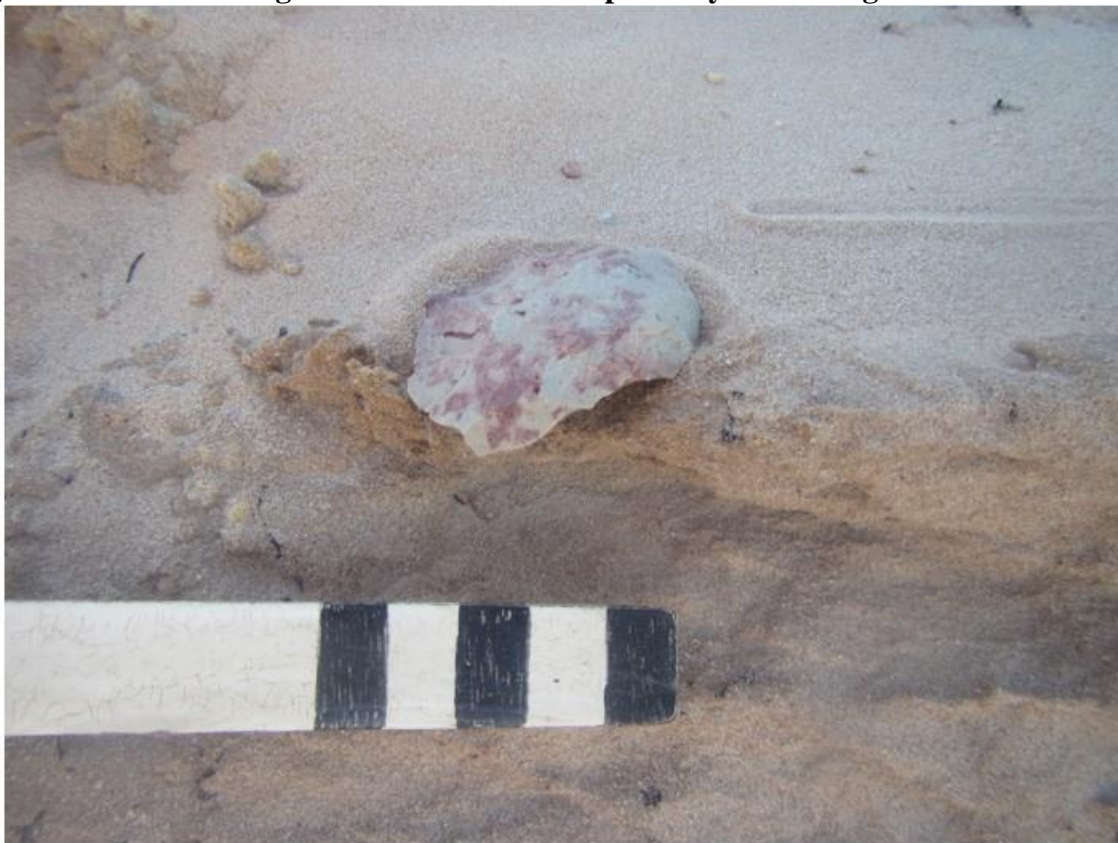
**Figure 9. JO 431. White Langebaan Fm. encrustation on silcrete flake *in situ* on pale red and light grey sediment, likely to be Springfontyn Fm.**

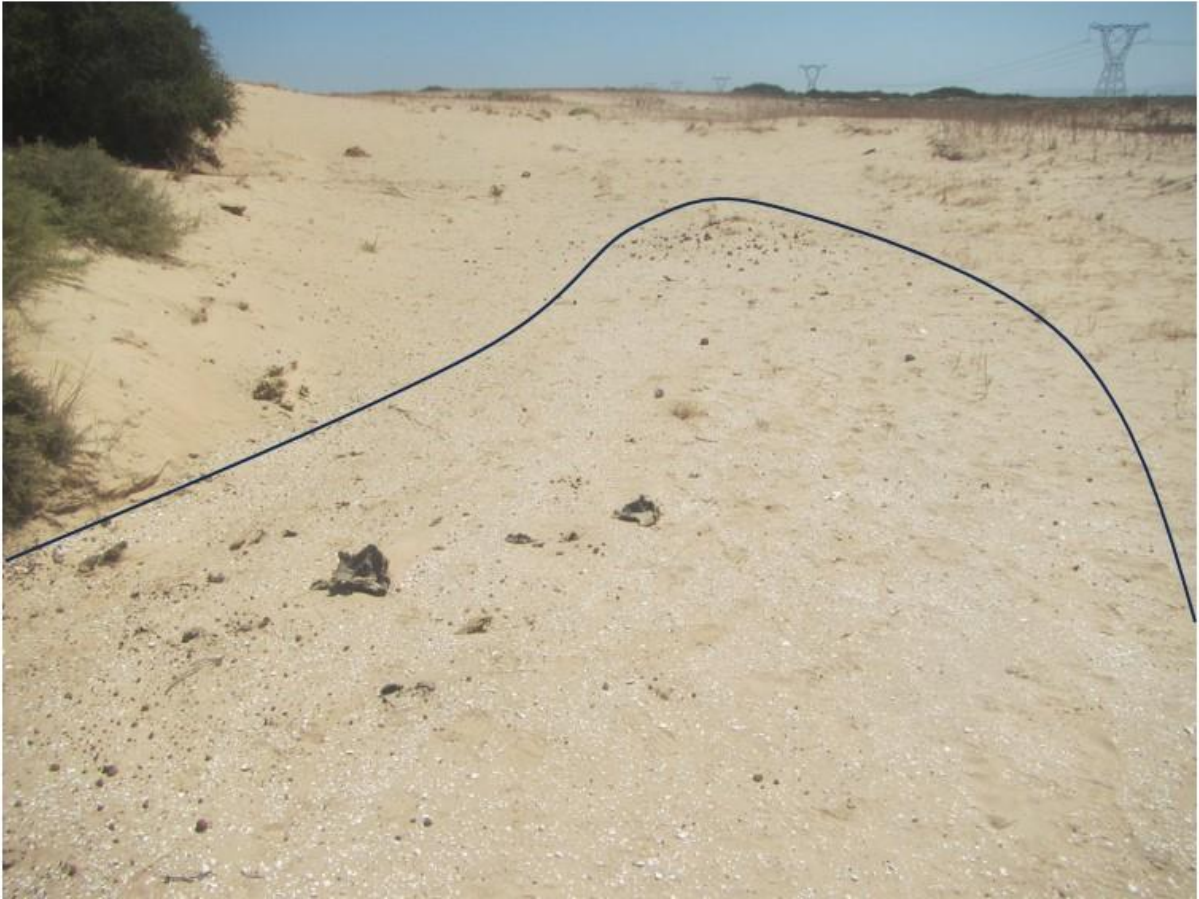
**Figure 10. JO 482. Deflated area with fossil shells: probably Velldrif Fm.**

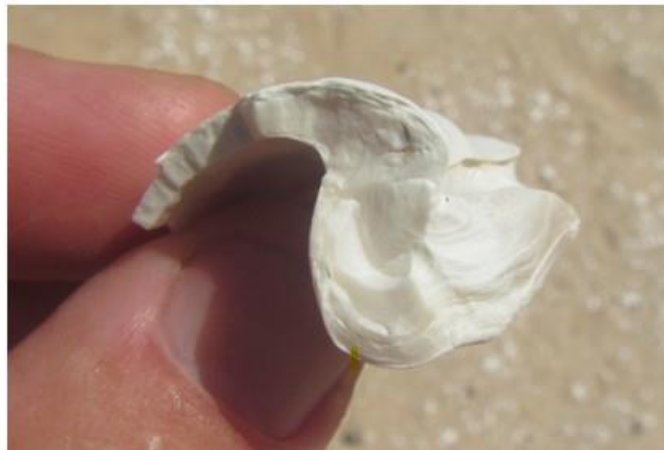
**Figure 11. JO 482. Large fossil shell: large bivalve probably Velldrif Fm.**

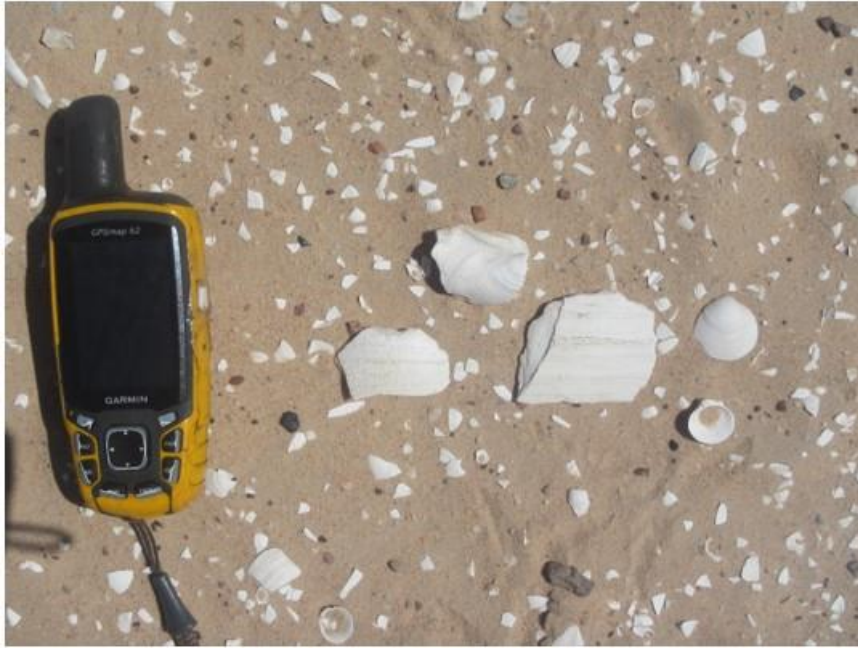
**Figure 12. JO482. Fossil shell fragments (2 bivalve species).**

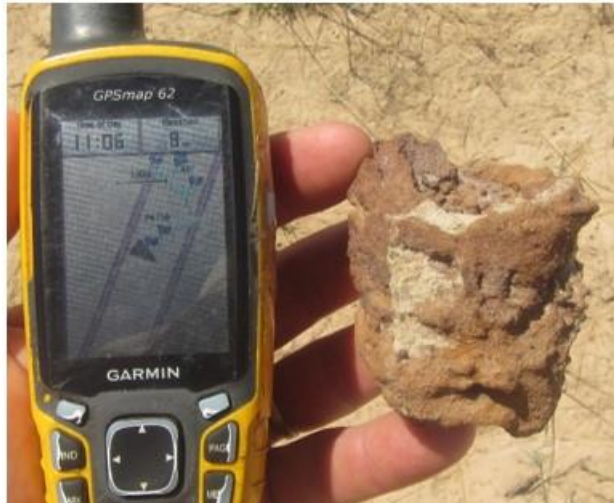
**Figure 13. JO 482; Ichnofossil: possible termite nest capsule with some white encrustation suggesting Langebaan or Velldrif Fm., but possibly a quite recent intrusion.**

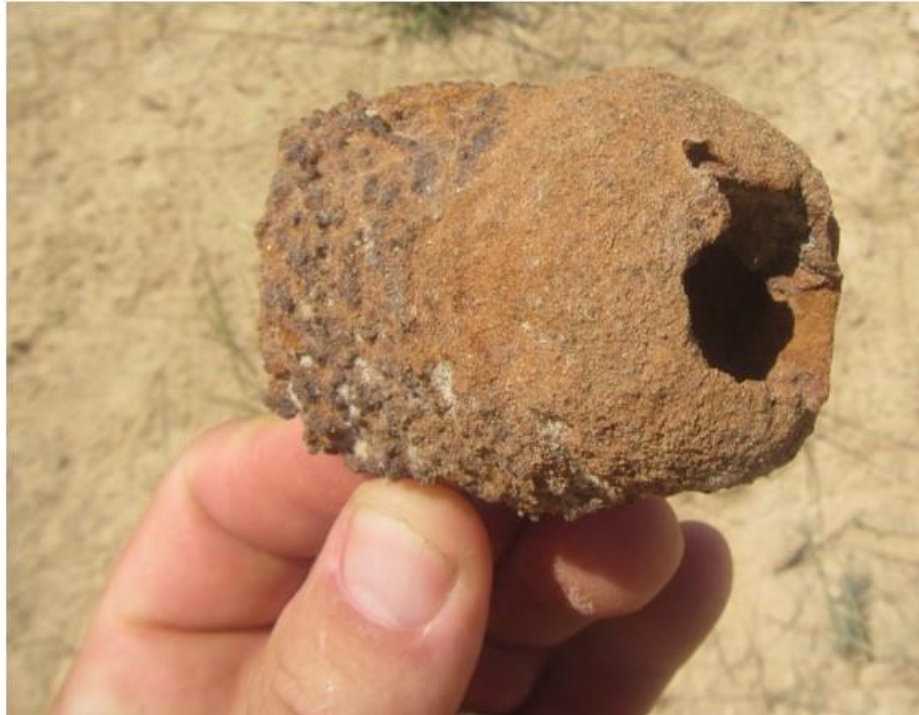
**Figure 14. JO482: Ichnofossil: possible termite nest capsule with some white encrustation suggesting Langebaan or Velddrif Fm., but possibly a quite recent intrusion.**
