Aquatic Biodiversity Specialist Assessment

**Proposed maintenance plan for 'Adopt a Spot' land on RE/464,
George, Western Cape.**

Prepared for Cape EAPrac (Pty) Ltd

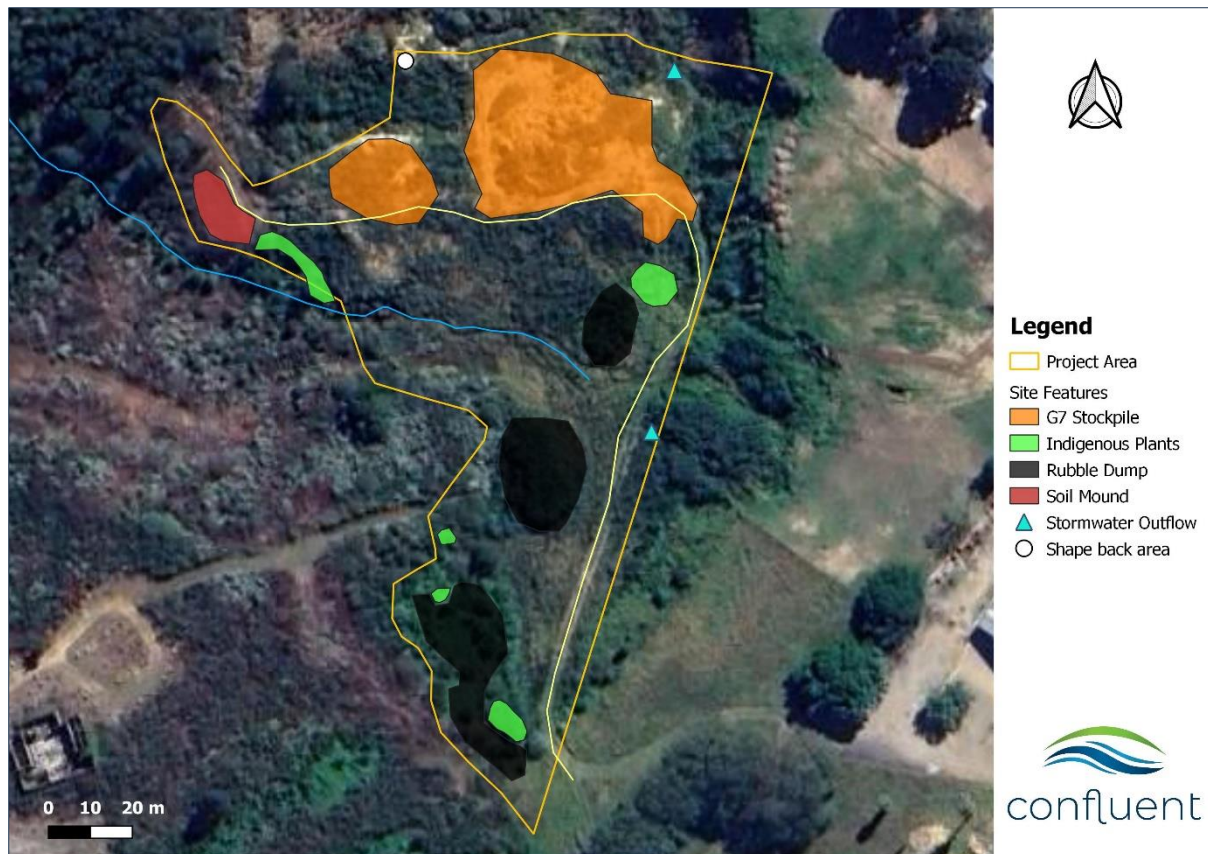
Figure 2. Relevant features present at the site which form part of the MMP.

From a broad perspective this MMP aims to remove waste materials, manage invasive alien vegetation and G7 gravel piles from the site, and improve disturbed areas through the placement and shaping of topsoil and revegetation with indigenous plants. Relevant features that form part of the MMP are mapped for the project area in Figure 2, with associated pictures shown in Figure 8.

The project area will be accessed via an existing (although somewhat overgrown) track indicated in Figure 2. At least 3 large piles of rubble will be removed which contain tyres, building rubble, plastic and other debris. An excavator and tipper truck will remove two G7 gravel platforms and the material will be used in the 1 on York development. A large soil mound which has created steep slopes and gradients will be reduced in extent and shaped to reduce steep slopes. Any steep gradients which could exacerbate erosion or create instability will be trimmed and stabilised with vegetation. Topsoil from the 1 on York development will be used to reshape excavated areas to gentle slopes which will be revegetated with indigenous plants suitable to the site. Alien vegetation has mostly been controlled in an initial exercise but will be regularly followed up for maintenance of the site. Stormwater outflow points will be revegetated and protected if necessary to prevent erosion of gullies and soil loss.

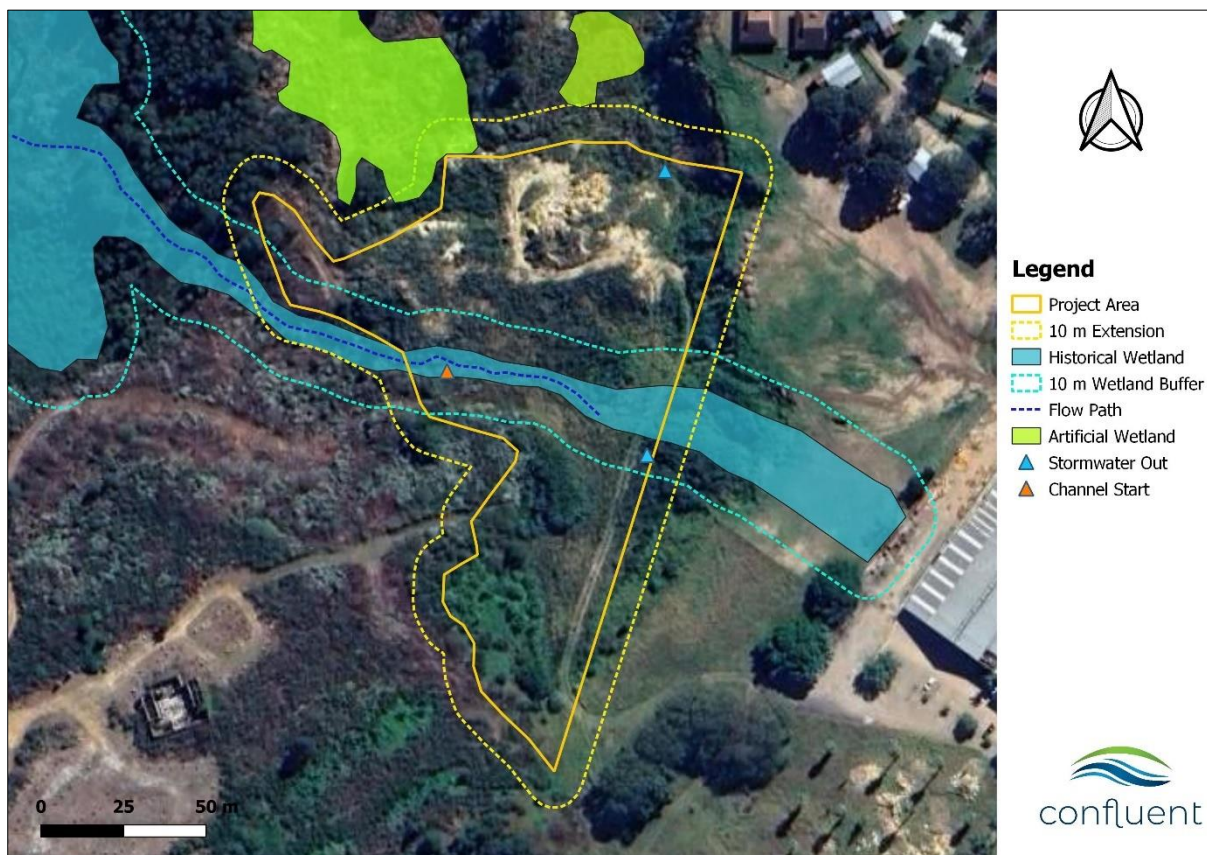
Figure 10. Historical wetland area indicating 10 m buffer either side, and 10 m extension area (if necessary) around the Project Area.

In addition to the delineated project area and historical wetland, a 10 m buffer zone was mapped for each of these features and is indicated in Figure 10. These two buffer zones serve different purposes. In the case of the Project Area, the 10 m line provides additional area within which beneficial activities can be undertaken provided they are covered by this MMP. For instance, if tyres associated with a rubble pile extend into the area beyond the Project Area, then these may also be cleared for up to 10 m distance from the Project Area. The 10 m buffer around the historical wetland indicates an area where limited disturbance should occur and revegetation should prioritise plant species which are considered temporary to seasonal wetland plants.

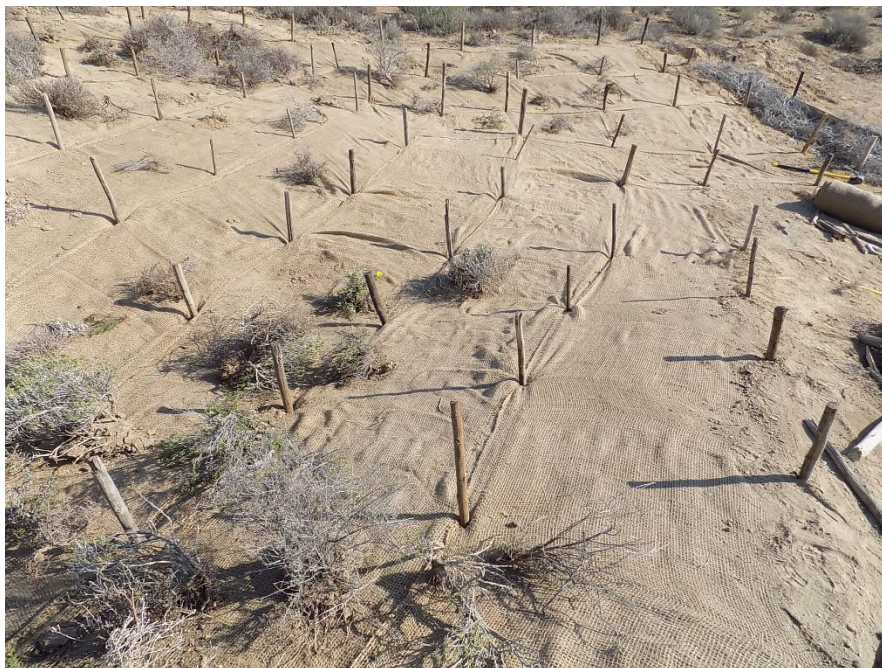
Figure 20. Example of how Soilsaver is fitted to the soil surface (Photo courtesy Ken Coetzee). Note holes to accommodate indigenous vegetation.

The role of the erosion control matting is not to provide long-term protection for slopes from erosion, but to protect the soil surface until vegetation can establish and become the permanent stabilising feature. The slope should be seeded and mulched, and then covered with erosion control matting which will remain in place until the vegetation has established. Matting should be overlapped by about 10cm and secured using wooden stakes along the edges. Terminal ends of the matting can also be staked or buried in an anchor trench.

- Lightly rake over the soil to create a uniform surface.
- Seed the areas between silt fences with a light cover of weed-free **oats** purchased from a registered supplier (e.g. Agricol). Oats are an annual, non-invasive plant that will rapidly provide cover and stabilise the soil. The seeding rate should be 20 kg / ha. Seed should be scattered as uniformly as possible to prevent clumping, and the silt fences should be avoided as seed will probably collect along these lines anyway.
- The seeded area must be covered in a **light mulch (1-2cm deep)**. This can consist of shredded woody material but must not be wood chips. Suppliers such as Grow Green Organics can be contacted for options.
- Cover the seeded and mulched slopes with a rolled erosion control product (such as jute, coir or straw matting). Only use a natural (vs. man-made), bio-degradable product.
