# **Aquatic Biodiversity Impact Assessment**

**Proposed construction of a new 14.5 ML reservoir for bulk water supply on RE/325, Pacaltsdorp (West), George.**

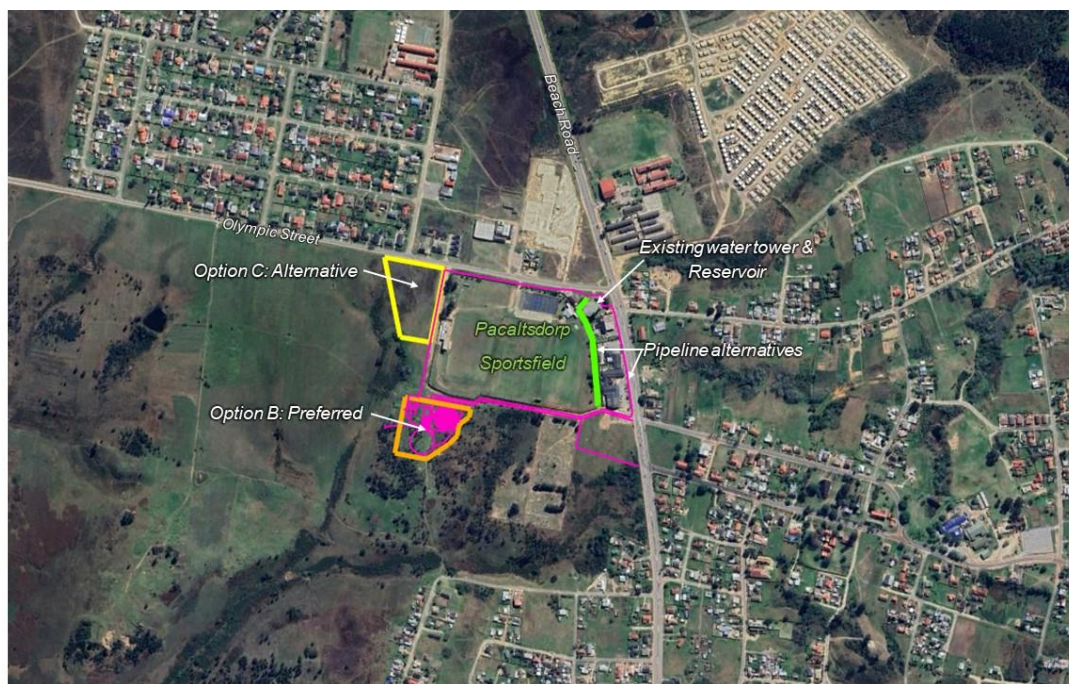
Figure 1. Proposed alternative sites for the location of a 14.5 ML reservoir, pumpstation and pipelines on RE/325, Pacalstdorp.

Option C is located adjacent to Olympic Street and west of the Pacalstdorp Sportsfields, while Option B which is the preferred alternative, is located southwest of the sportsfields (Figure 1).

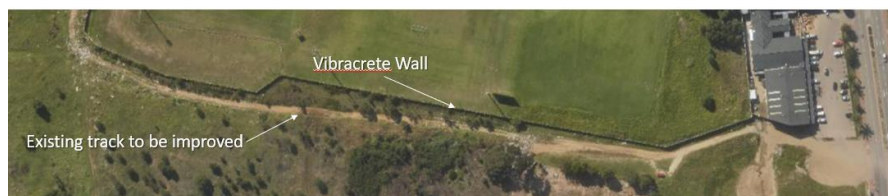
Figure 4. Cross section showing proposed improvements to the southern access track.

The southern access road that must be upgraded to accommodate maintenance of pipelines for the first and 2<sup>nd</sup> phase will be maintained at the same width as the present track, but a new surface of gravel will be laid and compacted to improve accessibility. The pipelines will be laid between the road and the existing vibracrete wall along the boundary of the sportsground (Figure 4).

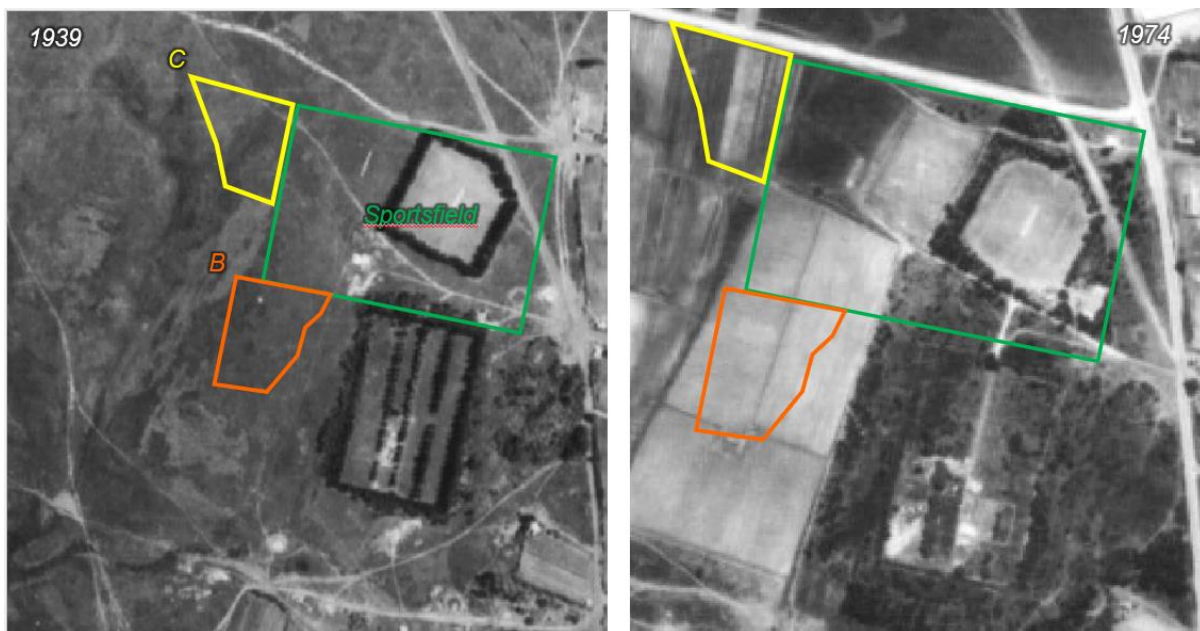
Figure 10. Historical photos showing the two optional development sites through notable changes between 1939 and 1974 (CD:NGI & Google Earth imagery).

In 1939, darkened areas of vegetation indicative of wetlands were distinct at development option C, but non were observed at option B. These features correspond with mapped drainage lines indicated in Figure 6. A rectangular feature consisting of tree rows was established south of the present-day sports fields in 1939. This area is now a cemetery, and the rectangular area may have been the initial establishment of this land use. The cemetery was established partially over the mapped wetland and darker vegetation area south of the sportsfield, and it is noteworthy that the north-west corner is not used and has revegetated, as a wetland is not suitable for this purpose. The 1974 image shows that vegetation in both site options was cleared for agricultural use. Probably grazing livestock.

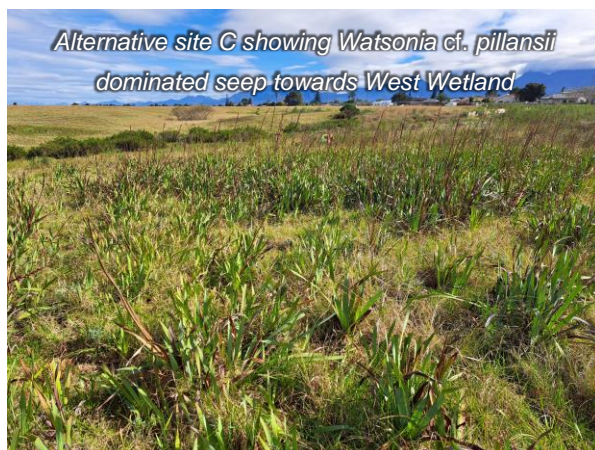
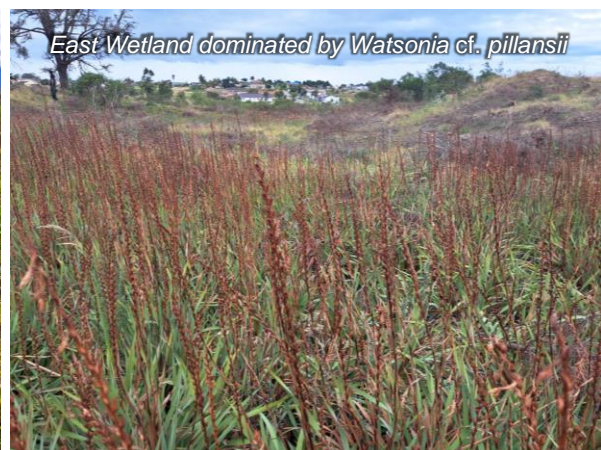
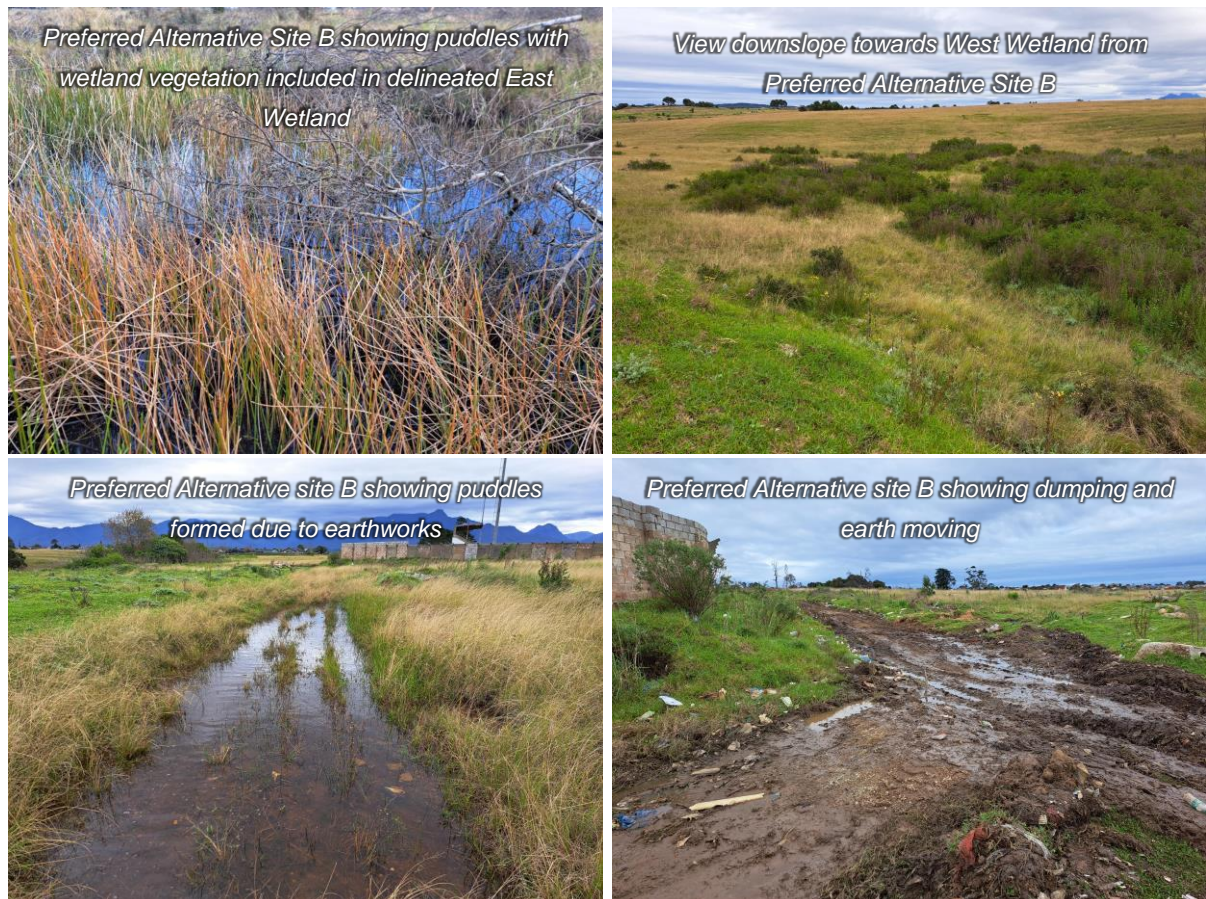
Figure 14. Photos of East and West Wetland and typical conditions on Site Options B and C.

Wetlands were delineated using a combination of hydrophilic plant species, soils with redoximorphic features (e.g. mottling and/or gleying), and topographical location. A distinctive feature of the East Wetland and a seep area in the West Wetland was extensive stands of *Watsonia cf. pillansii* as well as *Juncus effusus*, *Juncus exertus*, *Eliocharus limosa*, *Typha capensis*, *Helichrysum foetidum*, *Cliffortia strobilifera* and *Zantedeschia aethiopica*. Within the development area of Option B is extensive earth moving and dumped rubble and soil which is obscured by vegetation, especially kikuyu grass. There are a few areas within the site where earth moving (excavation or soil dumping) have resulted in small ‘puddles’ of standing water. The delineated wetland extent is indicated in Figure 16.

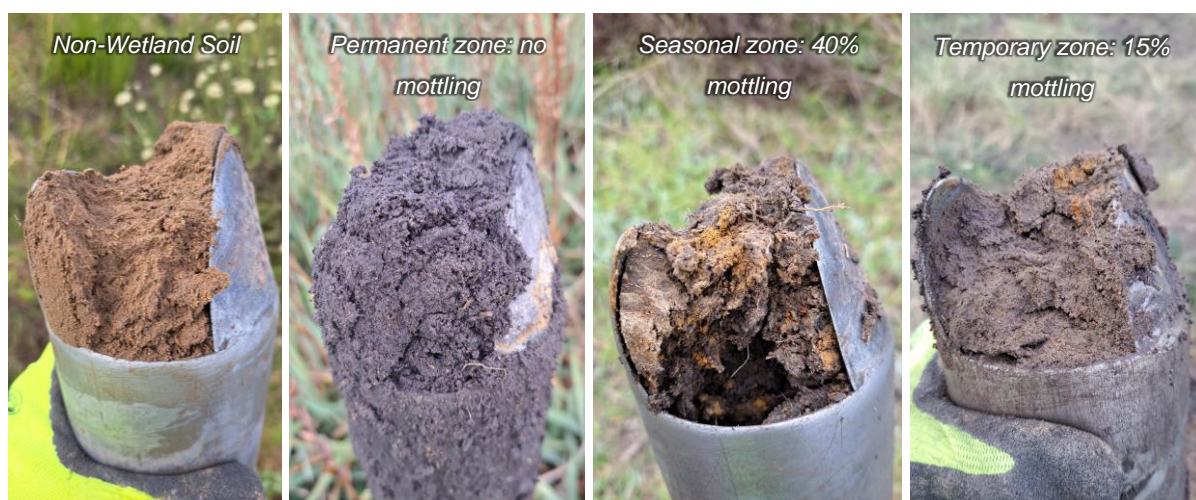
Figure 15. Soil auger examples from wetland and terrestrial areas in the site area.

Hydric soils display indicators which are predominantly formed by the accumulation or loss of iron, manganese, sulfur or carbon under permanent or periodic saturated and anaerobic conditions. Soil auger samples from the permanent zone of East Wetland had a dark organic-rich mineral layer with no mottling, indicative of reduced microbial activity under saturated conditions (Figure 15). West Wetland soils and outer areas of the East Wetland were typical of temporary and seasonal wetland soils where saturation periods are less than or greater than 3 months of the year respectively (as a general guideline).

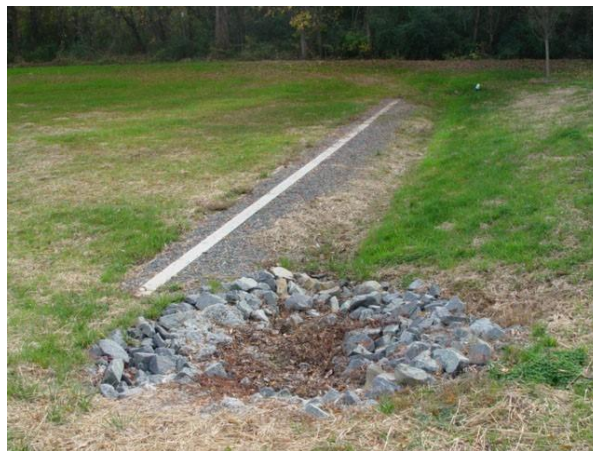
Figure 17. Example of a level spreader with the outflow section protected by rip rap.

The proposal to manage stormwater and reservoir scouring events is to attenuate most of the water on the reservoir site. Scour water would be split in two directions (west / east) and the outflow is indicated as headwalls in Figure 2. The fenceline of the reservoir is specified to be set in concrete, which will be slightly raised around the perimeter to retain and spread scour and stormwater on the site. The site is mostly level, but water will be directed to protected (rock-lined) channels from where it can seep into the ground. (Figure 17).

Furthermore, stormwater from the site was subsequently split between both sides and will ultimately drain via the level spreaders to both the West and East Wetland, further reducing the impact of high velocity, concentrated flows. The comparison of stormwater impacts with and without mitigation is assessed in the operational phase impact assessment.
