**Aquatic assessment in terms of Section 24G of NEMA application  
for construction of a dam on Portion 3, Farm 36, Buffelsfontein near  
Ladismith, Western Cape.**

**Prepared by: Dr. Jackie Dabrowski, Confluent Environmental (Pty) Ltd**

**For: Cape EAPrac**

**Updated in August 2021**

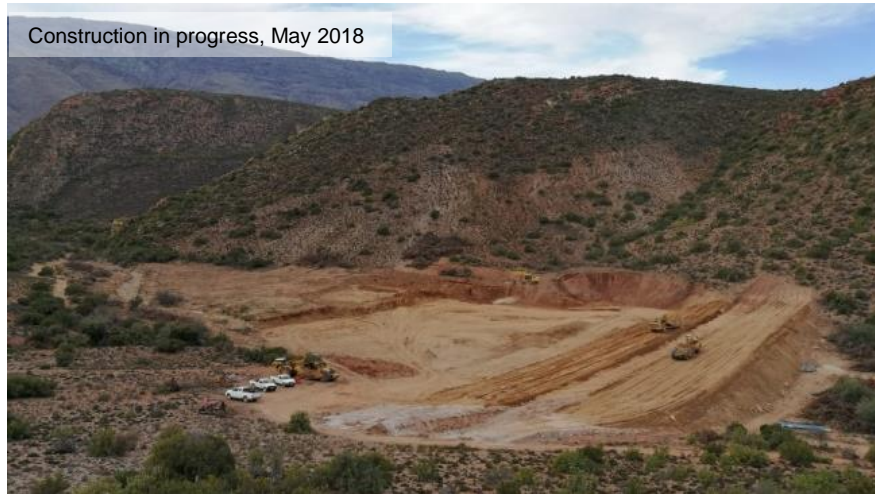
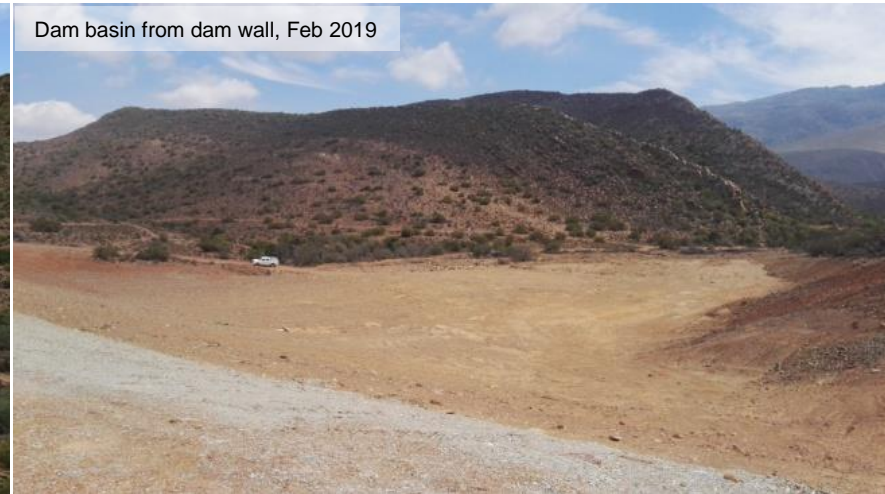
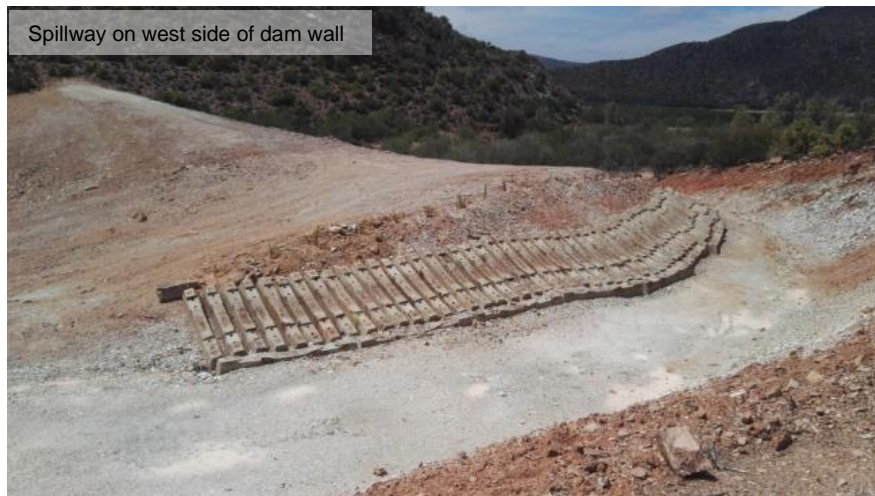
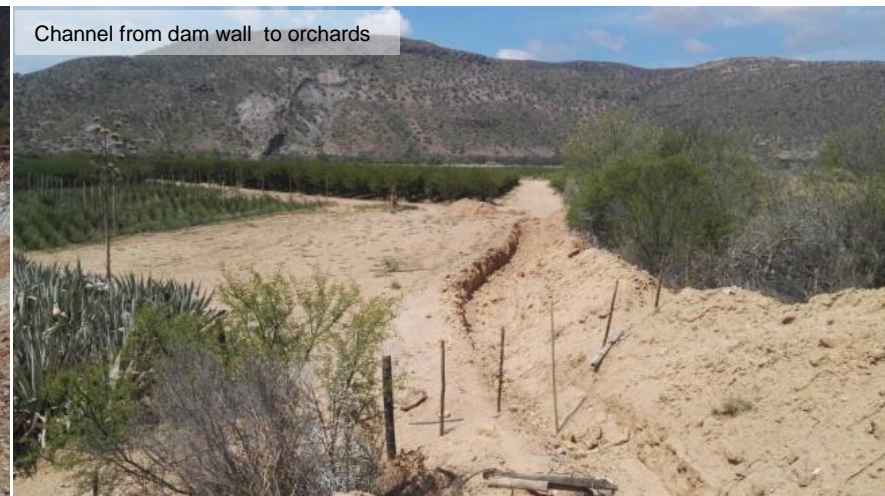
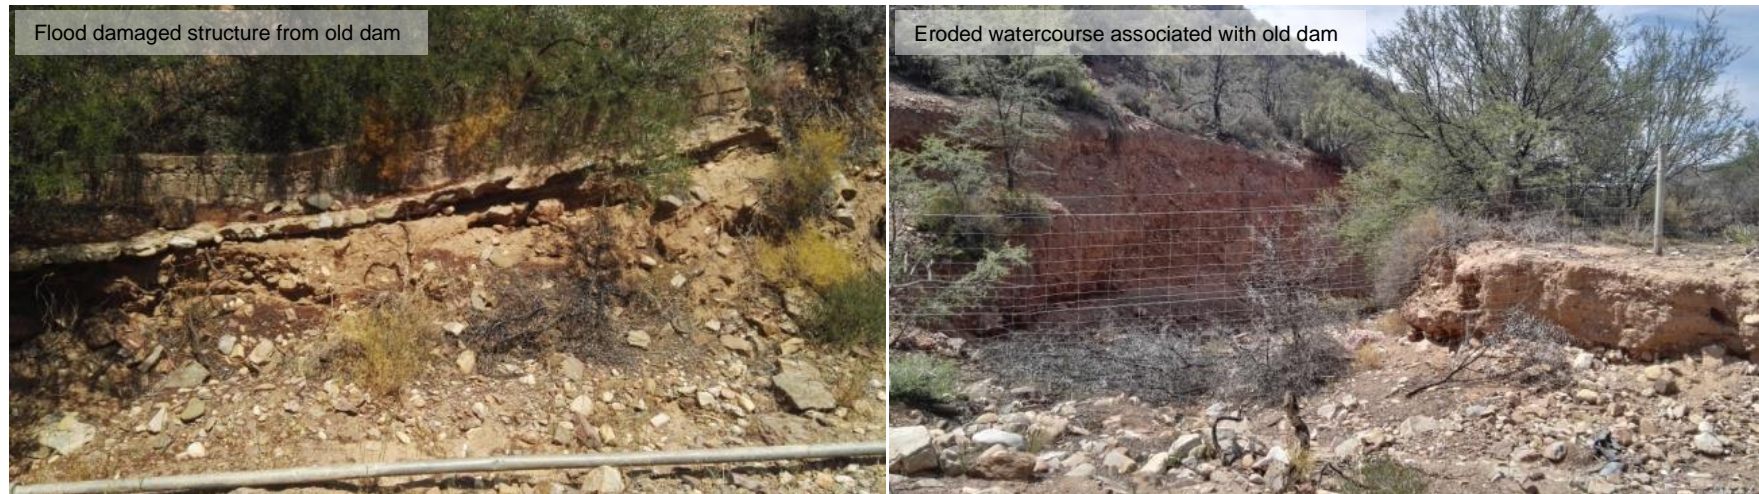
Construction in progress, May 2018

Dam basin from dam wall, Feb 2019

Spillway on west side of dam wall

Channel from dam wall to orchards

**Figure 1.** Photos showing construction of the new dam in progress and the finished dam as well as the spillway and channel constructed from the dam wall to orchards for irrigation. The old dam was washed away in floods with associated debris and erosion damage still visible in the basin downstream of the new dam.

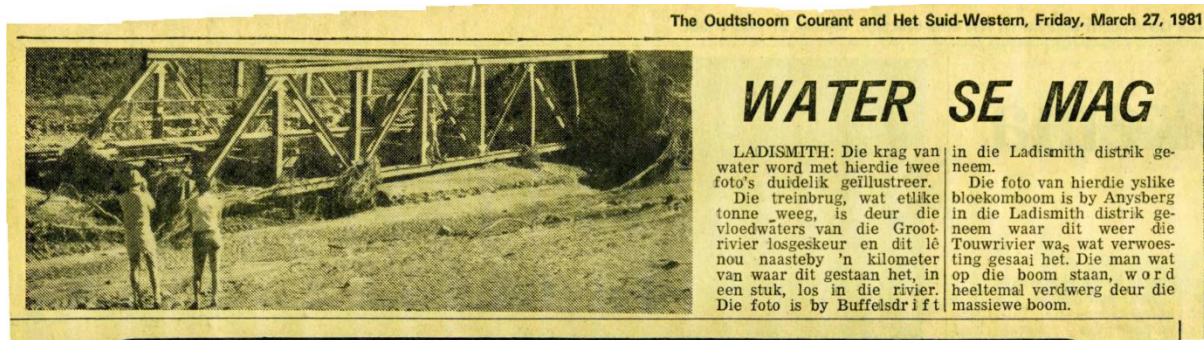
**Figure 5.** Newspaper clipping from the Oudtshoorn Courant in 1981 describing how severe flooding of the Groot River washed an entire steel train bridge more than 1 km downstream.

Floods in the Groot River during heavy rainfall events can be severe as depicted by the newspaper clipping in Figure 5.

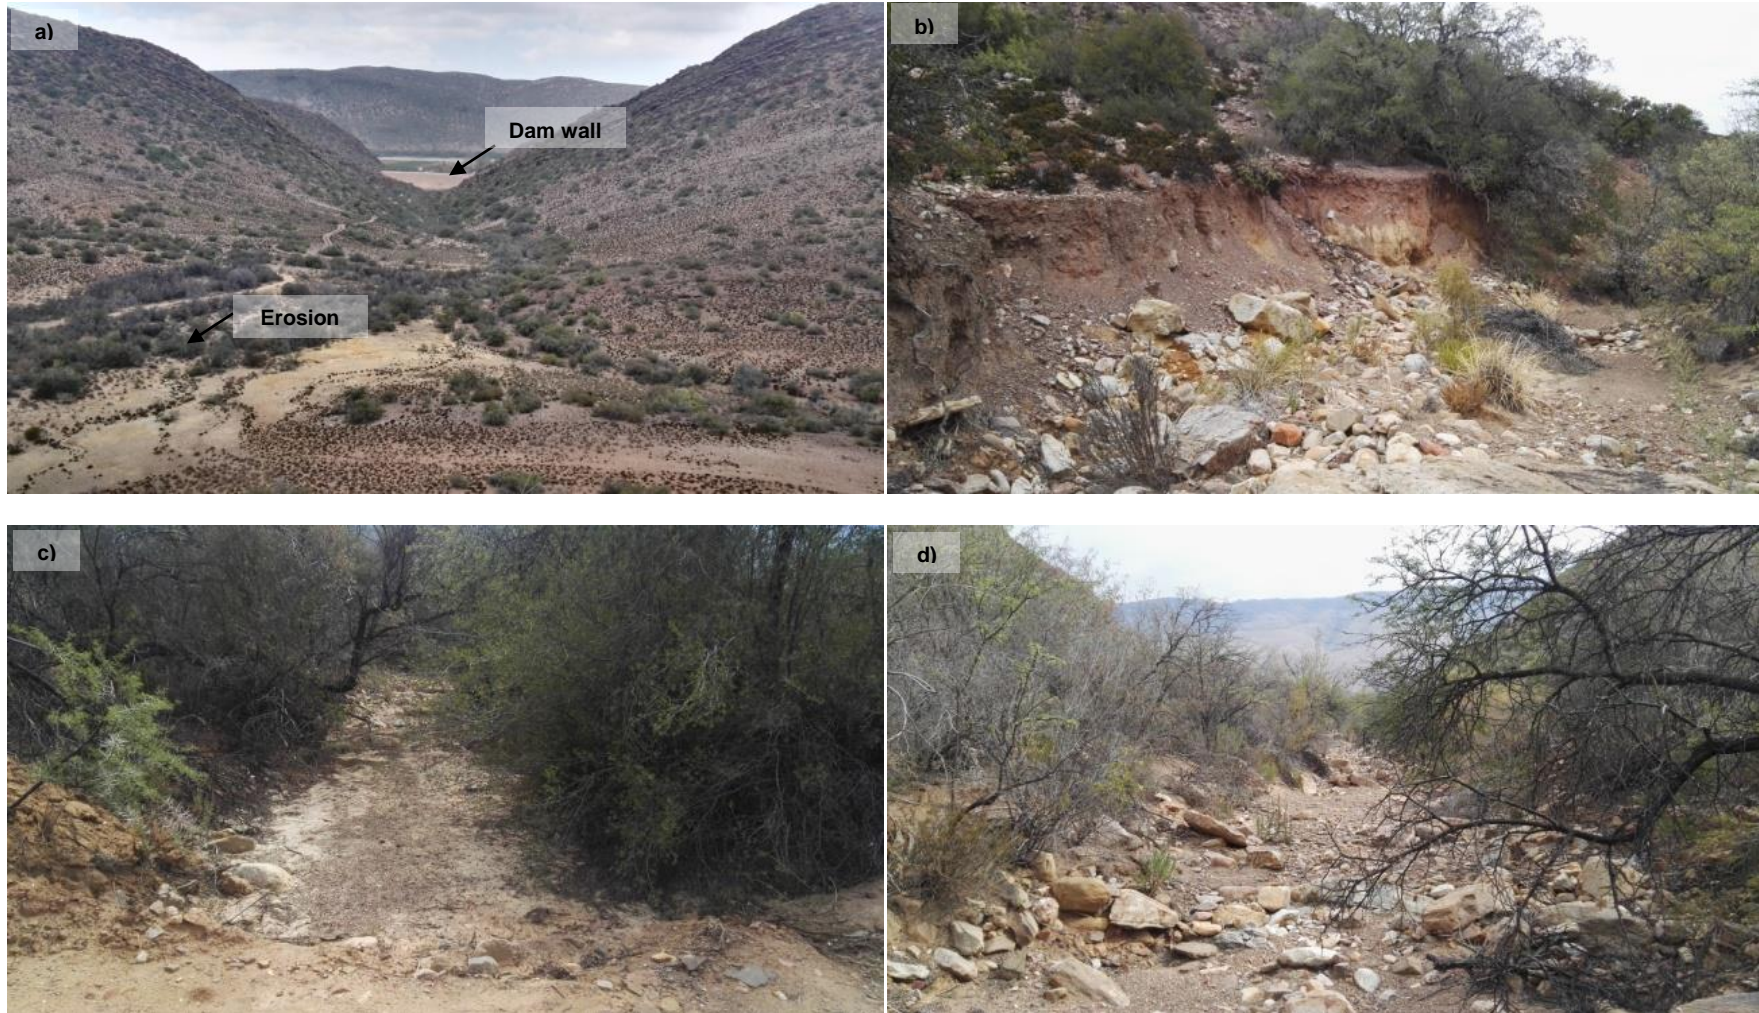
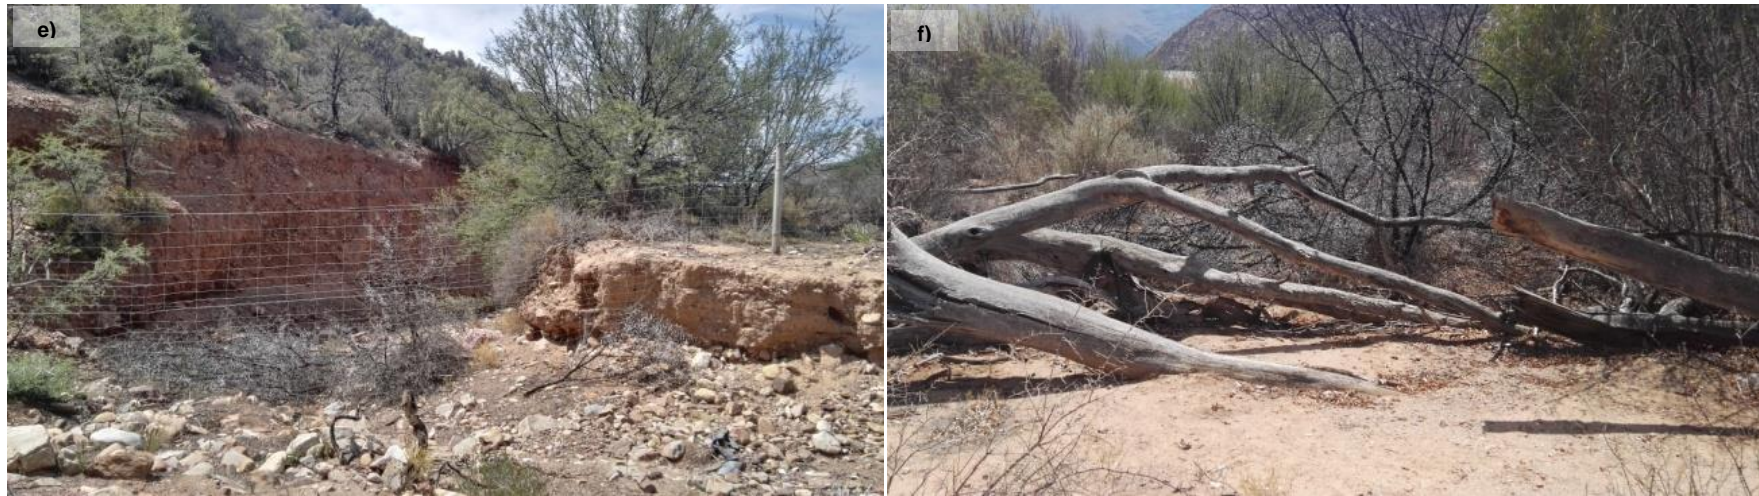
**Figure 8.** Photos from various points assessed along the watercourse including the area upstream of the dam with erosion of the banks and channel (a and b) and accumulated sediment in the river bed (c), part of the watercourse in relatively good condition that lies within the full supply level of the dam but hasn't been cleared yet (d); and, flood damage and erosion of the watercourse (e), along with sedimentation in areas (f) downstream of the dam wall.
