# **RAPID ASSESSMENT OF PERCEIVED SILTATION IN PLACES WITHIN THE THESEN ISLANDS CANALS, KNYSNA**

**Thesen Islands Home Owners' Association**

**Laurie Barwell**

**May 2017**

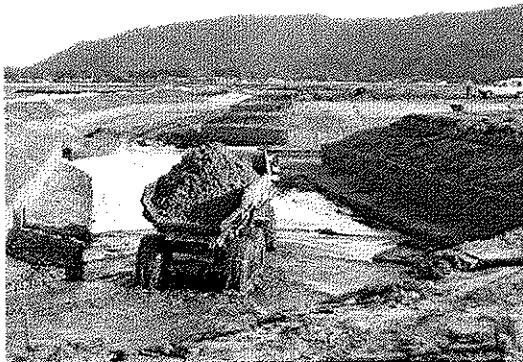
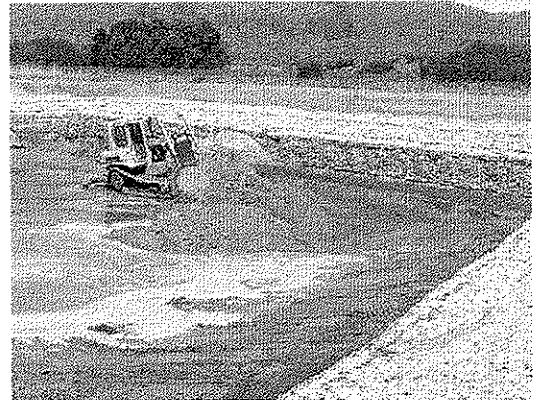
Ashmead perimeter canal (19/04/2001).

Finishing off canal (29/09/2000).

Figure 4: Heavy construction vehicles were used which resulted in a highly compacted foundation profile within the canal system and beaches. (Photos: PBPS)<sup>6</sup>

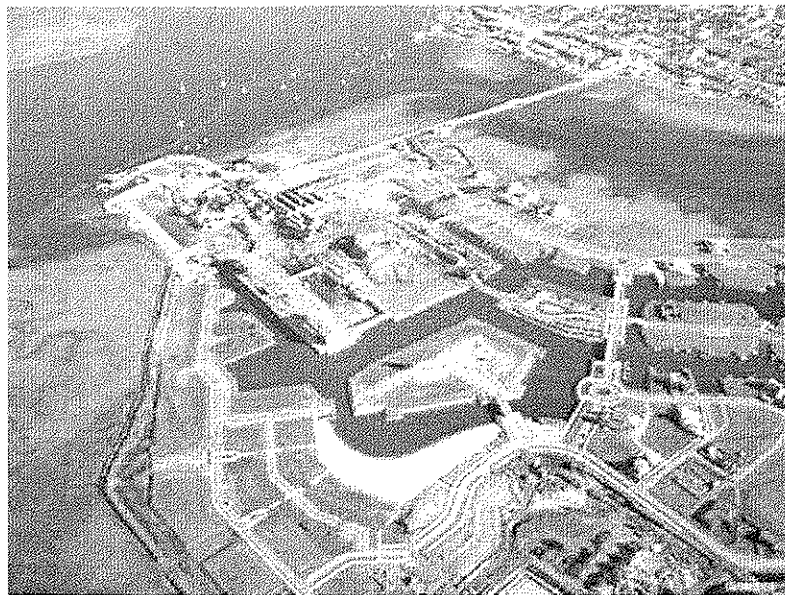
Figure 5: The main beach and canals prior to the opening of the main entrance. (Photo: 18/08/2003)<sup>7</sup>

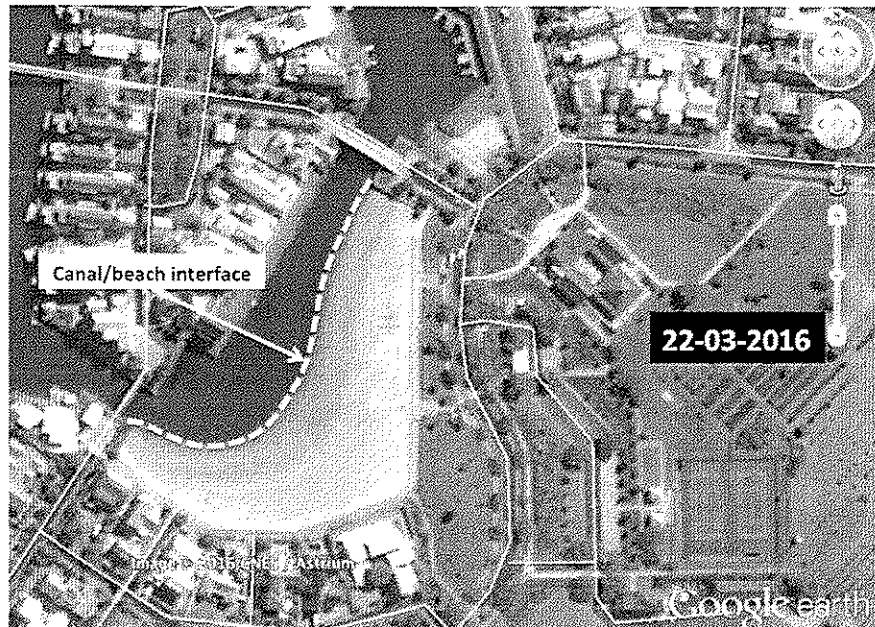
Figures 10 and 11 show the 'beach-canal interface', which is relatively easy to observe on aerial images as the boundary between the dark areas (canal and deeper water) and the light areas (beach sand and shallower water). Tracking these lines over time provides a useful indicator of positional trend/stability as discussed below. Adjacent infrastructure such as the Gabion™ canal edge and bridge structure provides reference points.

Figure 10: Example of tracing the 'beach-canal interface' on the March 2016 aerial image.

It is fortunate that the imported beach sand has a distinctly different colour to that of the in-situ sand. The shape of the beach-canal interface is therefore clearly seen on aerial photographs even when the tide level is unknown.
