# Upgrade of the Fancourt Golf Club Security Fence Crossing the Modder River, George, Western Cape.

## Management and Maintenance Plan

**Prepared For:** Cape EA Prac  
**Author:** Dr. J.M. Dabrowski (PhD)  
Confluent Environmental Pty (Ltd)  
7 St. Johns Street,  
Dormehls Drift,  
George, 6529  
**SACNASP:** Pr. Sci. Nat. (Water Resources – 114084)  
**Date:** 7 February 2025  
**Version:** Draft Final

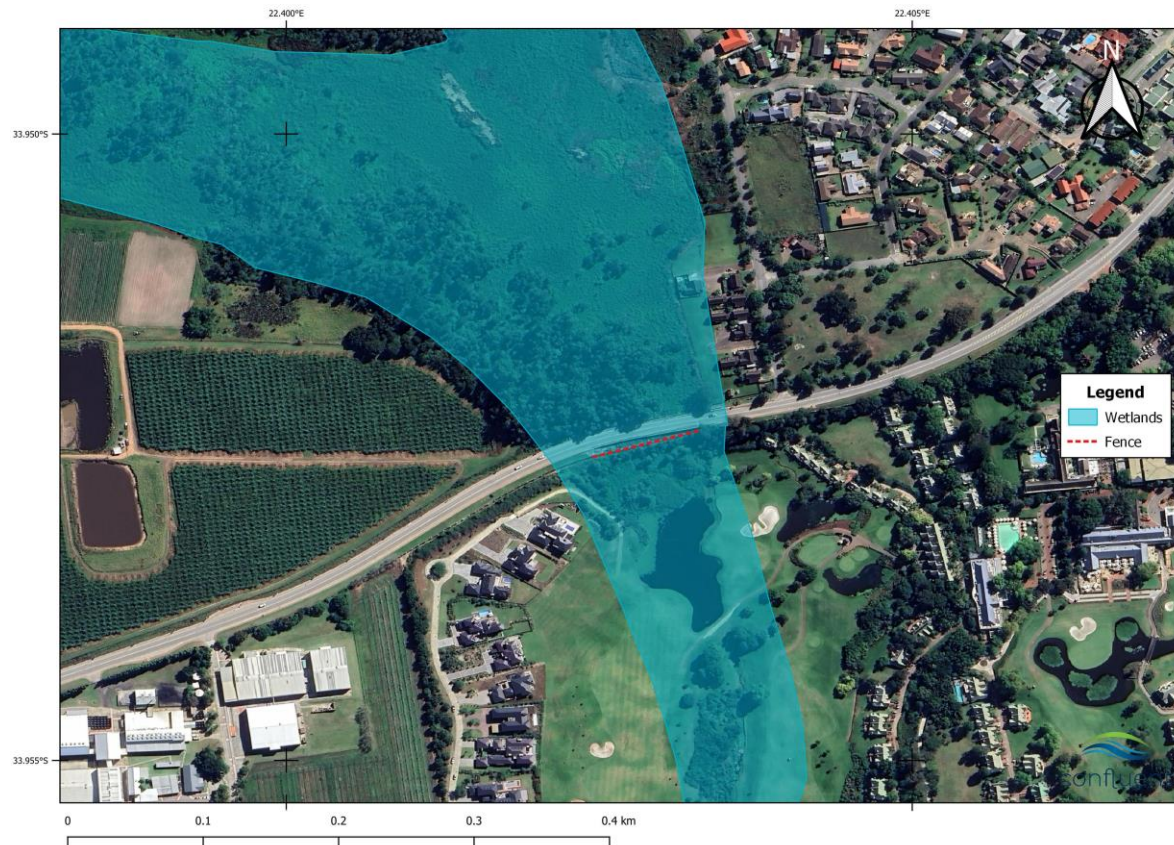
Figure 3: The proposed development area in relation to mapped watercourses.

The project area is located in quaternary catchment K30B, which extends from the Outeniqua Mountains to the north, all the way to the coast. The main river draining the catchment is the Gwaing River (Figure 2) which is fed by several tributaries, all of which originate from the mountains at the top of the catchment. The Modder River also originates from the Outeniqua Mountains, after which it flows through an agricultural area and then through the Fancourt Golf Estate after which it meets up with the Malgas River to form the Gwaing River. According to the latest national wetlands geospatial database (CSIR, 2018) most of the length of the Modder River is mapped as an unchannelled valley bottom (UVB) wetland (Figure 3).

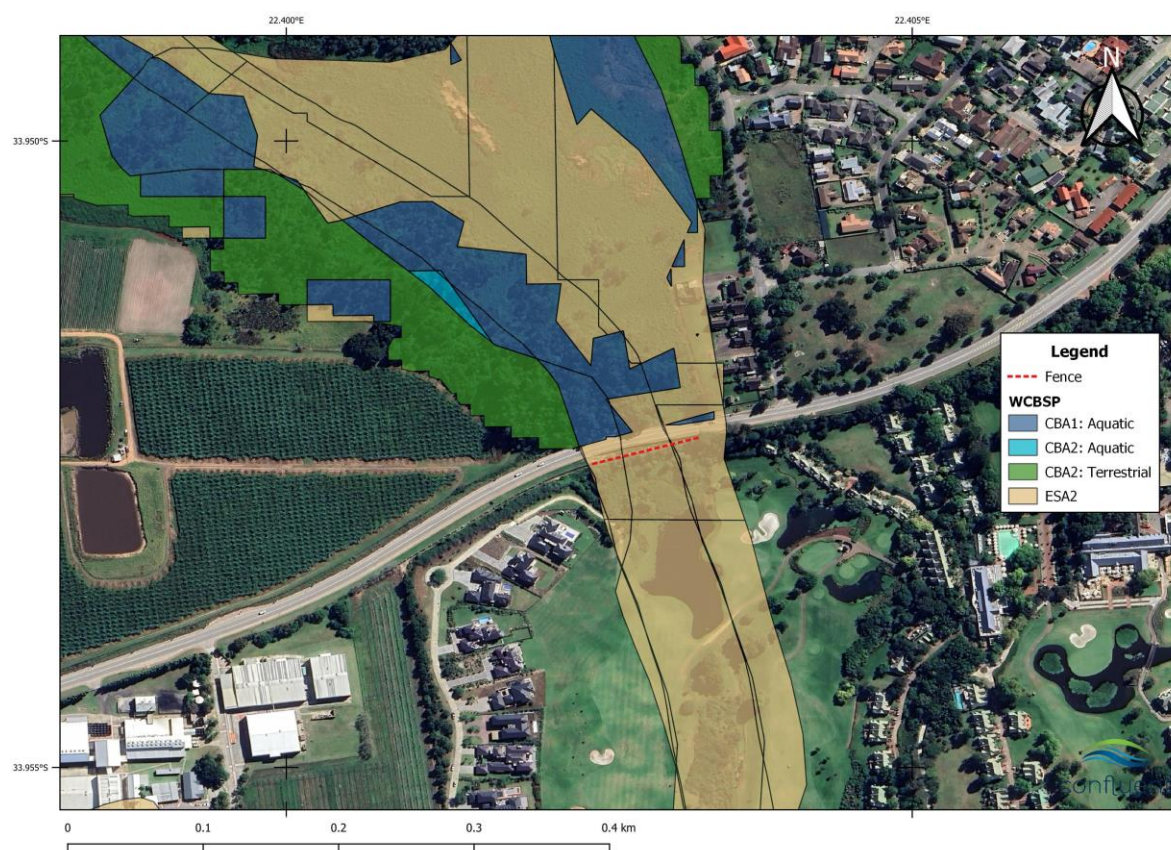
Figure 4. The proposed development area to mapped conservation features of the Western Cape Biodiversity Spatial Plan (2017).

The affected section of the Modder River has been designated as an ESA2 (Figure 4), which are considered to be relatively degraded aquatic features that are not considered important for meeting biodiversity targets, but do provide an important hydrological function in terms of delivering surface water flows to larger more important systems and are also important from the perspective of providing corridors for faunal movement. Management objectives associated with these biodiversity categories are provided in Table 3.

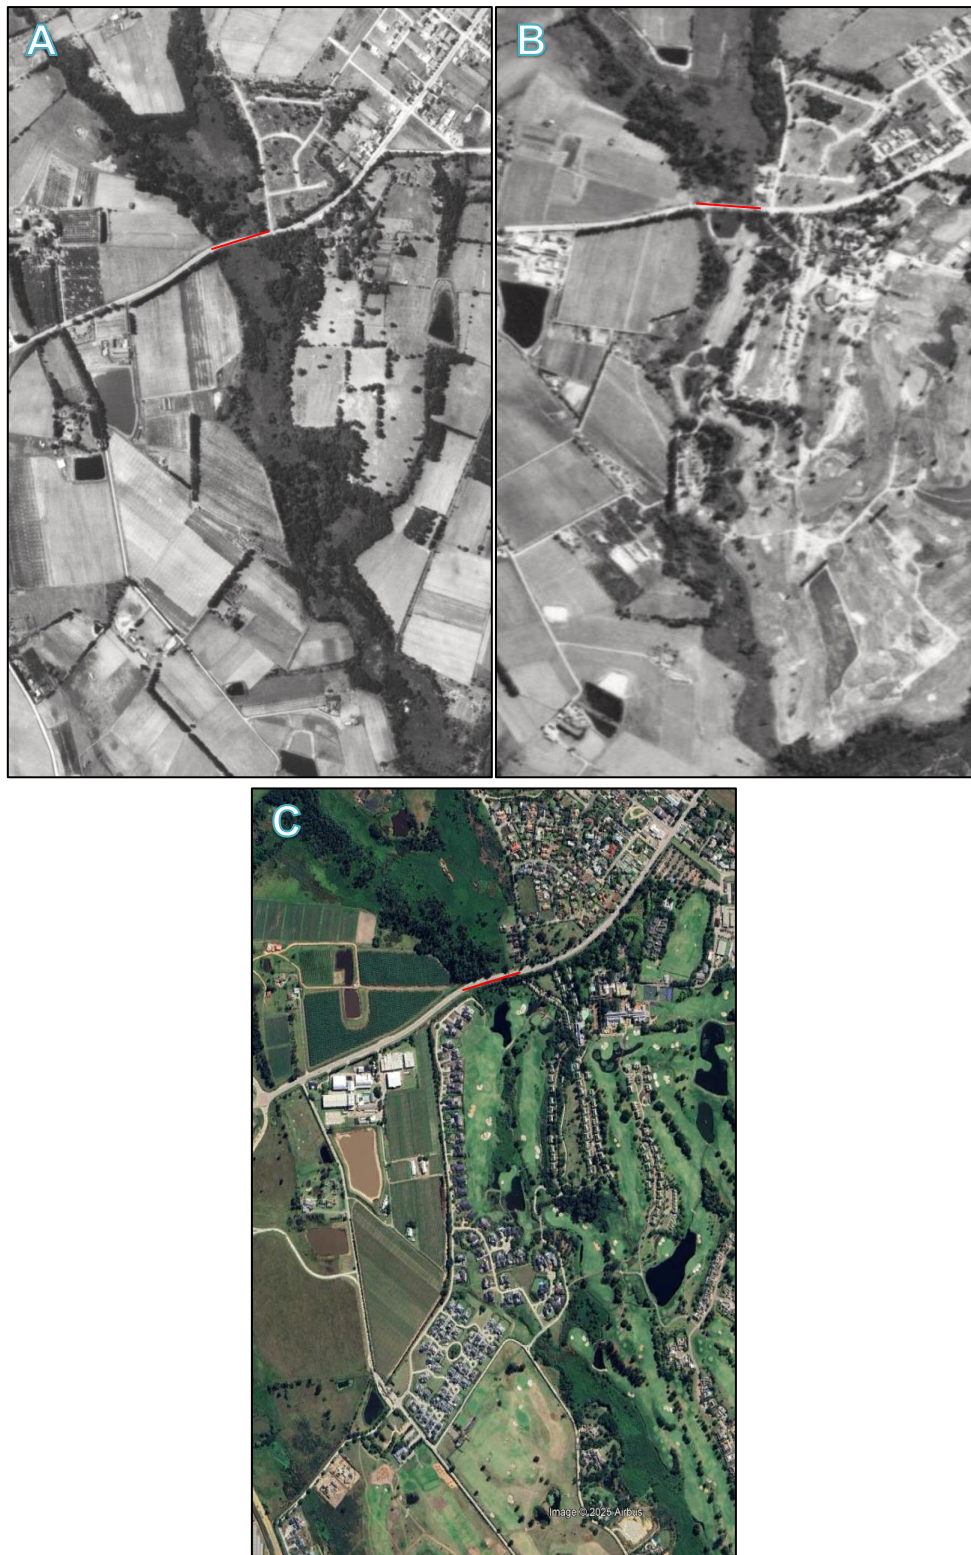
Figure 5: Historical images from 1974 indicating the former extent of the UVB wetland (A); and from 1991 (B) and 2024 (C), showing large-scale loss of wetland habitat south of the R404. Red line indicates the current location of the fence that will be upgraded.

- An aerial image from 1991, clearly illustrates the loss of wetland habitat south of the R404 in association with the development of the Fancourt Golf Estate. Wetland habitat upstream the R404 remains intact (although still partially invaded by invasive alien tree species).

- Most recent image (2024) shows small remaining pockets of wetland vegetation south of the R404. The majority of the former wetland area has been confined to a distinct channel running through the golf course.

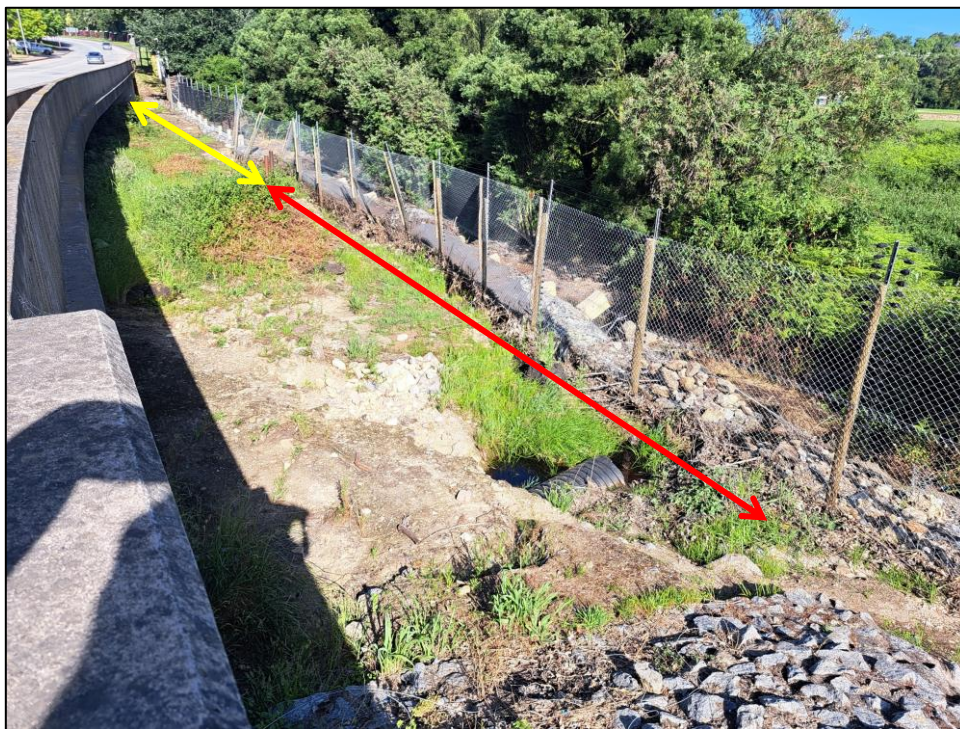
*Figure 6: Photographs indicating the western (red arrow) and eastern (yellow arrow) alignment of the fence and the bridge crossing the wetland upstream of the fence.*

Currently the fence is strung across fence posts that have been embedded in a gabion wall foundation that runs across the entire width of the river (Figure 6). Along its western most alignment the gabion wall has been displaced and is leaning over in a downstream direction (Figure 7). This displacement has created a narrow channel in between the gabion wall and the riverbed. Preferential flows along this channel (and towards a gap in the gabion wall) has caused some erosion of the riverbed, which is beginning to migrate upstream towards the bridge (Figure 8). The drop-off between the higher elevation of the riverbed and the lower elevation at the base of the gabion wall creates a knickpoint and there are signs of headcut erosion beginning at preferential flow paths along the riverbed (Figure 9). Culverts are located beneath the concrete slab – but it is uncertain how functional this infrastructure is. Concentrated flow through the wetland has resulted in erosion around these culverts. Evenly placed gaps in the gabion wall allow lower flows to pass through the wall, while higher flows will pass over the wall. There is a small patch of wetland habitat downstream of the fence followed by a small dam. Concentrated flows through the gaps in the gabion wall have caused eroded channels to form through this short wetland area. The eastern alignment of the gabion wall is intact – the top of gabion wall is elevated slightly above the level of the riverbed and will obstruct lower flows, diverting them towards a gap in the gabion wall. The wetland area upstream of the bridge remains intact and has largely retained its UVB characteristics and verified watercourses are mapped in Figure 10.

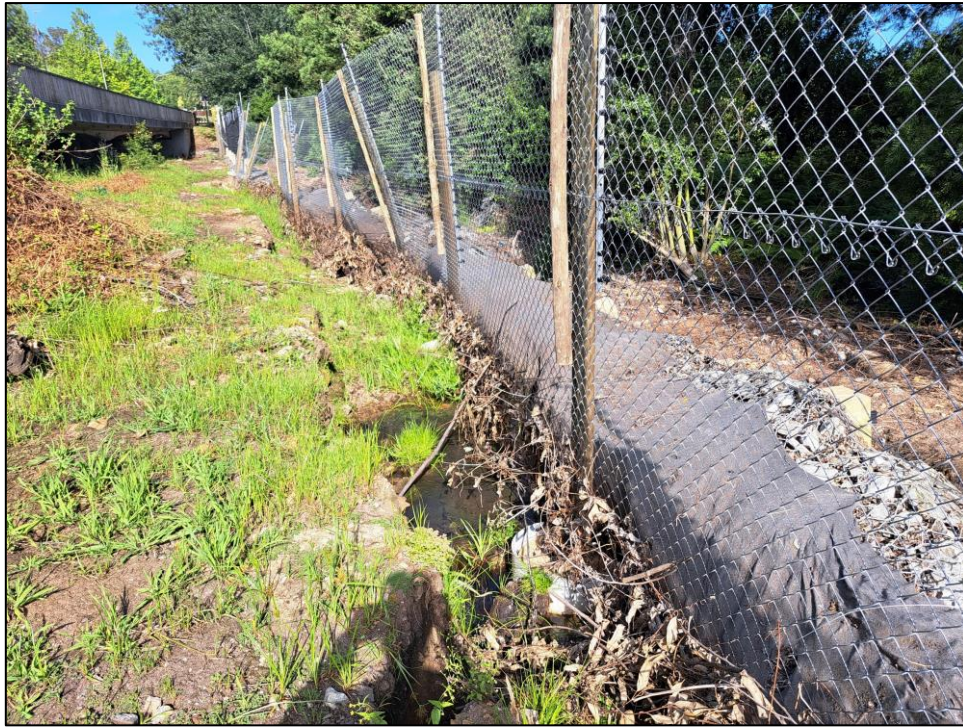
*Figure 7: Channelled flow between the partially displaced gabion wall and the elevated riverbed along the western alignment of the fence*

- The displaced gabion wall has created a sharp, vertical drop (between 0.5 and 1 m) in elevation along the western alignment of the gabion. This has already caused some localised erosion of the riverbed and represents a significant risk to the wetland. Failure to address this problem will result in further erosion of the riverbed which could also potentially place infrastructure upstream of the fence at risk.
- The gabion wall impedes flow and concentrates flows along specific sections of the channel which has resulted in erosion and formation of channels through wetland habitat downstream of the wall.
- The design of the fence cannot accommodate flood events and associated flood debris and will require ongoing maintenance.

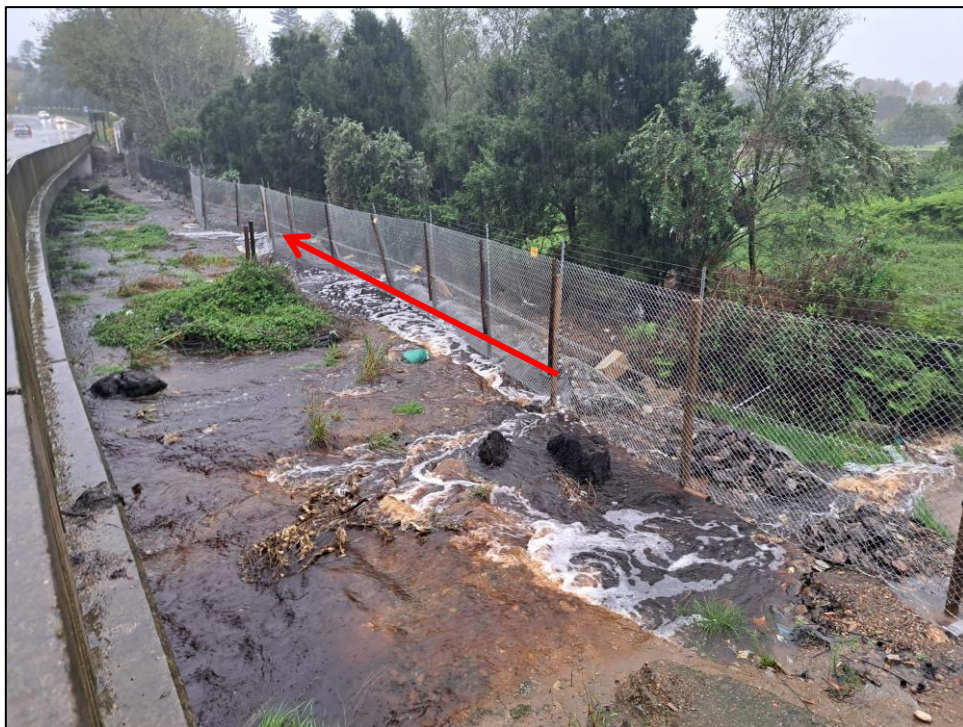
*Figure 8: Photograph taken during a heavy rainfall event (4 June 2024) which shows the displaced gabion along the western alignment and channelled flow in between the gabion wall and the elevated riverbed (red arrow) toward a gap in the gabion wall.*

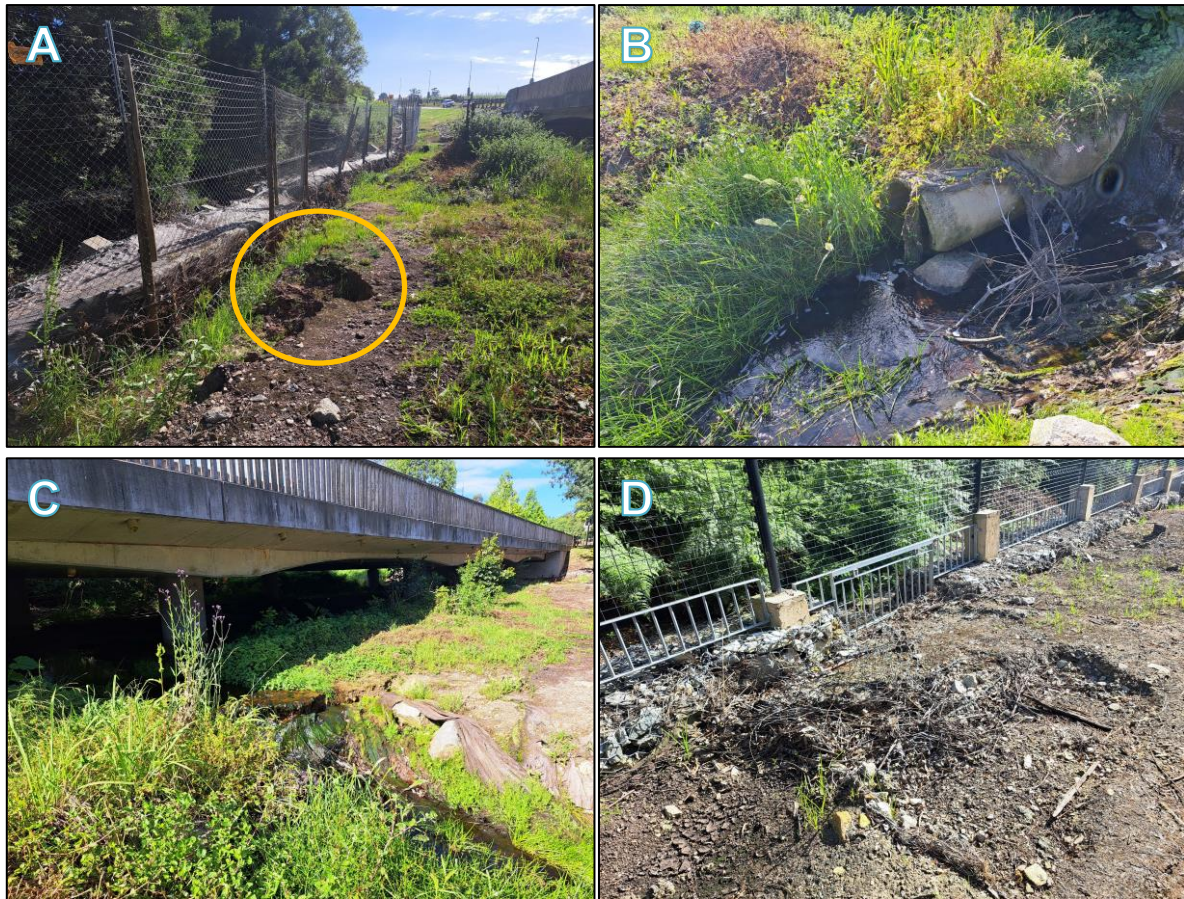
*Figure 9: Photographs showing signs of erosion upstream of the fence (A); erosion around a culvert beneath the bridge, most likely caused by more channelised flow through gaps in the gabion wall (B); partial undermining of the concrete slab beneath the bridge (C); and intact gabions along the eastern alignment of the fence – slightly elevated above the level of the riverbed (D).*

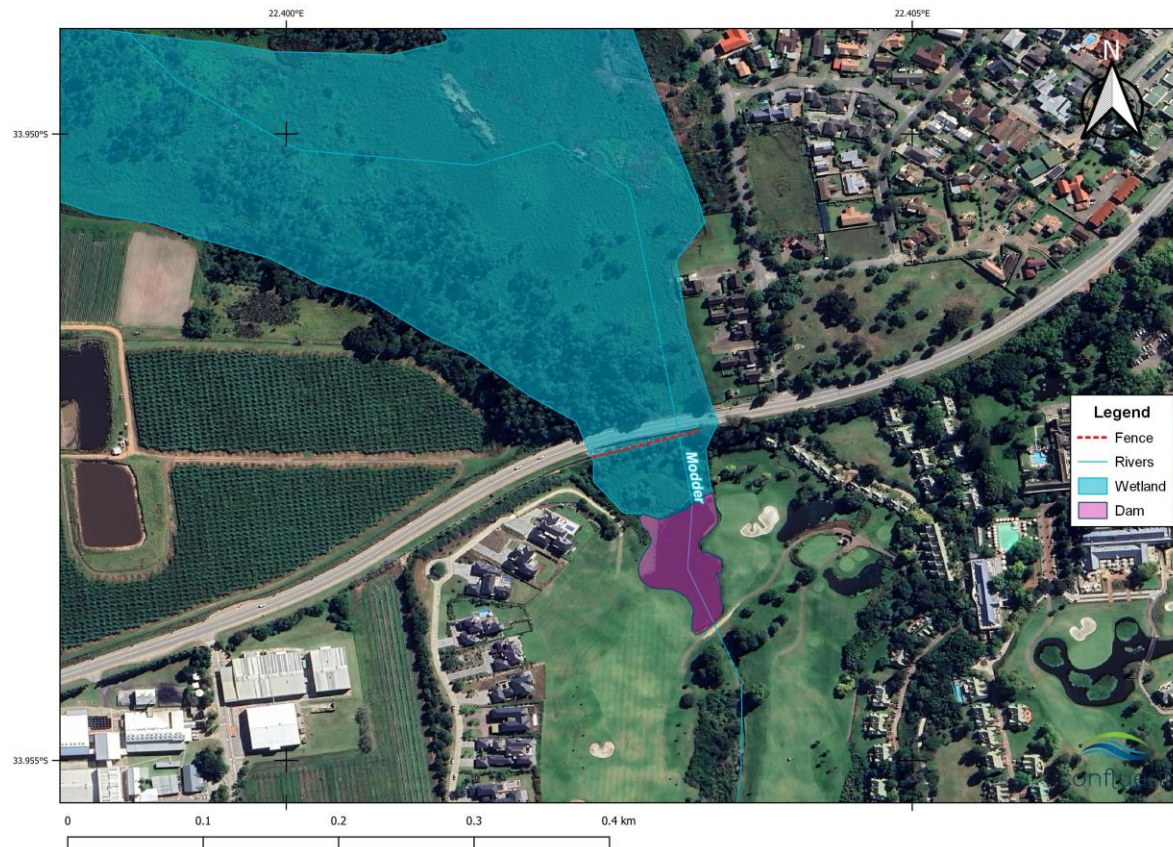
Figure 10: Map indicating delineated wetlands in the development area.

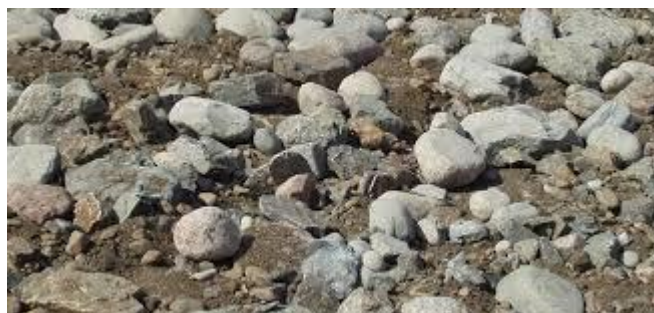
Figure 17: Example of VFR illustrating a homogenous mix of materials of different size classes.

As described above, removal of the gabion wall will result in a vertical drop-off that will be highly susceptible to erosion. It is recommended that the drop-off is protected by Void-Filled Riprap (VFR), which is essentially a construction material used to emulate natural riffle rock found in coarse gravel and cobble bed streams. The goal of VFR is to fill the voids of the conventional riprap (typically made up using large rocks) using a broad range (or size classes) of materials (cobbles, gravels, sands, and onsite soils) to emulate natural riffle rock. The mixture should create a dense, interlocking mass that keeps water flowing on the surface, mimicking a natural stream bed and encouraging growth of vegetation in trapped sediment. Material from the gabion structures that will be demolished can be used as a contributing material to the VFR.
