**RESIDENTIAL DEVELOPMENT ON THE REMAINDER
OF PORTION 60 OF THE FARM PLATTEBOSCH NO.
485, STILL BAY, WESTERN CAPE
EA REF: 16/3/3/5/D5/19/0001/22**

**PRE-CONSTRUCTION
START-UP ECO REPORT
JUNE 2024**

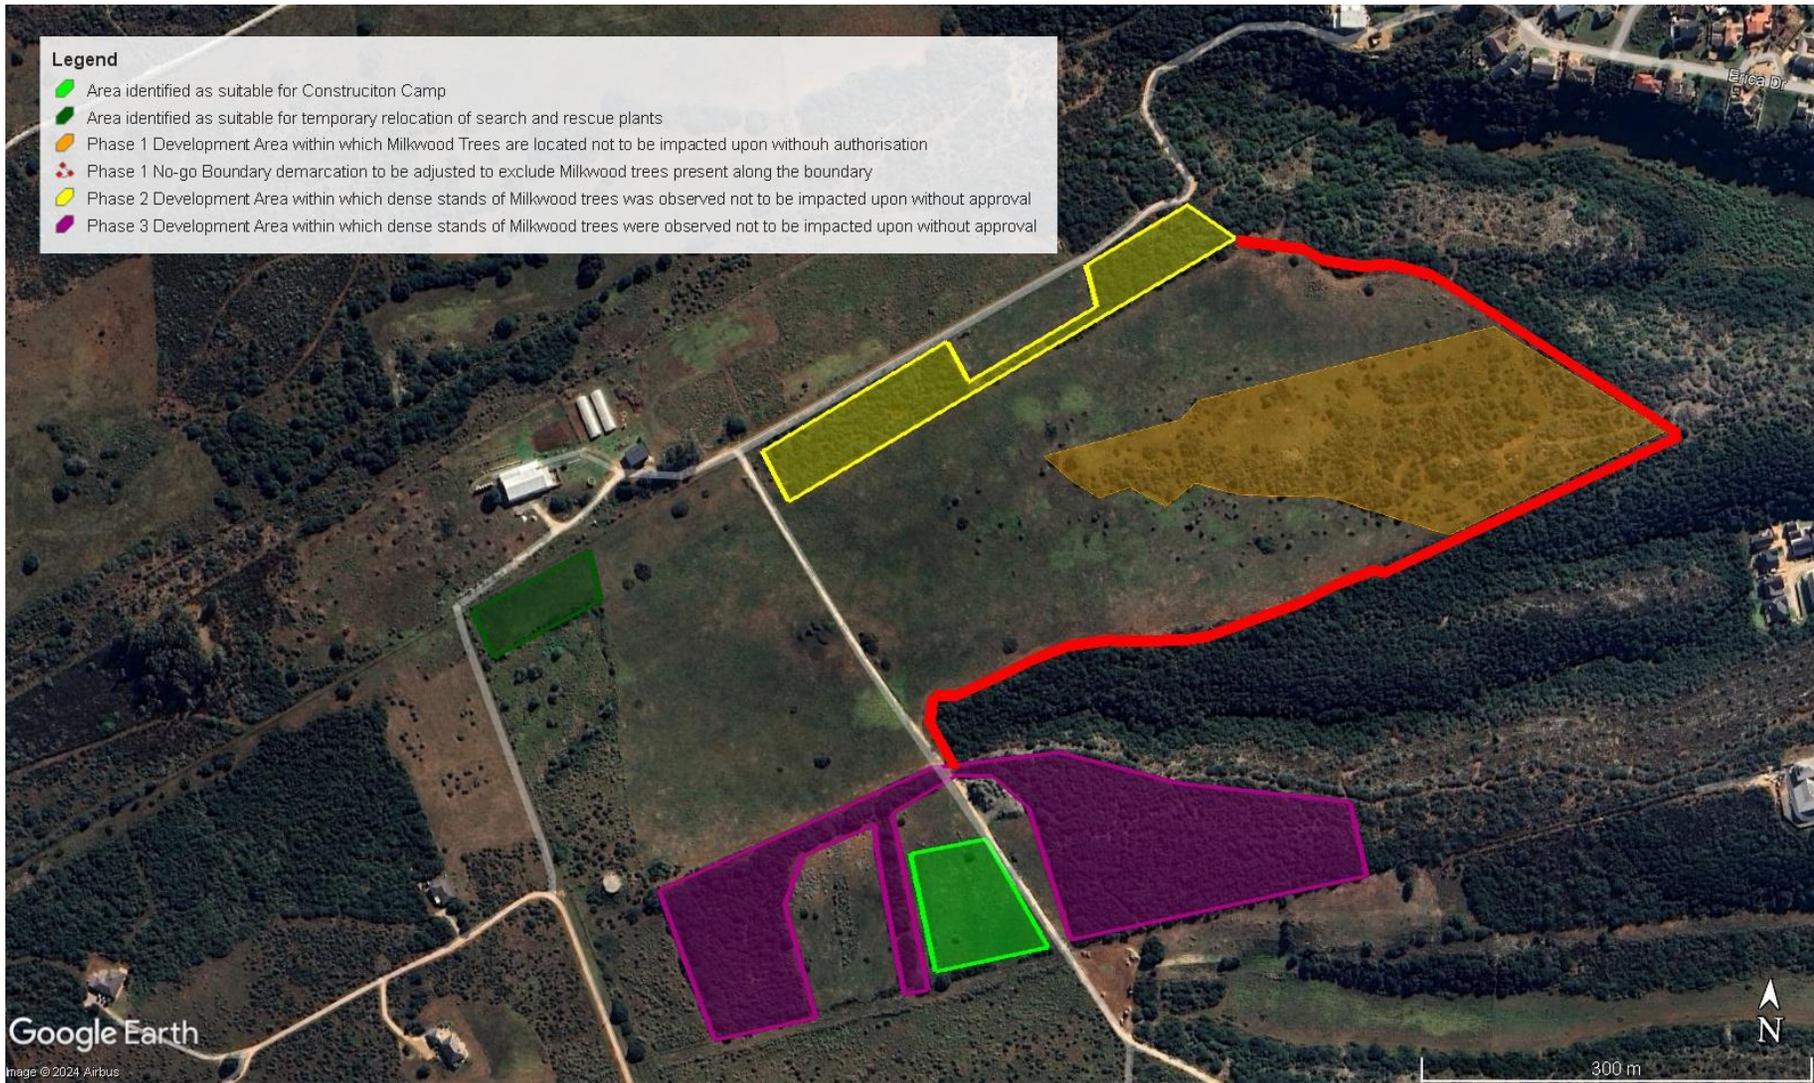
Map 1: June 2024 ECO map for indicating areas where Milkwood trees was observed and to be avoided; proposed construction camp placement; proposed search and rescue plants temporary placement; and Phase 1 no-go area boundary demarcation to be adjusted to exclude Milkwood trees present along the no-go boundary.

<p>Milkwood trees within and along no-go boundaries</p>	<p>avoided as far as possible and may not be impacted or damaged during any construction activities without authorisation/permits.</p> <p>It was observed that several Milkwood trees are located along the edge of the no-go areas as demarcated and impacts on these Milkwood trees can and must be avoided by adjusting the demarcations of the no-go boundary to exclude the Milkwood trees. Refer to the map below</p> <p>In some instances especially where demarcation was conducted within dense vegetation, there are no line of sight from one demarcation marker to the other, hence it was discussed with the EA holder that the demarcation markers must be clearly visible before any site clearance activities commences and this must be achieved by increasing the amount of demarcation markers placed along the no-go areas and clearing dense vegetation by hand i.e. chain saws to make sure that there is a clear line of sight visible from the one marker to the other so that machine operators do not impact on vegetation within no-go areas.</p>

<p>J2</p>	<p>Milkwood trees within proposed development area</p>	<p>At least 15 Milkwood trees were observed within the Phase 1 development area. NO MILKWOOD TREES MAY BE IMPACTED OR DAMAGED during any site clearance or construction activities.</p> <p>Extreme caution must be exercised during site clearance activities to ensure no impacts or damage to any protected Milkwood trees occurs.</p> <p>Once the Phase 1 development area has been cleared all Milkwood trees located within the approved development area must be recorded and applications for removal, relocation or pruning must be applied for and obtained from the relevant authority before any of these Milkwood trees may be impacted upon. As far as possible these trees must be accommodated on the layout within the proposed even.</p> <p>Dense stands of Milkwood trees were also observed within Phase 2 and Phase 3 remaining indigenous vegetation areas and when these areas are being cleared the shrubs around the Milkwood trees must be carefully cleared by hand not to damage any Milkwood trees and all Milkwood tress must be recorded and where removal or impacts on these trees cannot be avoided applications for removal, relocation or pruning must be applied for and obtained from the</p>

<p>relevant authority before any of these Milkwood trees may be impacted upon.</p> <p>Refer to the map below.</p>
J3	Construction Camp	<p>It was discussed and agreed with the EA holder that the construction camp will be established at the main entrance to the site which is further that 32m away from the edge of the drainage lines and not within an area containing Milkwood trees. Refer to the map below.</p> <p>All relevant construction camp requirements as per the EMP must be accommodated within this construction camp i.e. stockpiling; bunded fuel storage; fire fighting equipment; clear notice board with emergency telephone numbers; closed ablution facilities/chemical toilets for staff; hard copies of EA and EMP etc.</p>
J4	Plant Search and Rescue	<p>During the time of the visit search and rescue of viable indigenous vegetation species commenced under the guidance of the ECO. No bulb species for search and rescue operations were observed on the proposed development site, but restios and Mesembryanthemum sp. (small succent fig species) were identified for search and rescue and a suitable area as part of Phase 2 was identified for temporary relocation of these species until they can be used for rehabilitation purposes.</p> <p>Search and rescue operations continued over three days and success of temporary relocation of these species on site will be monitored by the ECO during the monthly site inspections.</p>

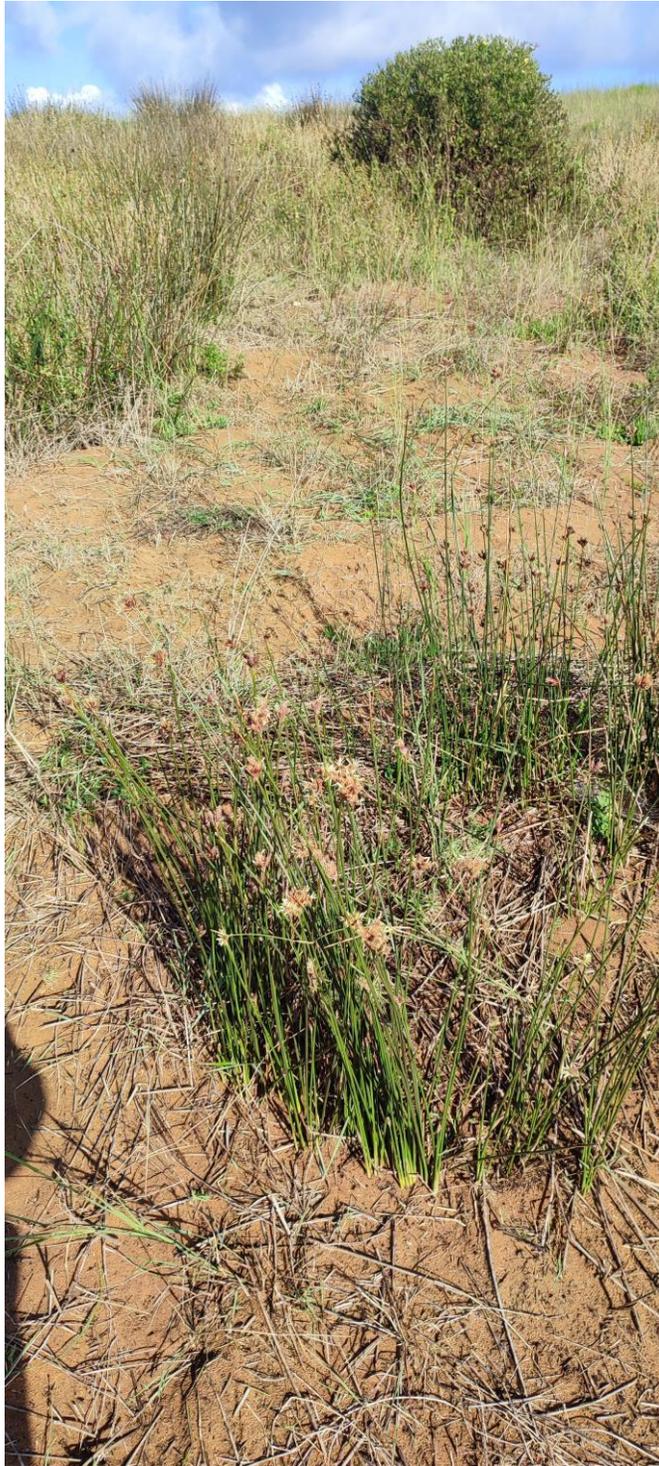
Photo 1: Restios observed on Phase 1 development areas removed for plant search and rescue purposes (photo taken 19 June 2024).

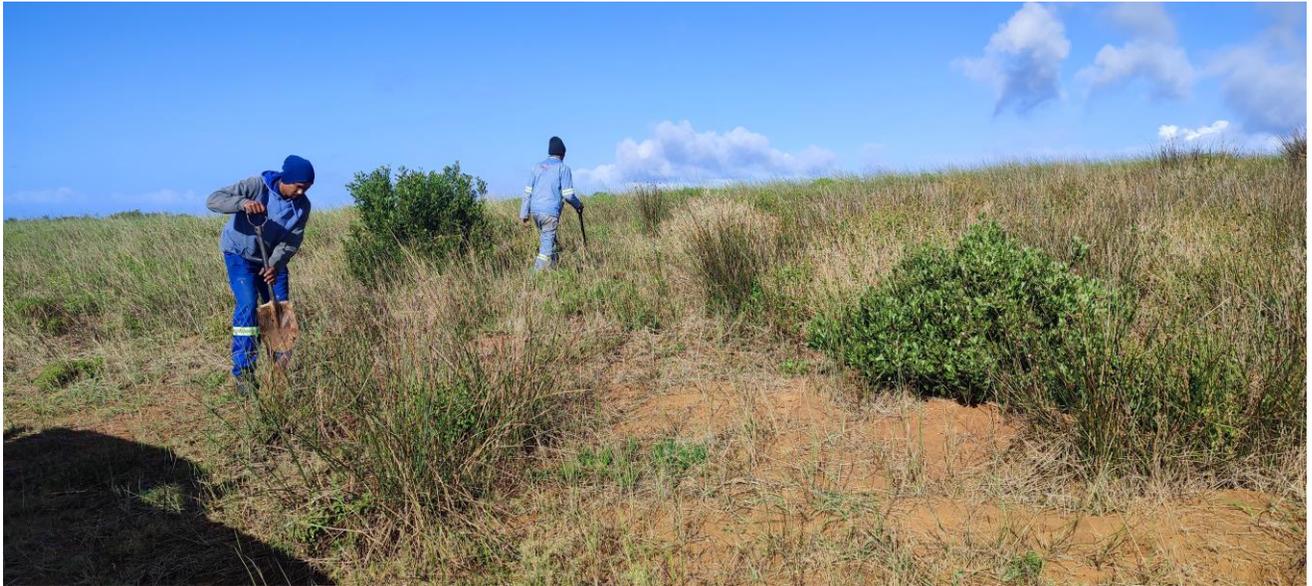
Photo 2: Active restio plant search and rescue operations taking place at Phase 1 development area before site clearance (photo taken 19 June 2024).

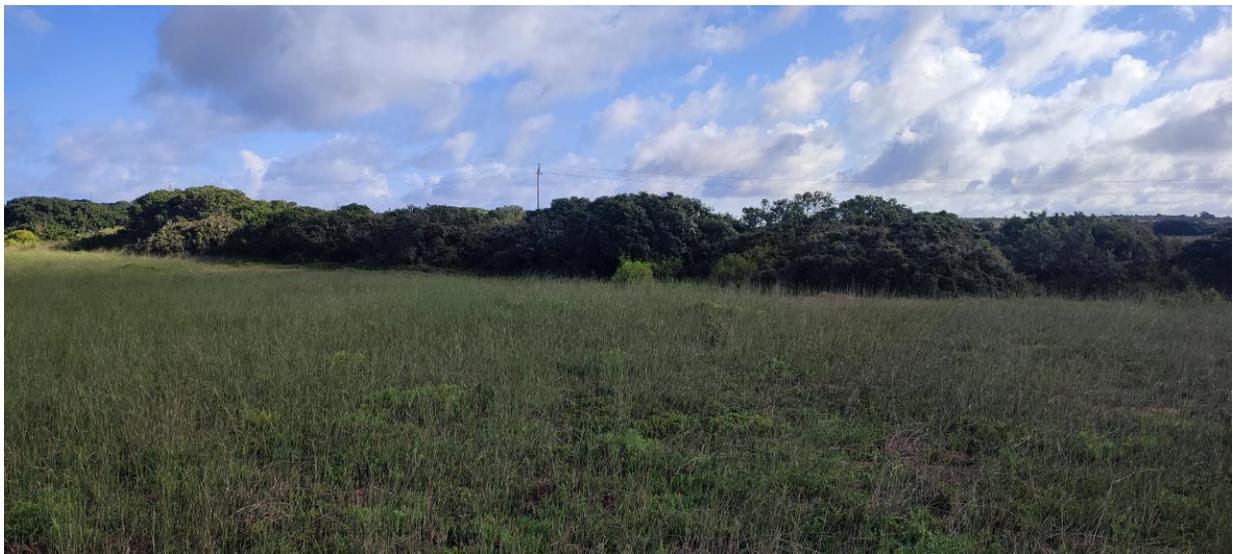
Photo 3: Dense Milkwood tree stands observed within Phase 2 development area, Milkwood trees not to be impacted upon by any site clearance of construction activities without authorisation (photo taken 19 June 2024).

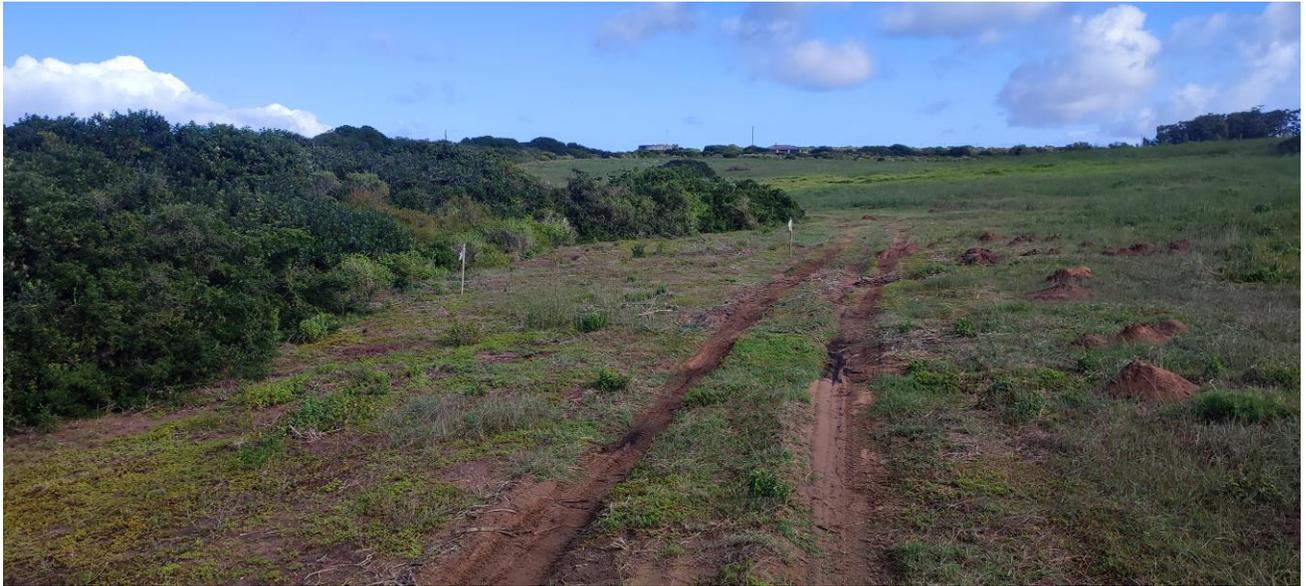
Photo 4: Demarcation of Phase 1 no-go boundary (photo taken 19 June 2024).

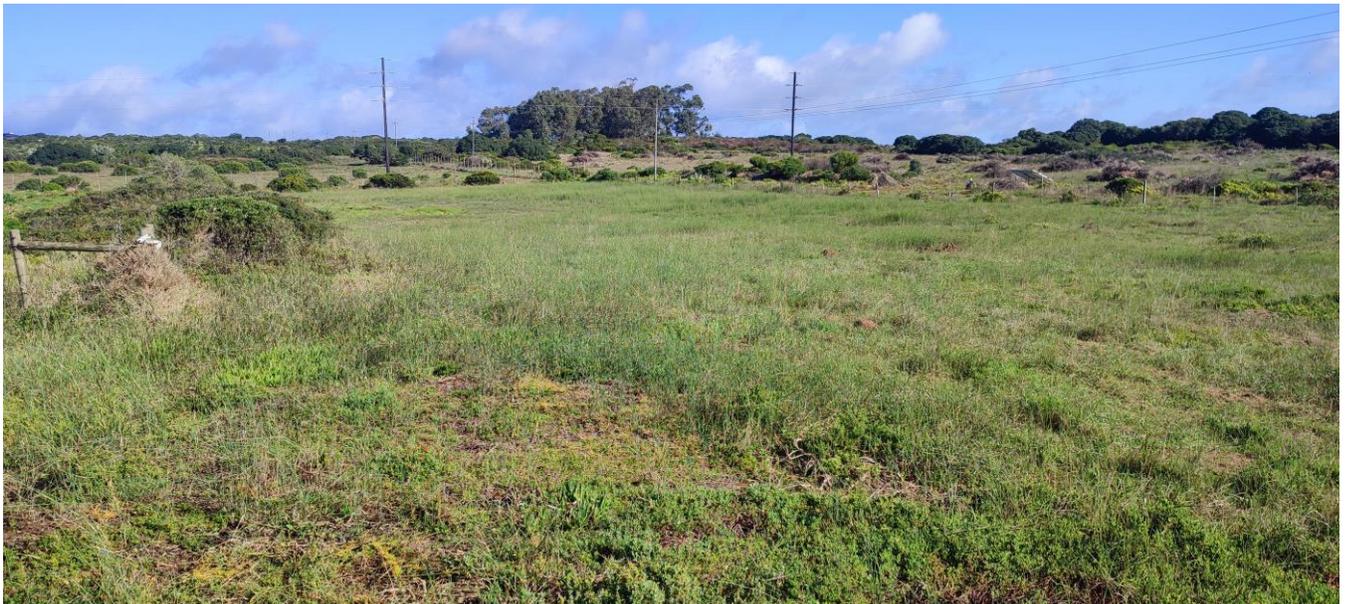
Photo 5: Suitable area identified on site for temporary relocation of plants searched and rescued (photo taken 19 June 2024).

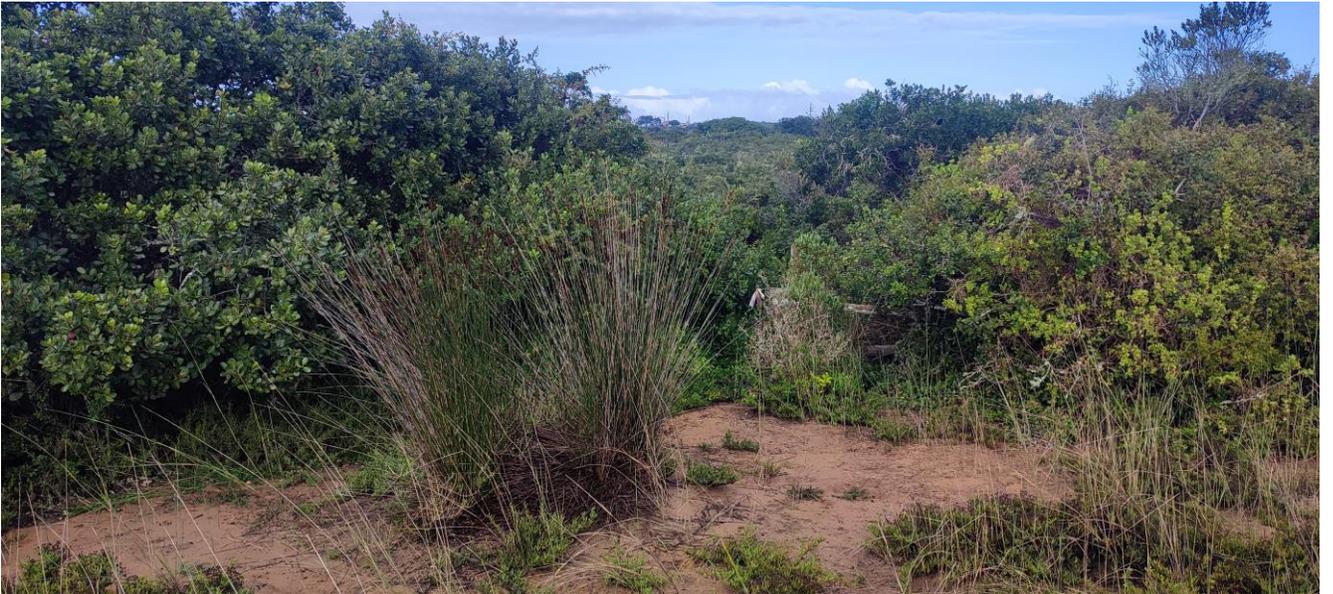
Photo 6: Restios observed on Phase 1 development areas removed for plant search and rescue purposes (photo taken 19 June 2024).

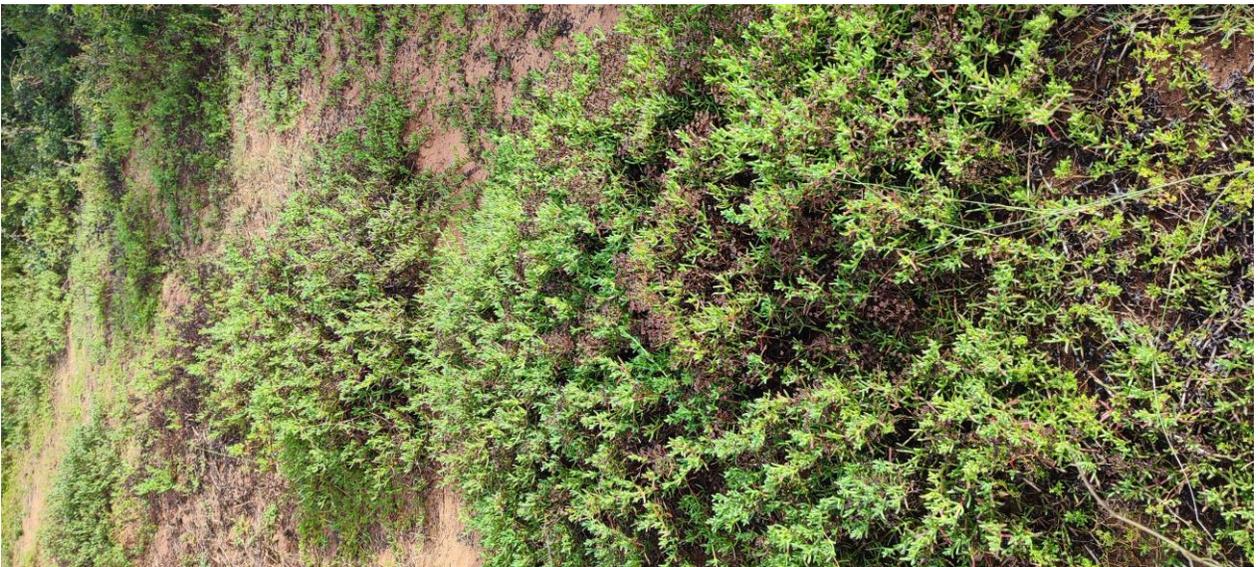
Photo 7: Mesembryanthemum sp (succulent figs) observed on Phase 1 development areas removed for plant search and rescue purposes (photo taken 19 June 2024).

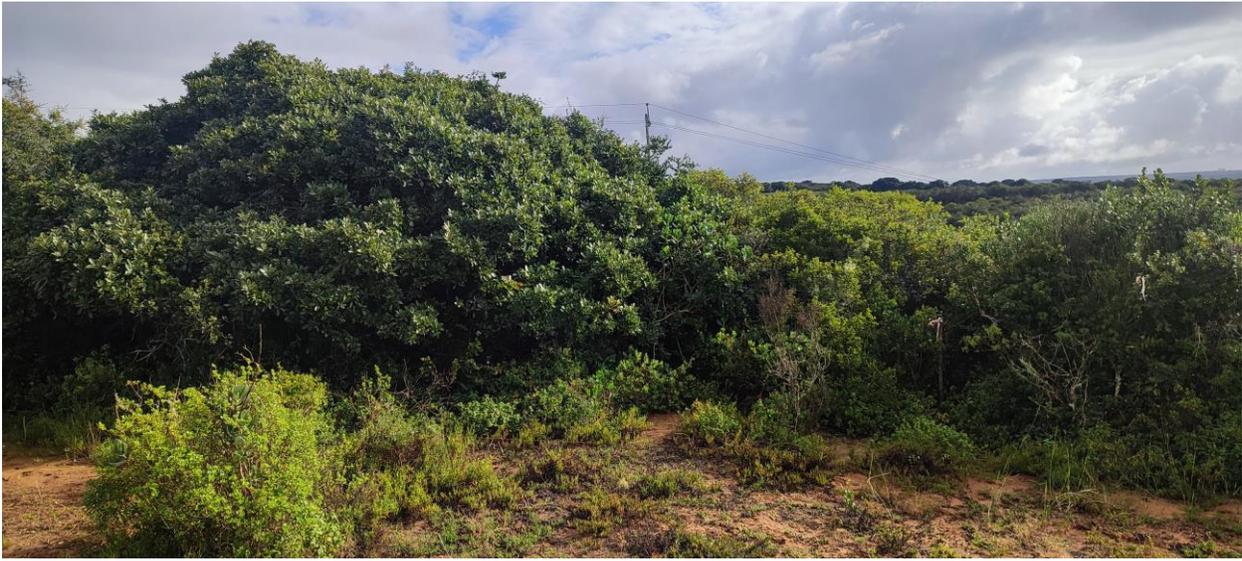
Photo 8: First example of no-go boundary demarcation marker next to Milkwood tree which must be moved inwards (within approved development area) to exclude Milkwood tree from development area (photo taken 19 June 2024)

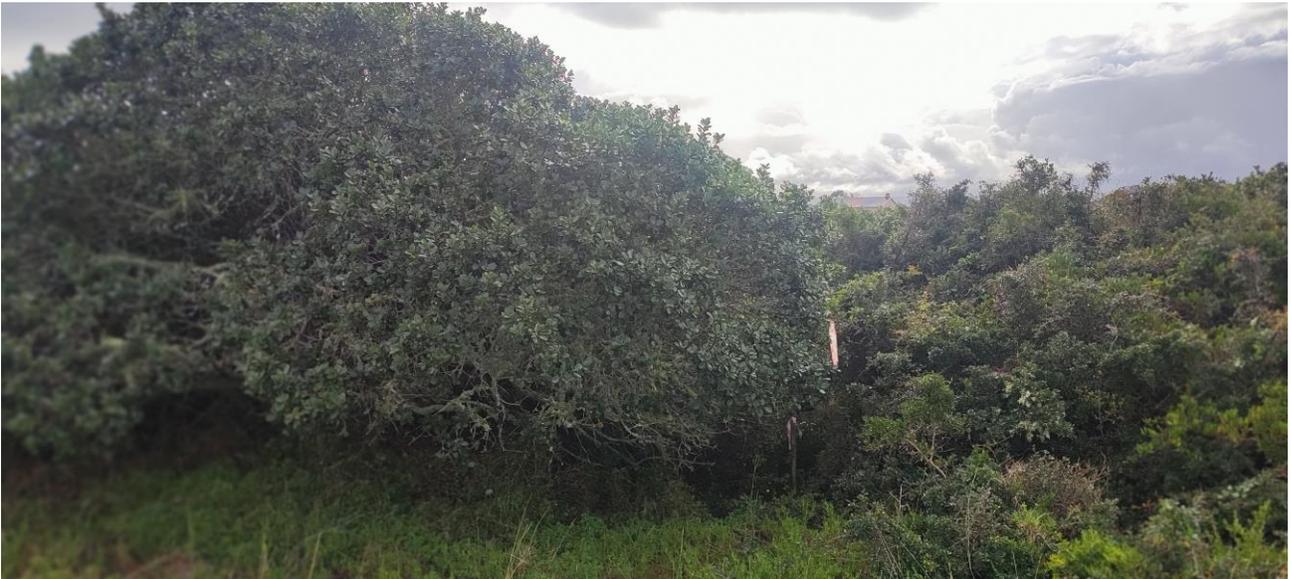
Photo 9: Second example of no-go boundary demarcation marker next to Milkwood tree which must be moved inwards (within approved development area) to exclude Milkwood tree from development area (photo taken 19 June 2024)

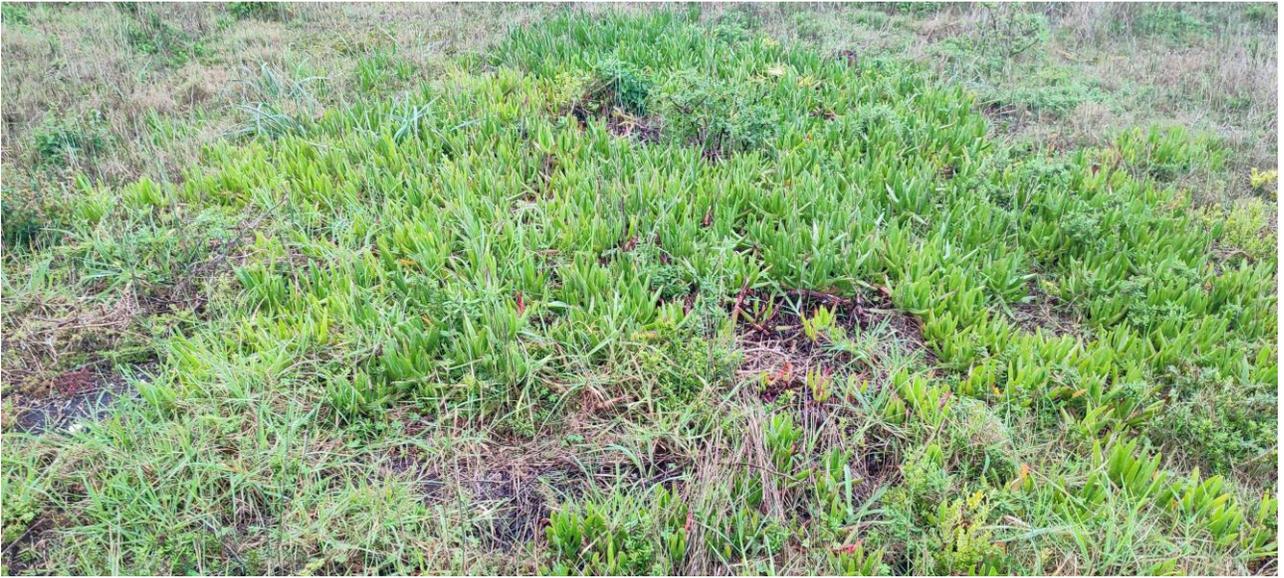
Photo 10: Mesembryanthemum sp (succulent figs) observed on Phase 1 development areas removed for plant search and rescue purposes (photo taken 19 June 2024).
