Proposed Housing Development on Erf 2841 Called Seegenot, Tergniet

Aquatic Biodiversity Compliance Statement

Prepared For: Cape EAPrac
Author: Dr. Jackie Dabrowski
Confluent Environmental Pty (Ltd)
7 St. Johns Street,
Dormehls Drift,
George, 6529
SACNASP: Pr. Sci. Nat. (Aquatic Science) – 115166
Reviewer: Dr. James Dabrowski
Date: 28 June 2024
Version: Final

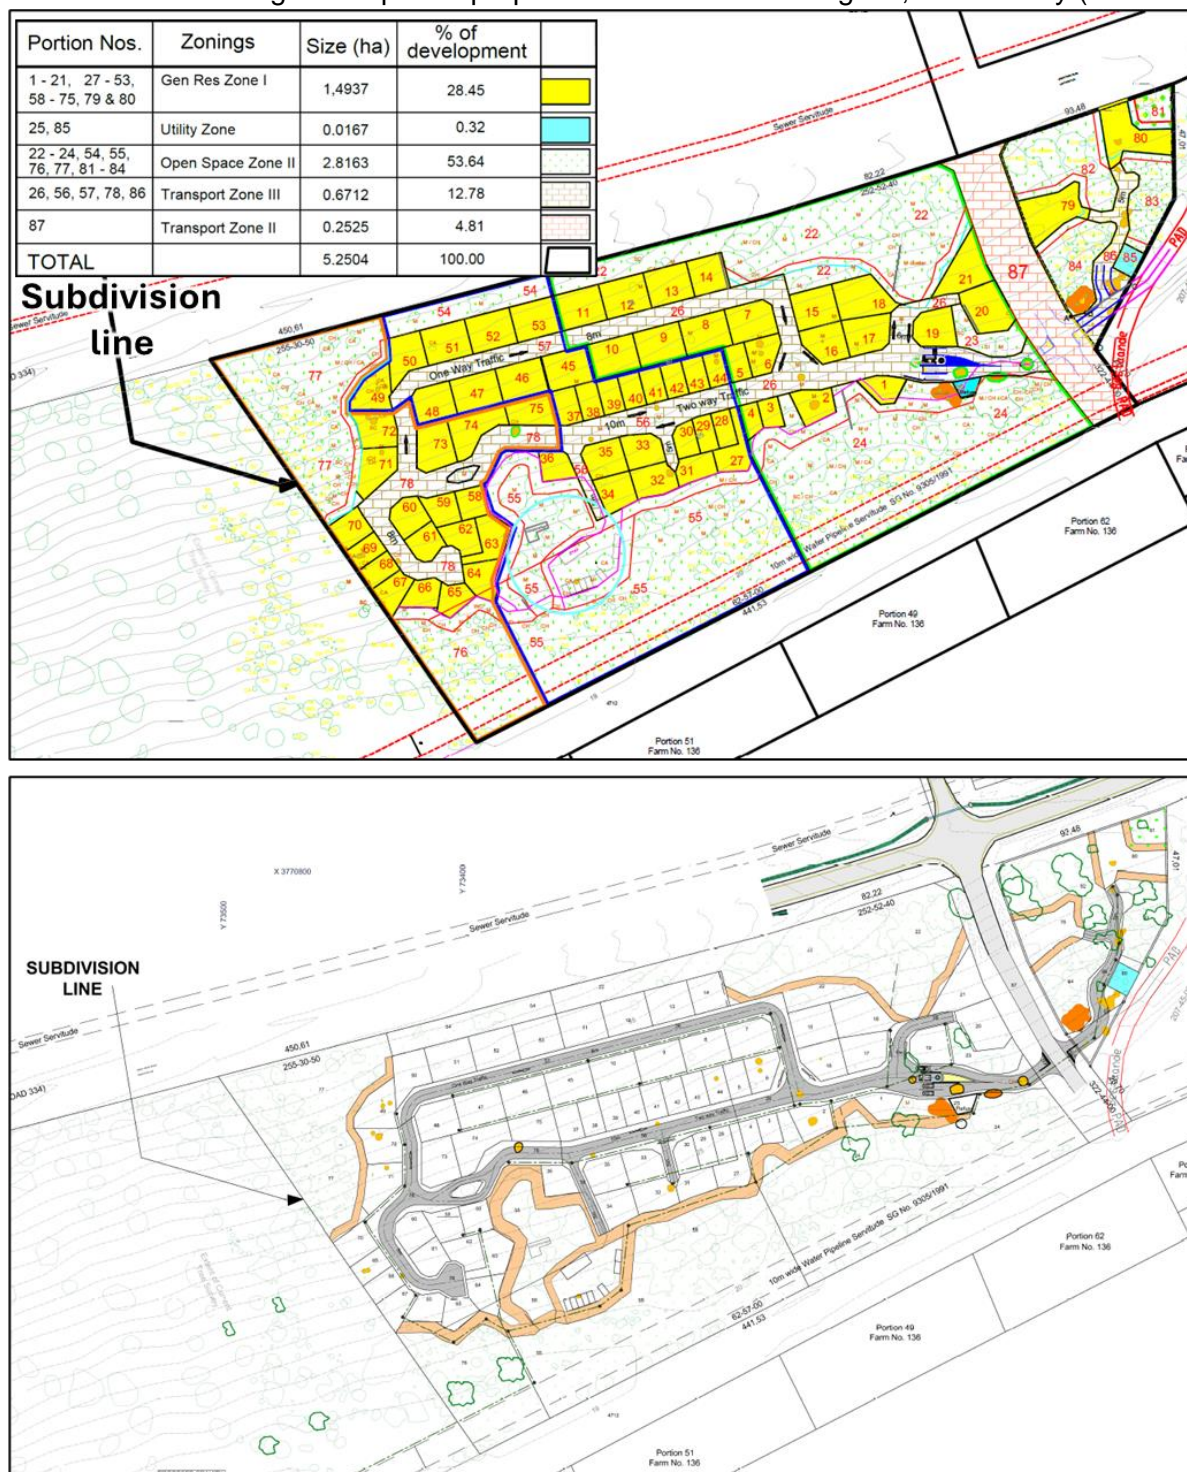
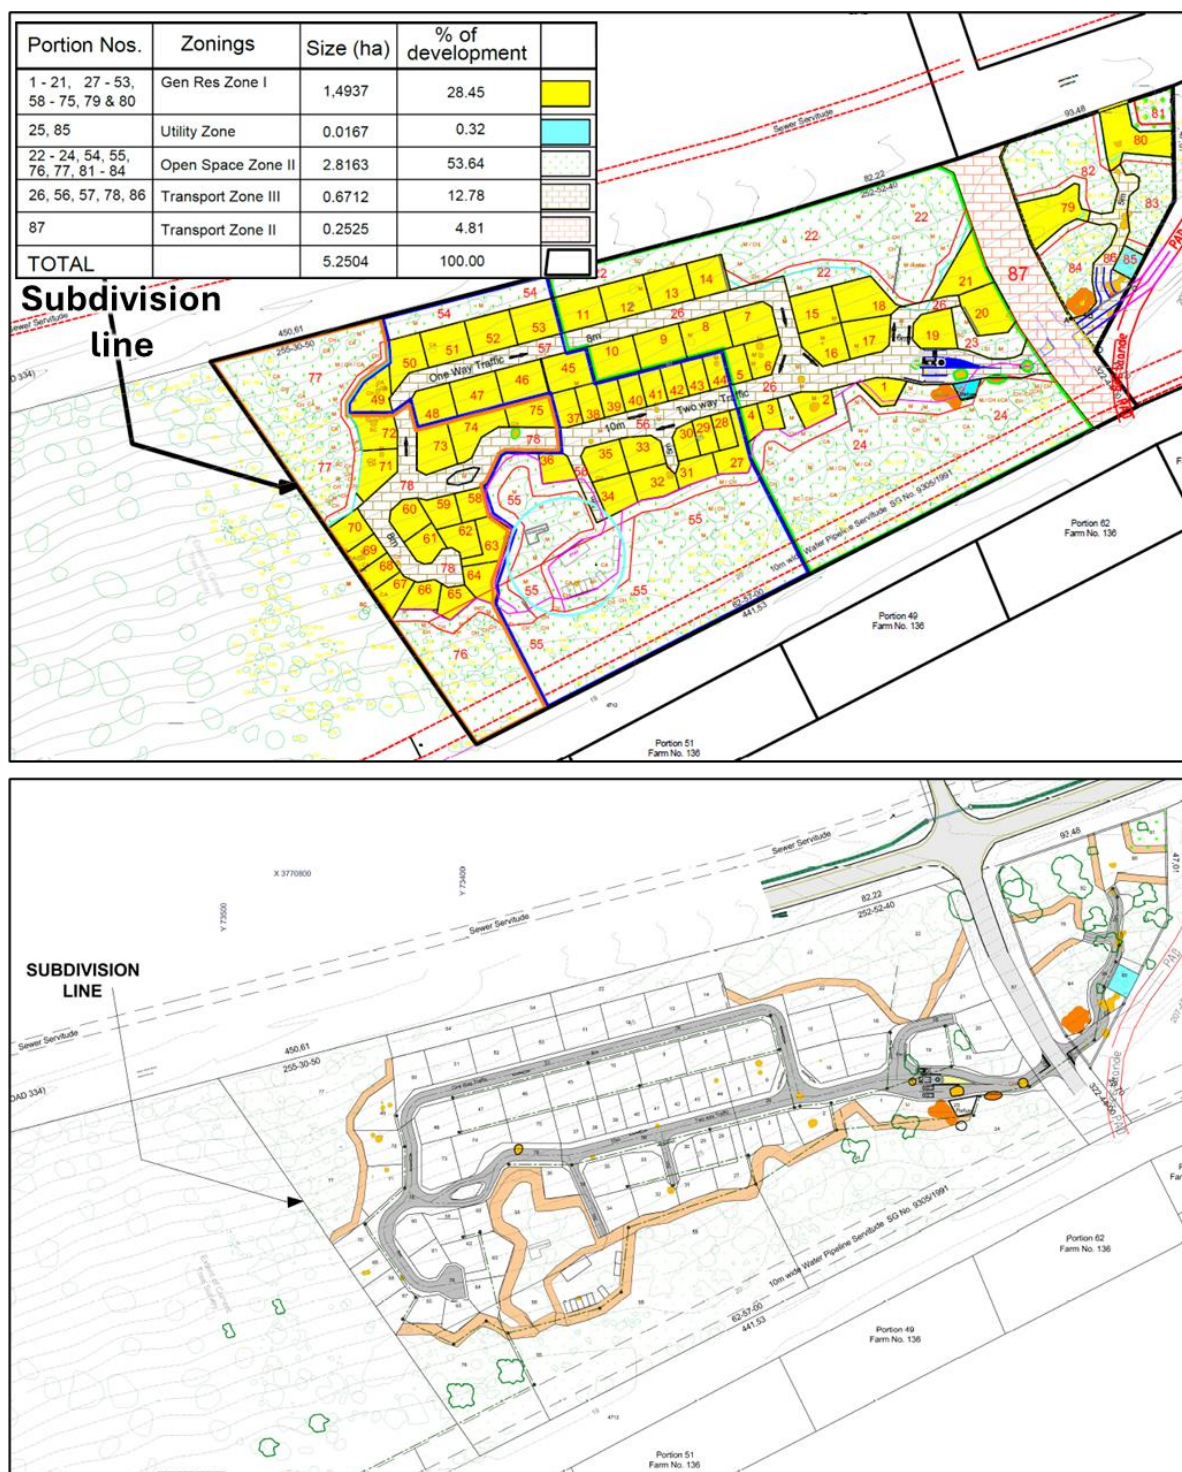
Figure 1: The site development plan of Erf 2841. The top plan indicates the planned layout, while the bottom map is for the proposed sewer lines and connections over the development area.

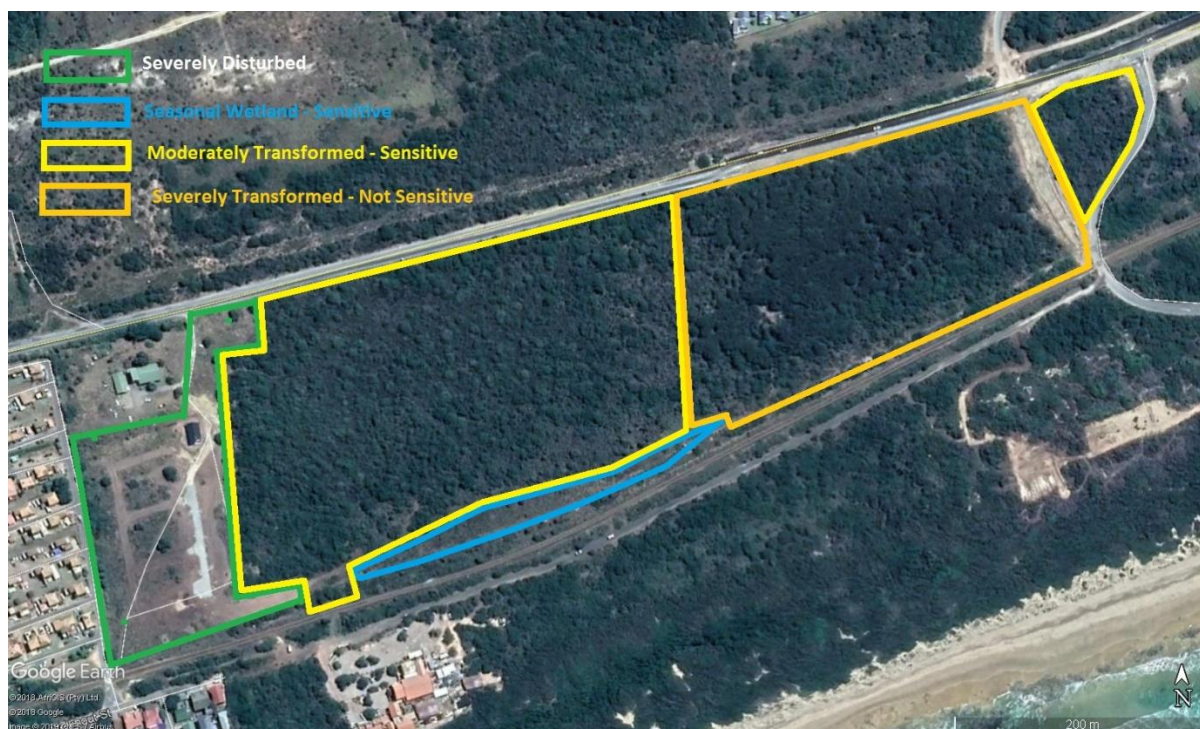
In a botanical specialist assessment of the site, the specialist indicated seasonal wetland habitat in the dune slack area towards the southern boundary of Erf 2841 (Figure 2). The purpose of this assessment was to provide aquatic specialist inputs to confirm the presence of the wetland, and if present, to provide a delineation and recommended setback area for the development (buffer zone).

Figure 2: Wetland area identified in the botanical specialist report (Jan Vlok, March 2019)

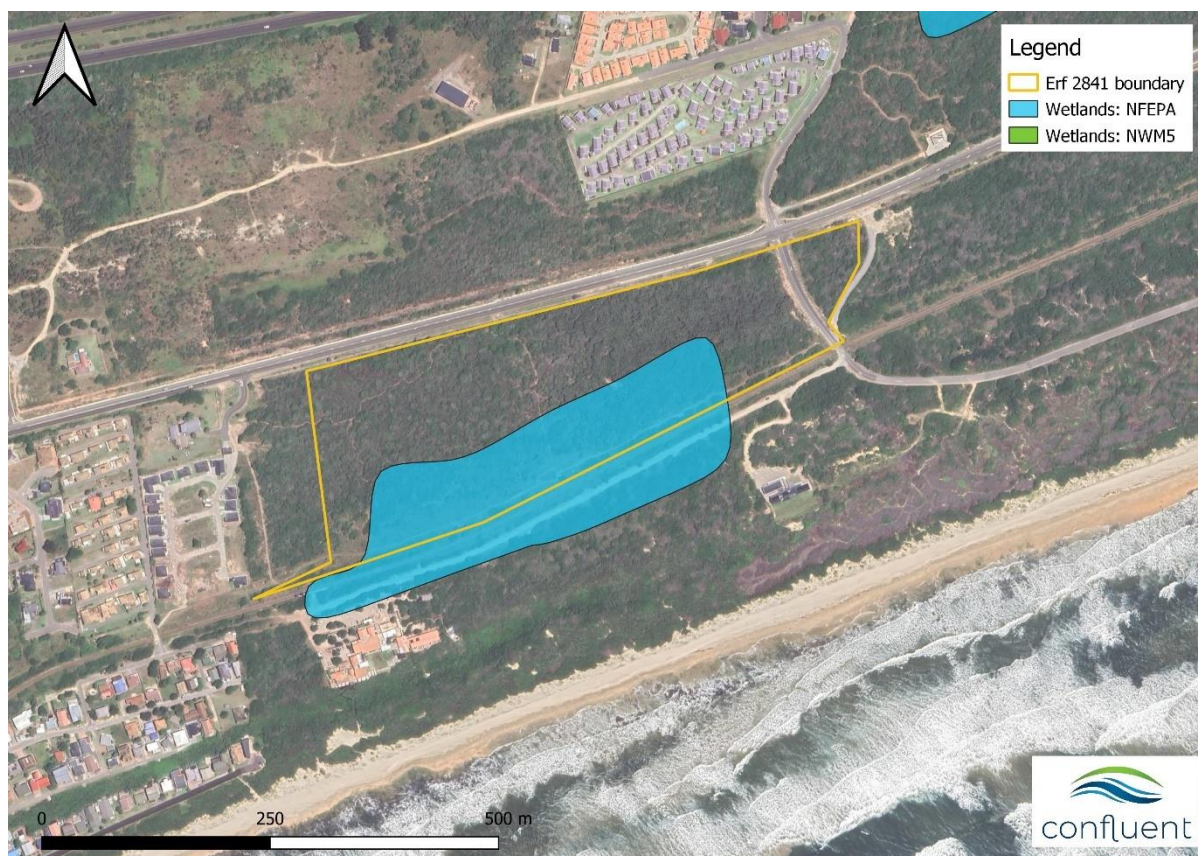
The wetland area indicated by the botanical specialist is also indicated as a wetland according to the National Freshwater Ecosystem Priority Atlas (Nel *et al.*, 2011; Figure 3). The Western Cape Biodiversity Spatial Plan (WCBSP) relied on wetlands identified in NFEPA and therefore indicates an Ecological Support Area 1: Wetland at the same location. However, the more recently developed National Wetland Map 5 (NWM5) does not indicate any wetland at this site.

Figure 3. Wetlands mapped according to national spatial layers on Erf 2841. No wetland is mapped at the site in NWM5.

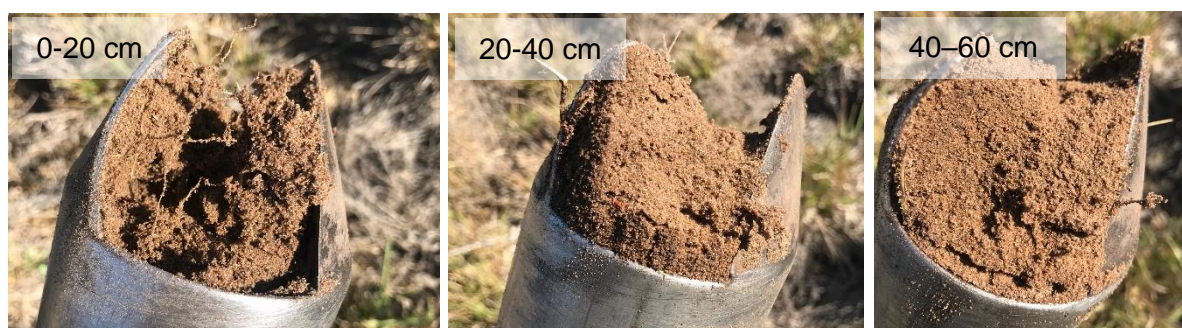
A leaking pipe connection and manhole was observed towards the east of the mapped wetland (Figure 6), and soil augering was done directly adjacent to the leak to determine whether redoximorphic features were present in the soil where water was known to be discharging. Even at this point, there were no redoximorphic features present (Figure 4). Water discharged was infiltrating the soil at a fast rate reflecting the deep, well drained soil at the site.

Figure 4. Soil auger samples taken below the leaking pipe.

The area dominated by *Stenotaphrum secundatum* (Buffalo Grass) may be more characteristic of a wetland. However, this is a small area, and likely results from the leaking pipe at this location. It is therefore unlikely to function as a wetland if the leaking pipe is repaired. Deep, well-drained soil at the site also ensures that the water drains away very quickly in close proximity to the pipeline.

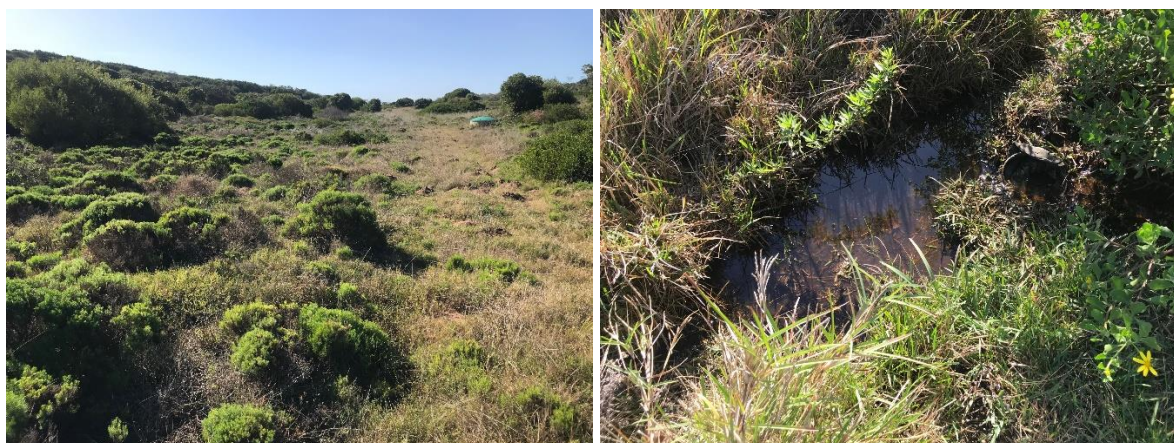
Vegetation in the mapped wetland area, or that indicated by the botanical specialist, was not dominated by typical wetland plant species. In the immediate vicinity of the water leak is an area with extensive growth of *Stenotaphrum secundatum* (Buffalo Grass) which is considered a facultative wetland plant species. This species can also tolerate unsaturated conditions and is a popular lawn or turf species. In this location, it is likely growing in response to the water leak, as there is a distinct zone where it becomes the dominant grass proximal to the leak (Figure 6).

Figure 5. Typical vegetation in the dune slack area indicated as wetland (left) and a small pool of water at the point of the water leak (right).

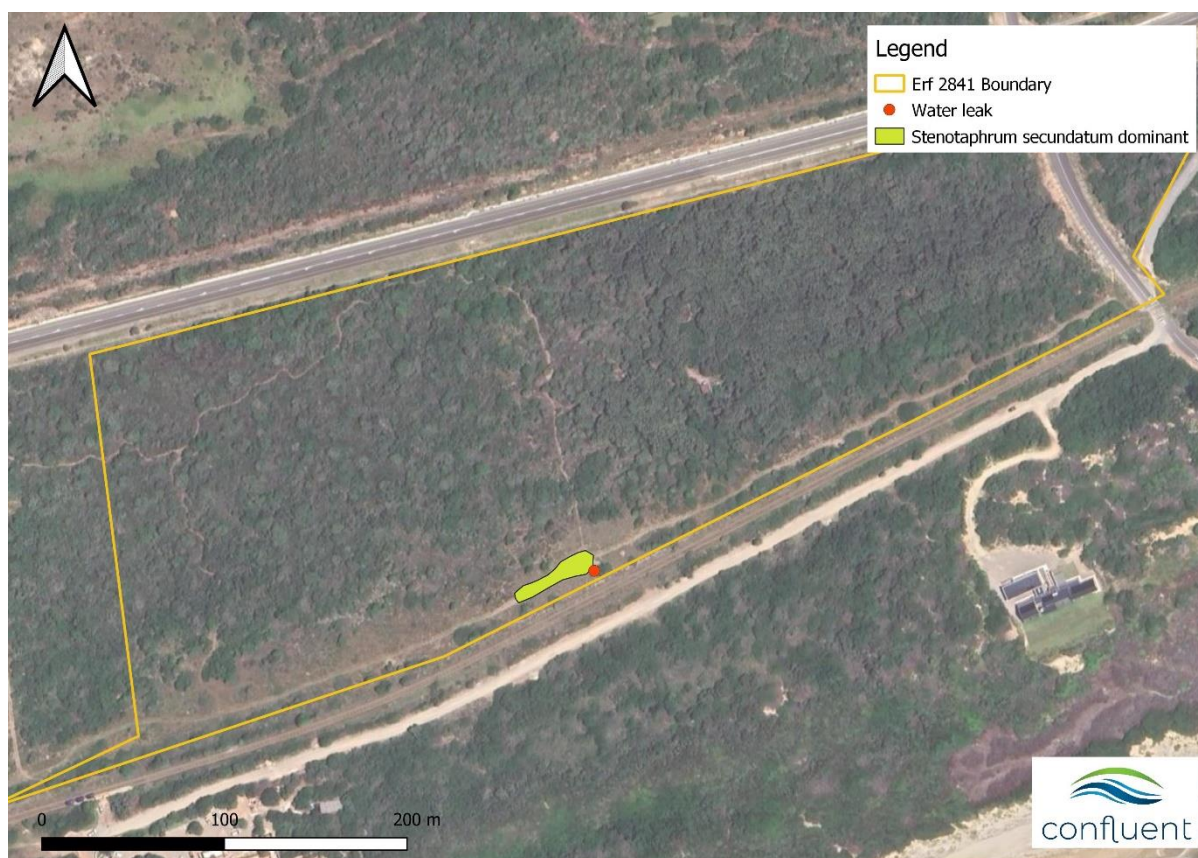
Figure 6: Photographs indicating dominant vegetation at the site.

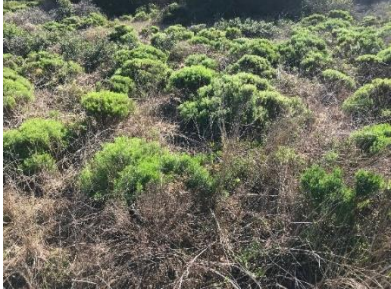
Species	Common names	
<i>Chrysocoma ciliata</i>	Bitterbush (Green shrubs)

Table 1. Dominant vegetation in the area mapped as a wetland (NFEPA)

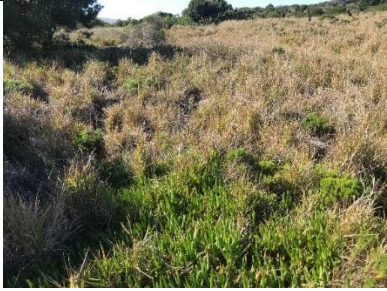
<i>Carprobrotus edulis</i> <i>Stenotaphrum secundatum</i>	Sour fig (Green succulents) Buffalo grass (grass)

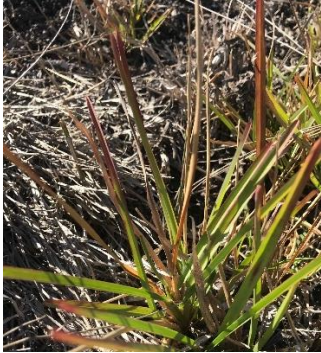
<i>Stenotaphrum secundatum</i>	Buffalo grass (grass)

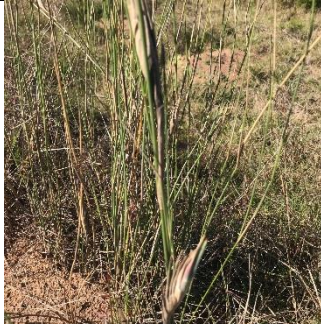
<i>Ehrharta villosa</i>	Pipe grass

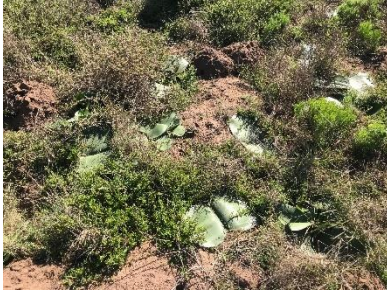
<i>Haemanthus sanguineus</i>	Veldskoenblaar (Tongue-like leaves)

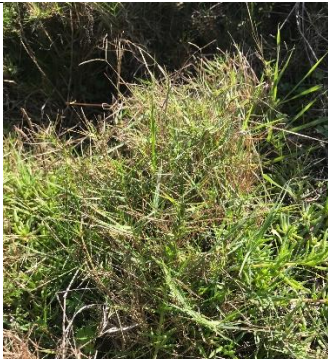
<i>Cynodon dactylon</i>	Bermuda grass

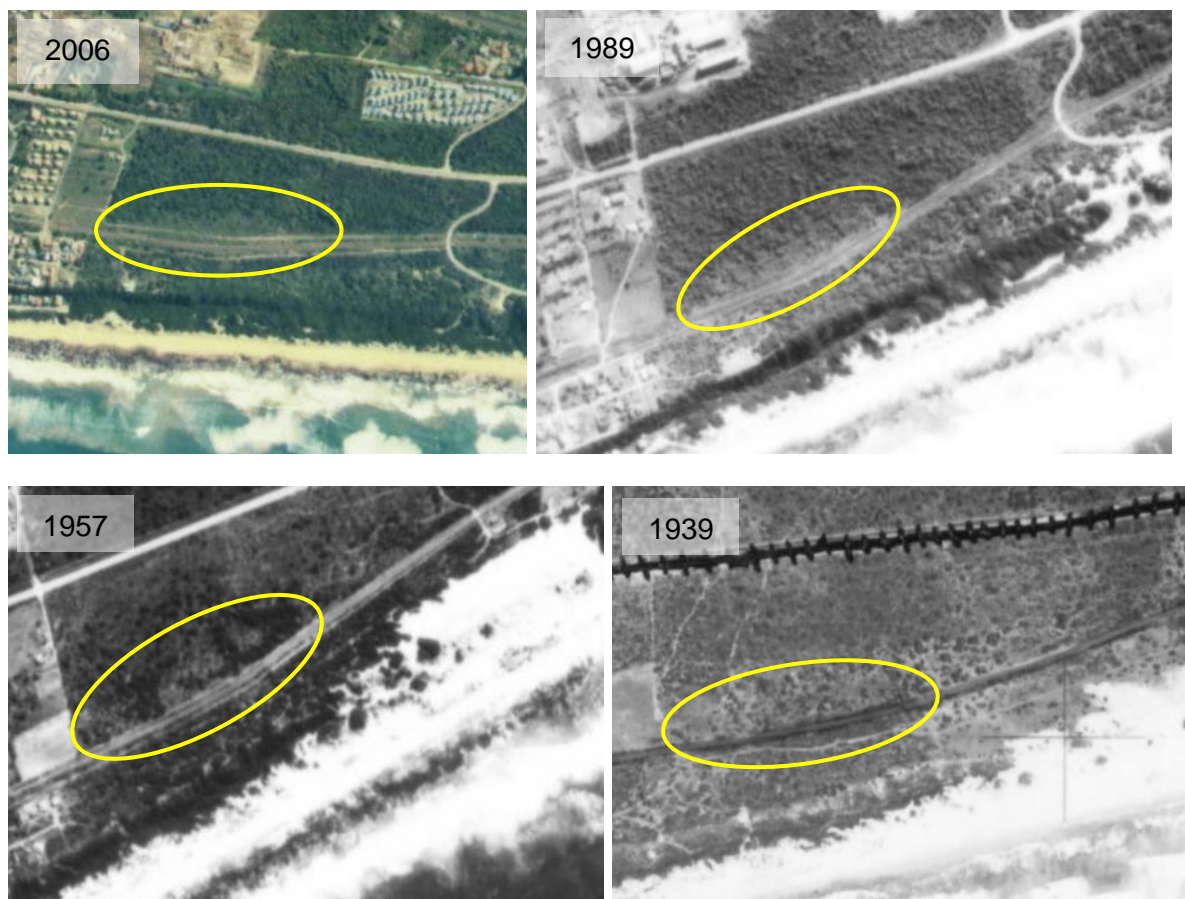
A number of historical images of the site are presented in Figure 7. In certain images the slight difference in vegetation in this area (less shrubs and trees) is evident such as 2006 and 1989. In 1957 there appeared to be a lot more woody vegetation at the site, and prior to that in 1939 the vegetation was once again more sparse in this area. The difference in vegetation is not consistent and may also have been influenced by construction of the railway line and subsequent installation of the large pipeline and associated service road.

Figure 7. Historical images of the mapped wetland area on Erf 2841.

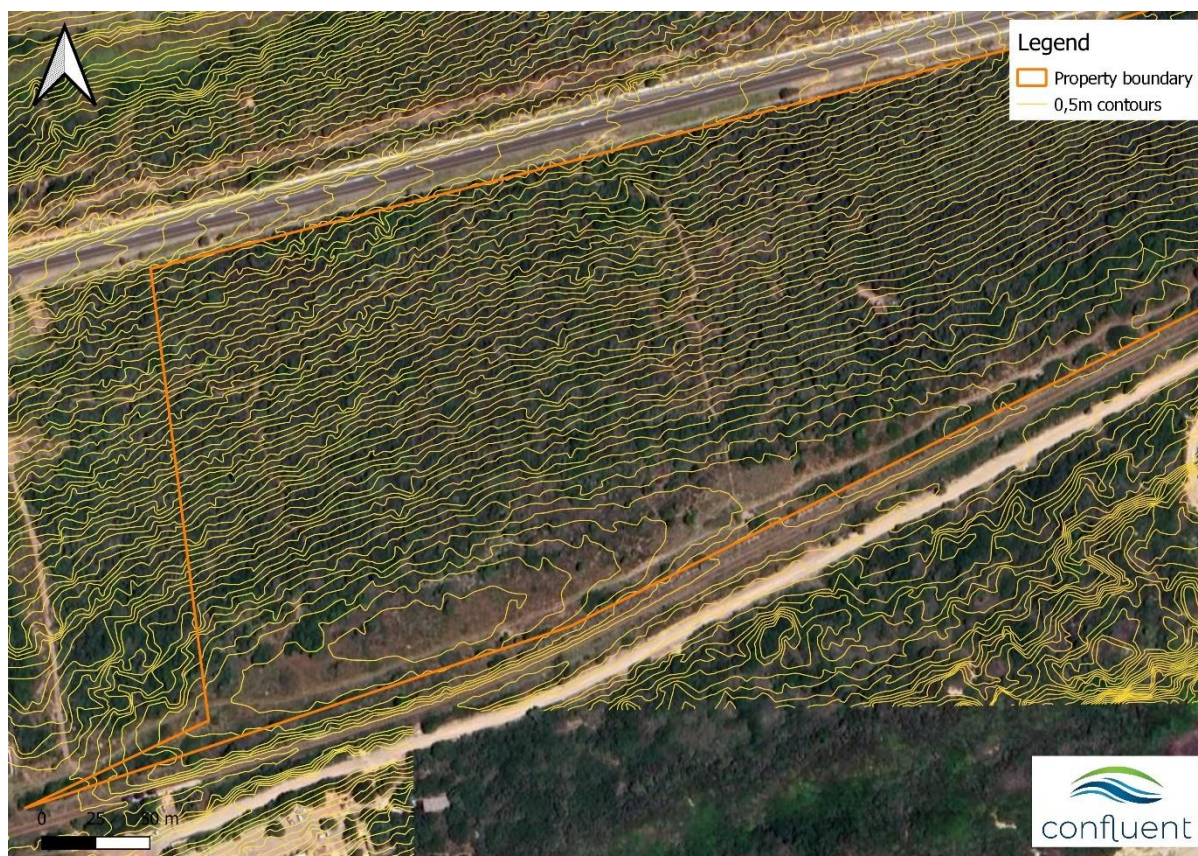
Dune slacks are interdune depressions which are often damp. The location of the mapped wetland as a depression between dunes is not inconsistent with what can be expected from these areas. Mapped 0.5m contours of the site demonstrate clearly that the location of the possible wetland area coincides with a localise depression surrounded by higher ground on all sides. Groundwater may be closer to the surface during different seasons as it flows towards the sea (Mucina *et al.*, 2006). While the topography may predispose the site to development of a wetland, neither the soil nor vegetation features strongly indicate the presence of a wetland at this location. However, the distinct vegetation in this area, and topographic predisposition to draining surrounding slopes require careful management of this area, which should ideally not be developed with any hard infrastructure.

Figure 8. Project area overlaid with 0.5m contours (Lidar survey, Western Cape Government)

Given the topographical position of the site, it will receive runoff and drainage from surrounding slopes, and hard infrastructure in this area would be flood prone. It is therefore recommended that no hard infrastructure (roads, buildings, parking areas) be planned for this area.
