# Development of a Dwelling (Seebederfie) on Erf 4735, Tergniet, Mossel Bay.

## Aquatic Compliance Statement

**Prepared For:** Cape EAPrac  
**Author:** Dr. J.M. Dabrowski (PhD)  
Confluent Environmental Pty (Ltd)  
7 St. Johns Street,  
Dormehlsdrift,  
George, 6529  
**SACNASP:** Pr. Sci. Nat. (Water Resources) – 113456  
**Reviewer:** Dr. J. Dabrowski (PhD)  
**Date:** 16 January 2024  
**Version:** Draft Final

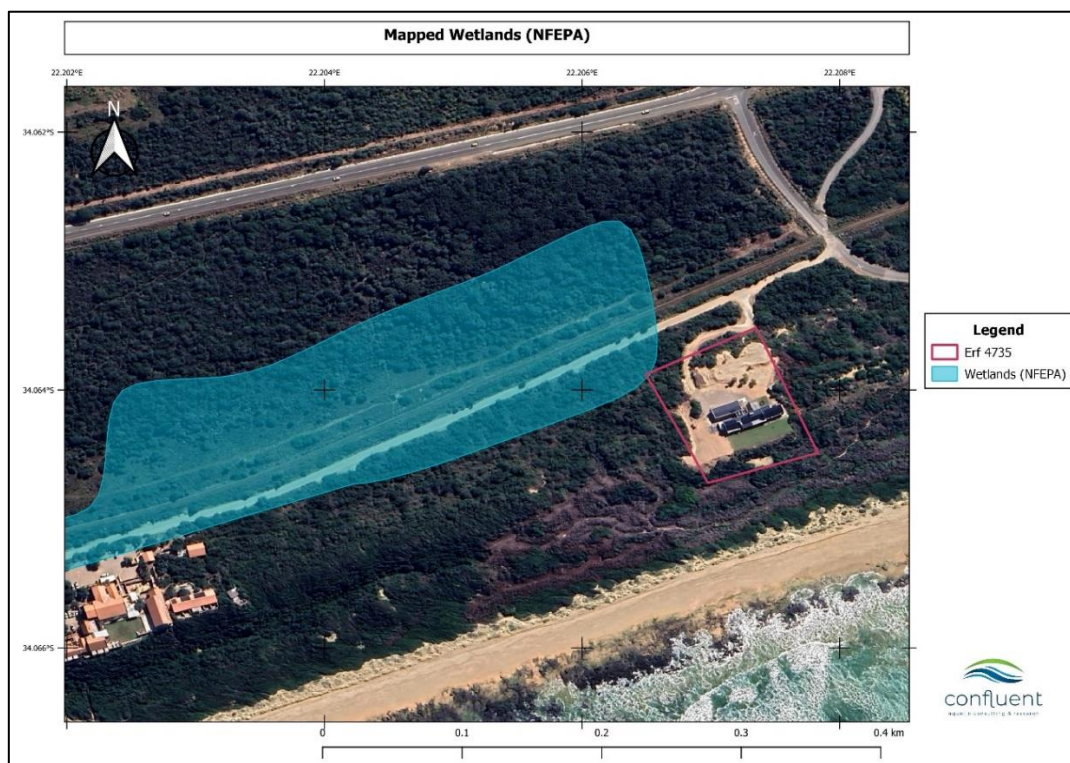
The site falls within Primary Catchment K (Kromme) area and in quaternary catchment K20A (Figure 1). The designation of the area by the WCBSP as a CBA wetland most likely stems from the earlier NFEPA Wetland Atlas (Nel, 2011) which identified an unchannelled valley-bottom wetland extending from the north-west corner of the property (Figure 2). The more recent NWMV5 (CSIR, 2018) map does not highlight this area as a wetland and according to

Figure 2: Mapped wetlands according to the NFEPA Atlas (Nel et al., 2011).

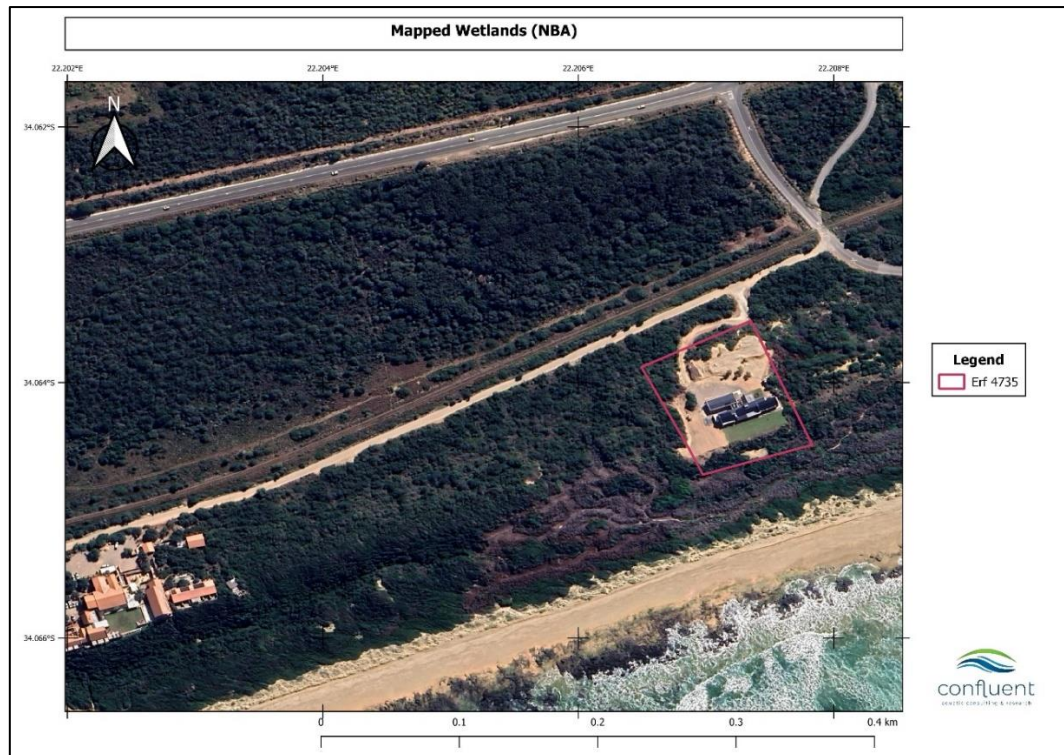
the most recent geospatial data sources no freshwater features are indicated to occur within the footprint of the property or within close proximity to the property (Figure 3).

Figure 3: Mapped wetlands according to the 2018 National Biodiversity Assessment (CSIR, 2018).

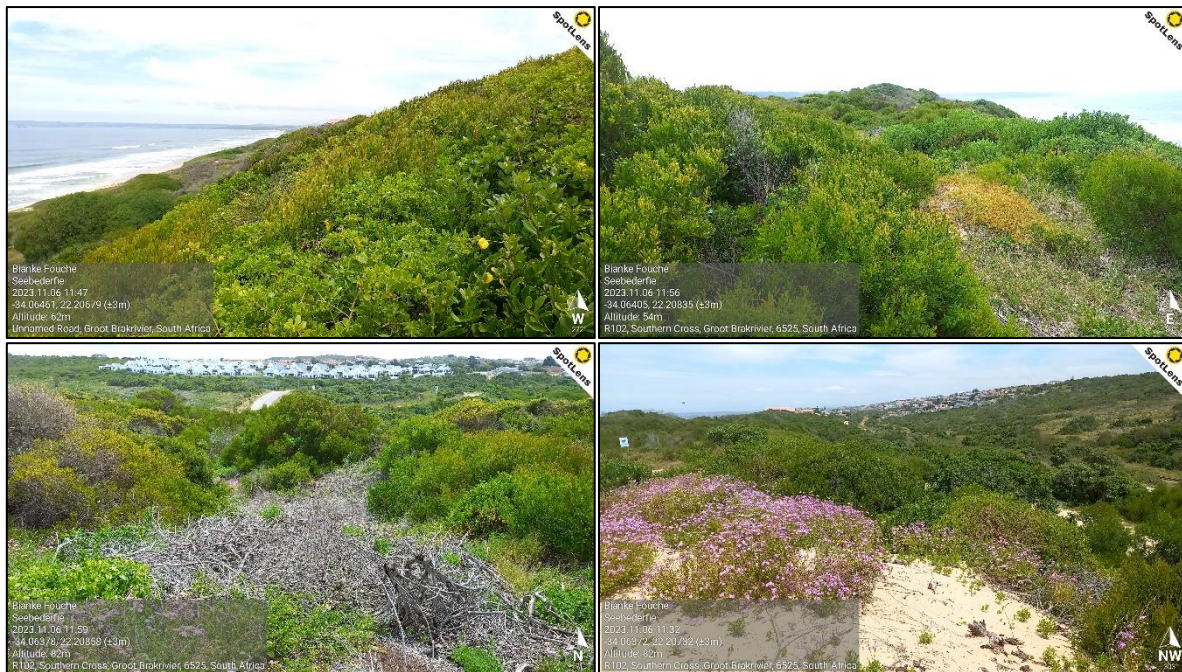
The site visit was conducted on 6<sup>th</sup> of November 2023 during which time the entire extent of the property was traversed by foot. The main dwelling is located on the ridge of a vegetated dune which slopes down to the coastline to the south and to the main access road and railroad to the north. There are however no clear areas of natural drainage on the property and no hydro-geomorphological landscape features (depressions, confined valleys, channels etc.) indicating the presence of a watercourse on the property (i.e. stream, river or wetland) (Figure 6). Vegetation on site has been confirmed as the Hartenbos Dune Thicket vegetation type, which has been heavily invaded by Rooikrans (*Acacia cyclops*).

The area mapped as a CBA wetland to the west of the property is a low-lying area in between two vegetated dunes. Observations on site however confirmed the lack of any wetland immediately adjacent to the property. In contrast, as mentioned above the terrain is characterised by a relatively long dune depression which is densely vegetated by dune thicket vegetation that has been heavily invaded by *A. cyclops*. There was no indication of any obvious wetland habitat within the depression. Soil on the site is very sandy and, under wetter seasonal or short-term climatic conditions, is unlikely to retain water for long enough to result in the formation of temporary or seasonal wetland habitat. A road and railway cross through the middle of the CBA but there are no signs of saturated soils or associated wetland vegetation. The general area is therefore consistent with the most recent NBA assessment, which does not indicate the presence of a wetland adjacent to the property (Figure 3). It can therefore be concluded, with a high degree of confidence, that no freshwater features occur within or adjacent to the property boundaries and that no aquatic biodiversity was affected by the construction of the main dwelling or clearance of vegetation on the property.

Figure 6: Photographs of the site including view to the west (A) and east (B). Photographs C and D are to the north providing a view of the area that has been mapped as an aquatic CBA and ESA.
