Arch Rock
Remainder Portion 5 of 296 Arch Rock
Keurboomstrand

DEA&DP Coastal Management Map

Arch Rock DFFE Coastal Viewer

Appendix A: Coastal Vulnerability Assessment of Portion 5 of farm 296

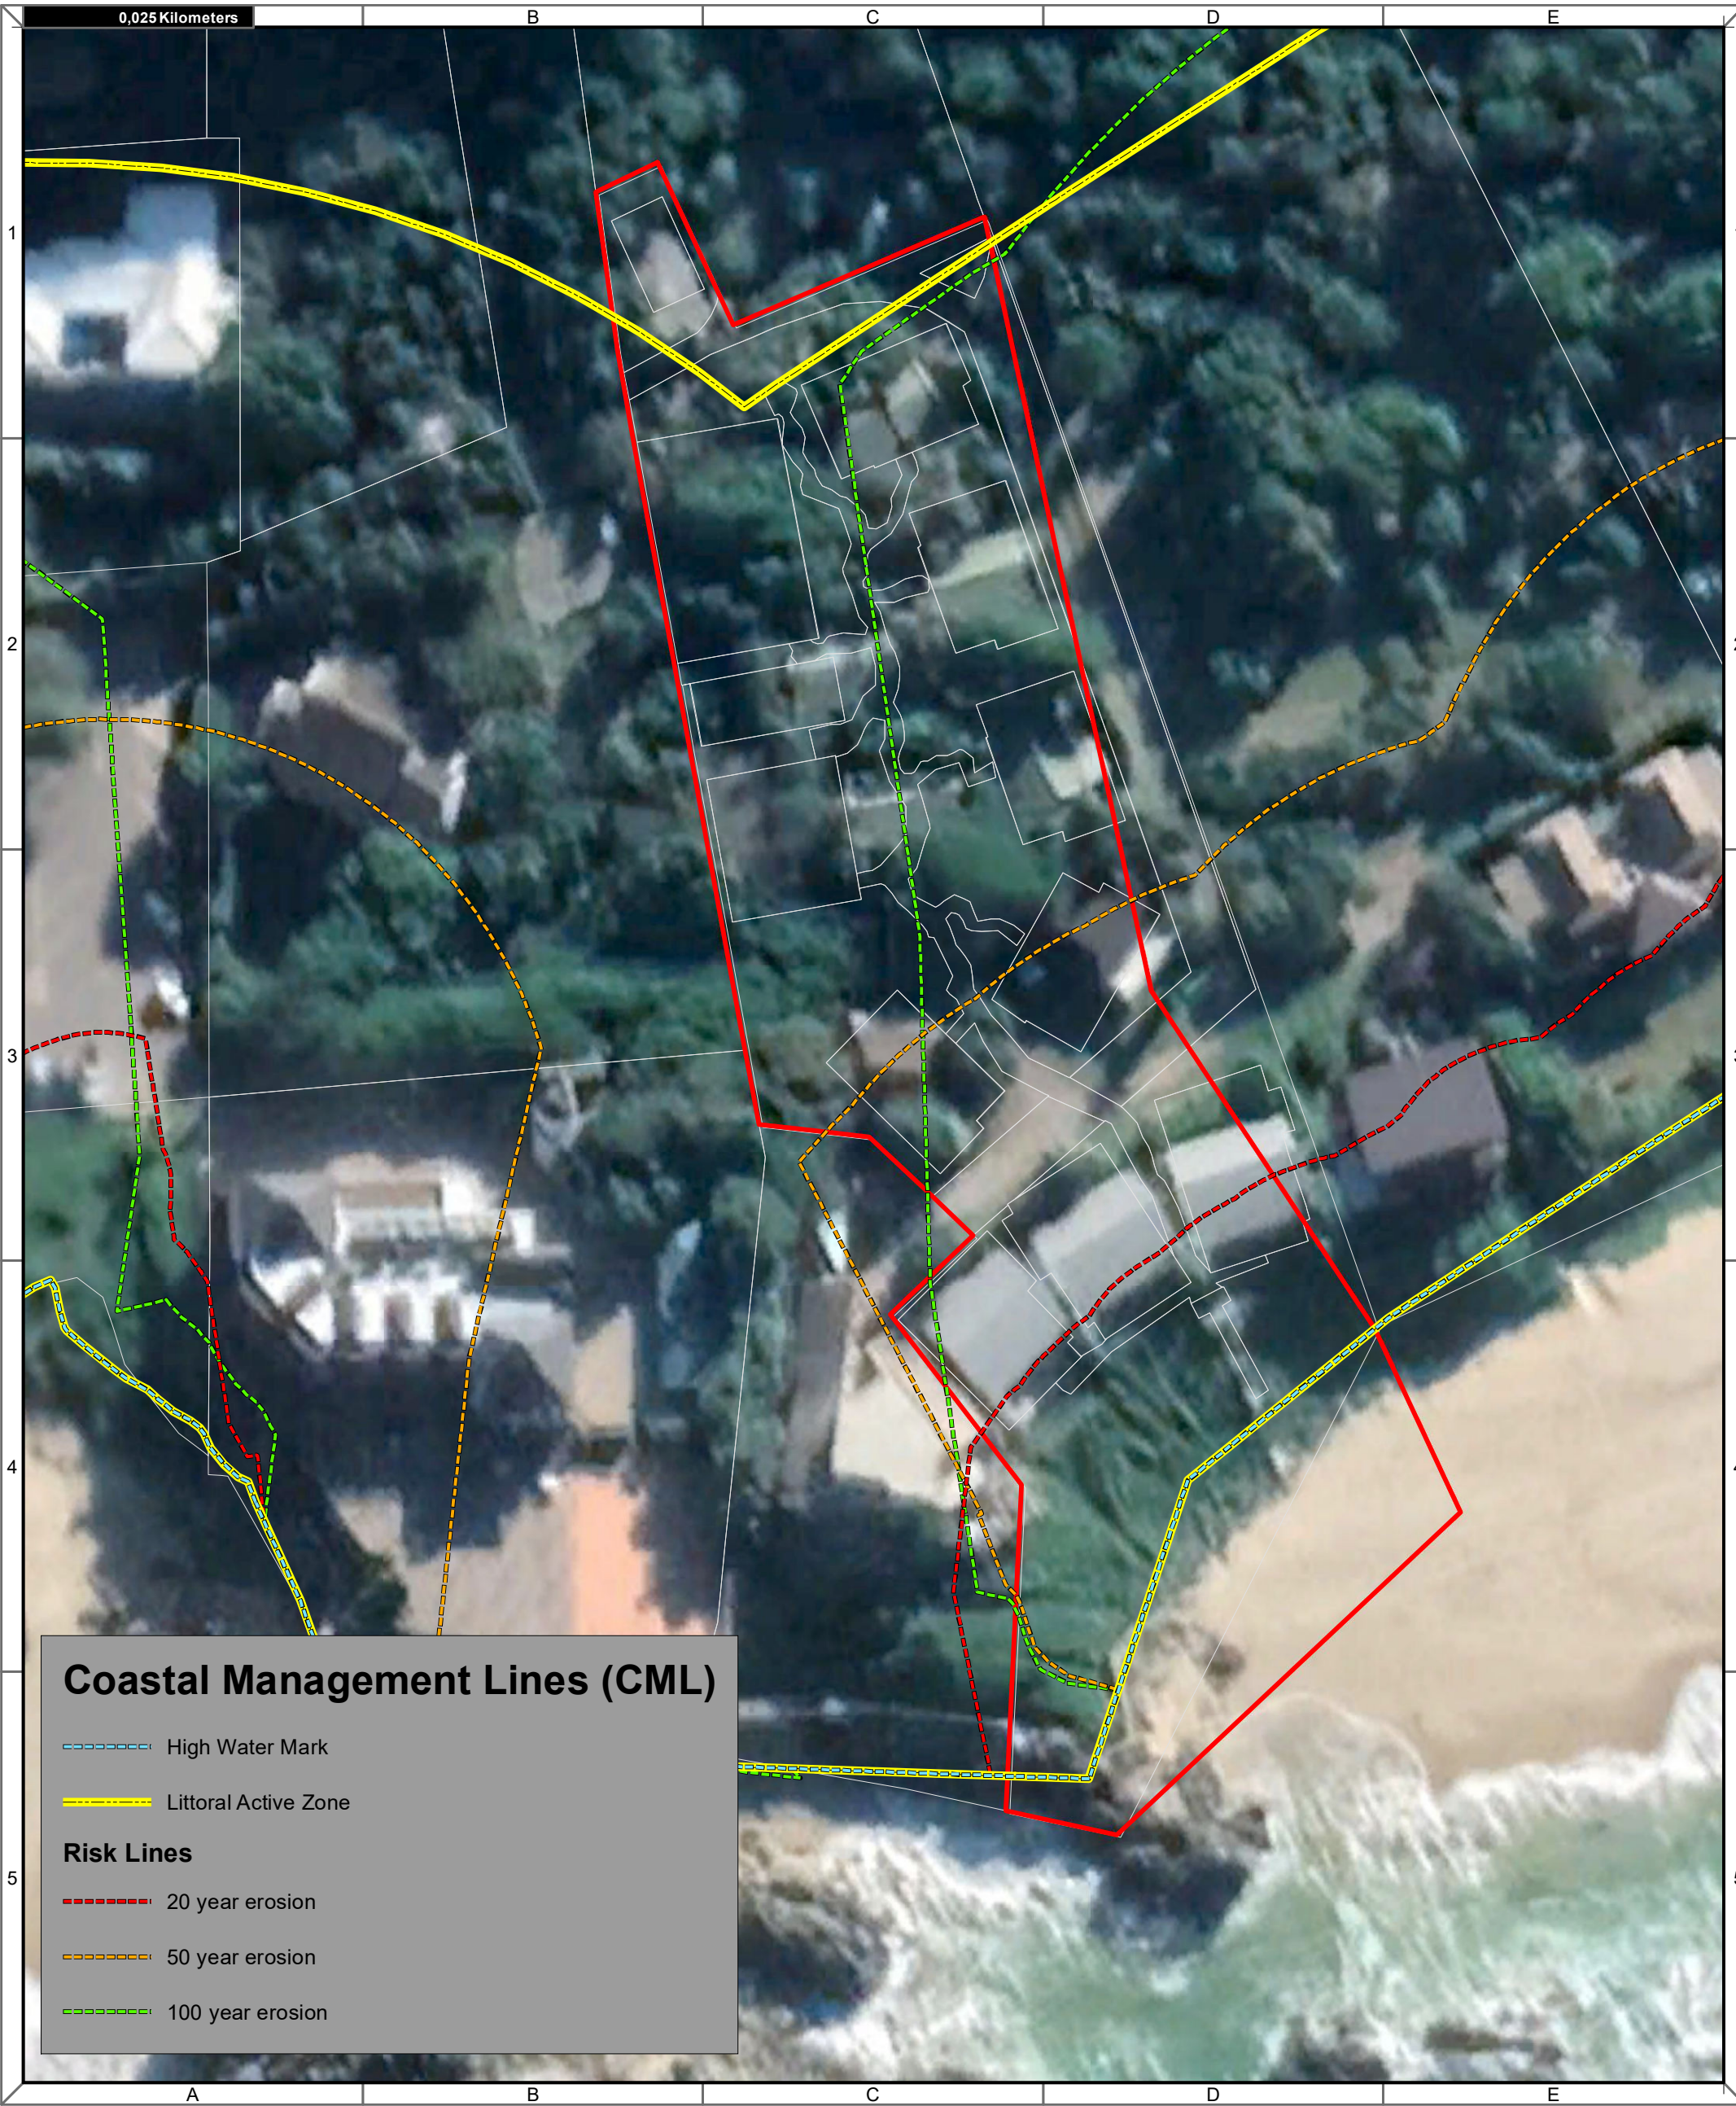
Coastal Management Lines (CML)

- High Water Mark
- Littoral Active Zone

Risk Lines

- 20 year erosion
- 50 year erosion
- 100 year erosion

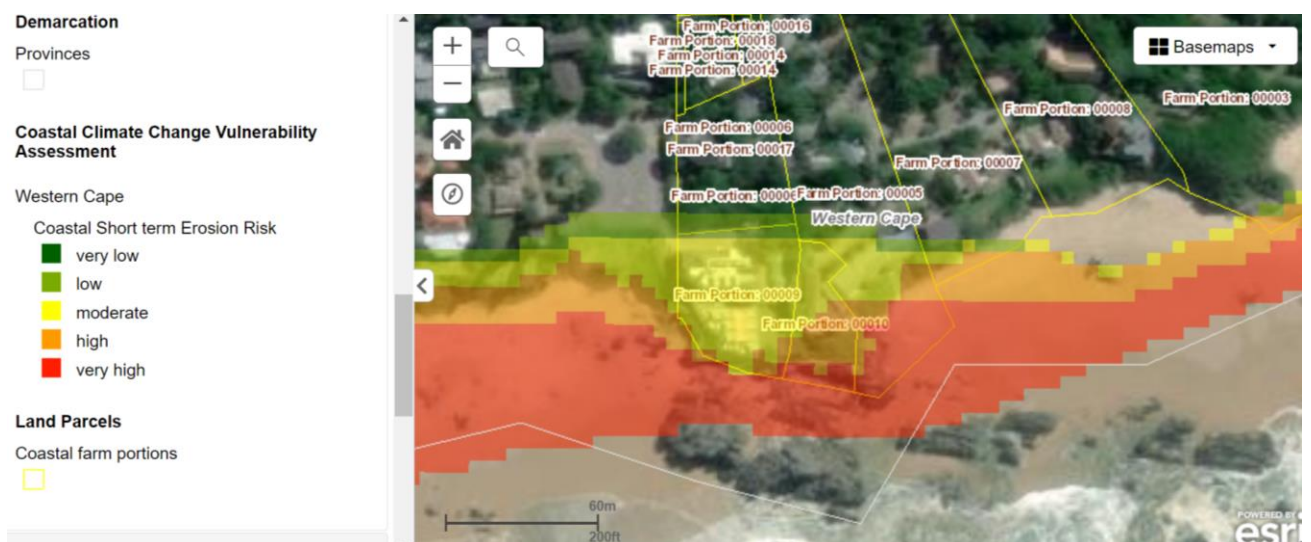
The property is located in an area that has short-term erosion risk ranging from very high to low. The slope has a high risk of eroding in the short term while the structures are located in an area that has moderate risk of short-term erosion.
