Keurbooms Rock (pty) ltd  
Farm No 296, Rem 5  
Keurboomstrand  
Western Cape

**Date:** 28 Aug 2020  
**Reference:** 20106 ~ REP01  
**Client:** Keurbooms Rock

## KEURBOOMS ROCK, ptn 5 of Farm 296 – SERVICES REPORT

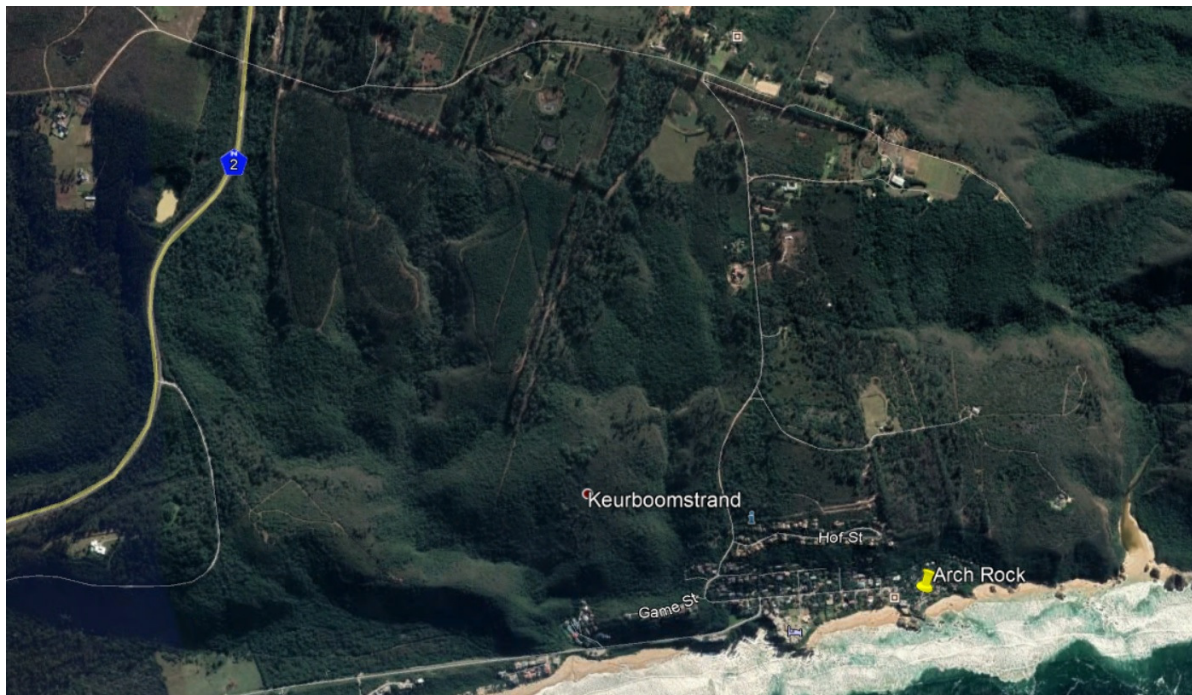
Figure 1 – Site location

Refer to figure 1 below for the locality of the property and separately refer to the architect's SDP plan.

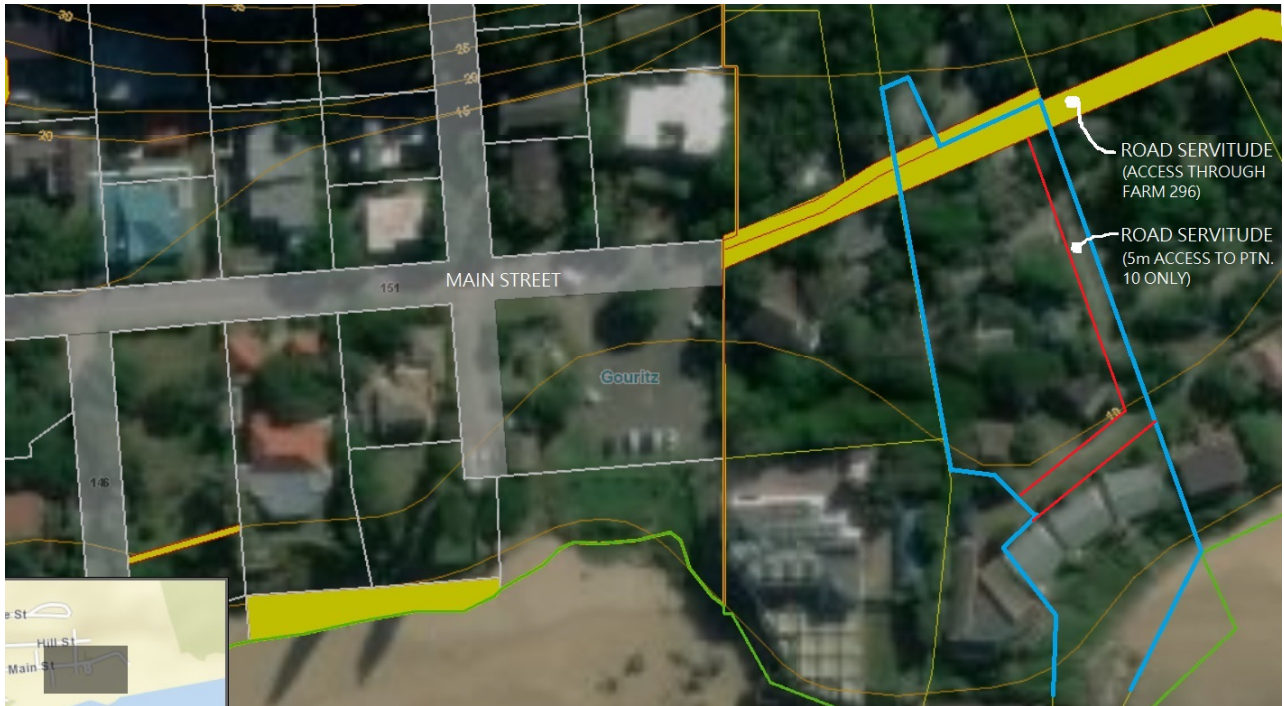
Figure 2 – Roads and access

Portion 5 (the relevant property) has access from a gravel road cutting through the north of the property. A 5m road servitude is registered to the benefit of portion 10 of farm 296.

See below figure 2 for a graphical depiction of the roads and access to and through the property.

The property (portion 5 of farm 296) forms part of a greater farm, subdivided in the 90's. Formal roads have not been built traversing the historic farm, but road servitudes are in place and gravel roads services the various portions of the greater farm 296.
