**HIGH LEVEL SAFETY HEALTH AND  
ENVIRONMENTAL RISK ASSESSMENT FOR  
THE PROPOSED DEVELOPMENT OF  
BATTERY ENERGY STORAGE SYSTEMS ASSOCIATED  
WITH THE PROPOSED KLIPPUT SOLAR PV FACILITY  
NEAR BANDELIERKOP IN THE LIMPOPO PROVINCE**

| <b>ASSIGNMENT NO:</b> | J3939M - 3 |
| <b>CLIENT:</b> | Klipput Solar PV (Pty) Ltd |

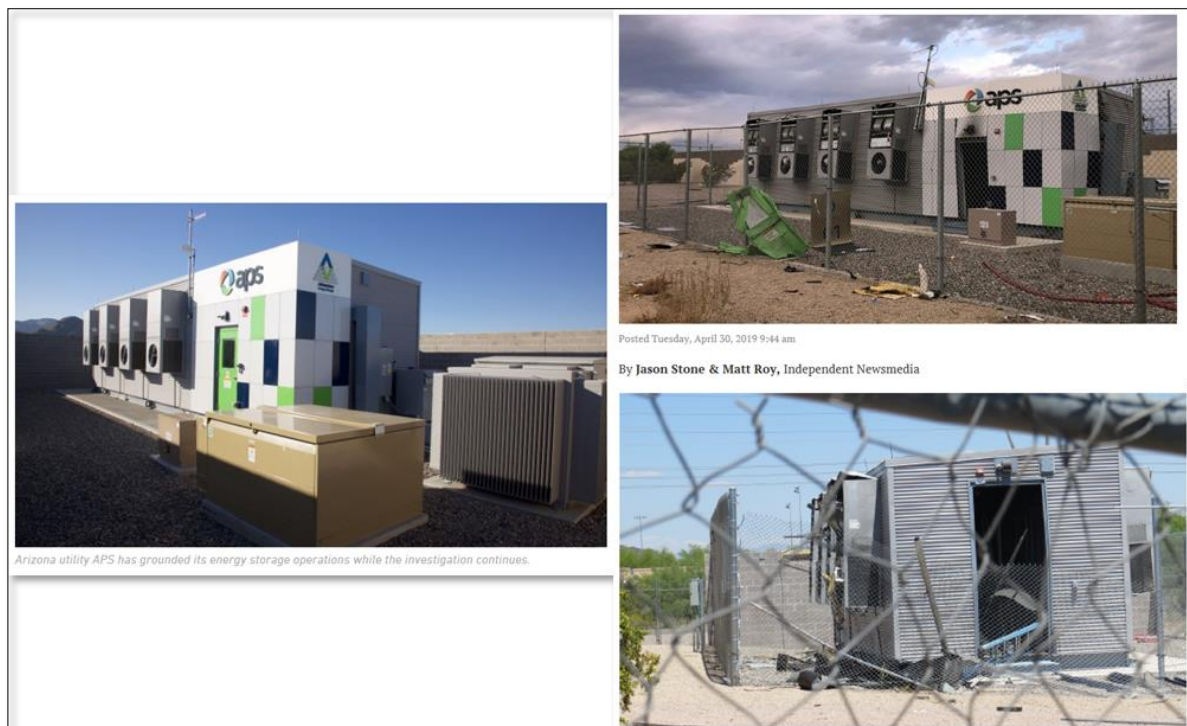
**Figure 3.4.1 – Photo of lithium battery explosion scene**

- Approximately three hours after thermal runaway began, the BESS door was opened by firefighters, agitating the remaining flammable gases, and allowing the gases to make contact with a heat source or spark. This led to the explosion.
