**HIGH LEVEL SAFETY HEALTH AND  
ENVIRONMENTAL RISK ASSESSMENT FOR  
THE PROPOSED DEVELOPMENT OF  
BATTERY ENERGY STORAGE SYSTEMS ASSOCIATED  
WITH THE PROPOSED MAKOPPA SOLAR PV FACILITY  
NEAR BANDELIERKOP IN THE LIMPOPO PROVINCE**

**17<sup>th</sup> August 2025**

| <b>ASSIGNMENT NO:</b> | J3939M - 4 |

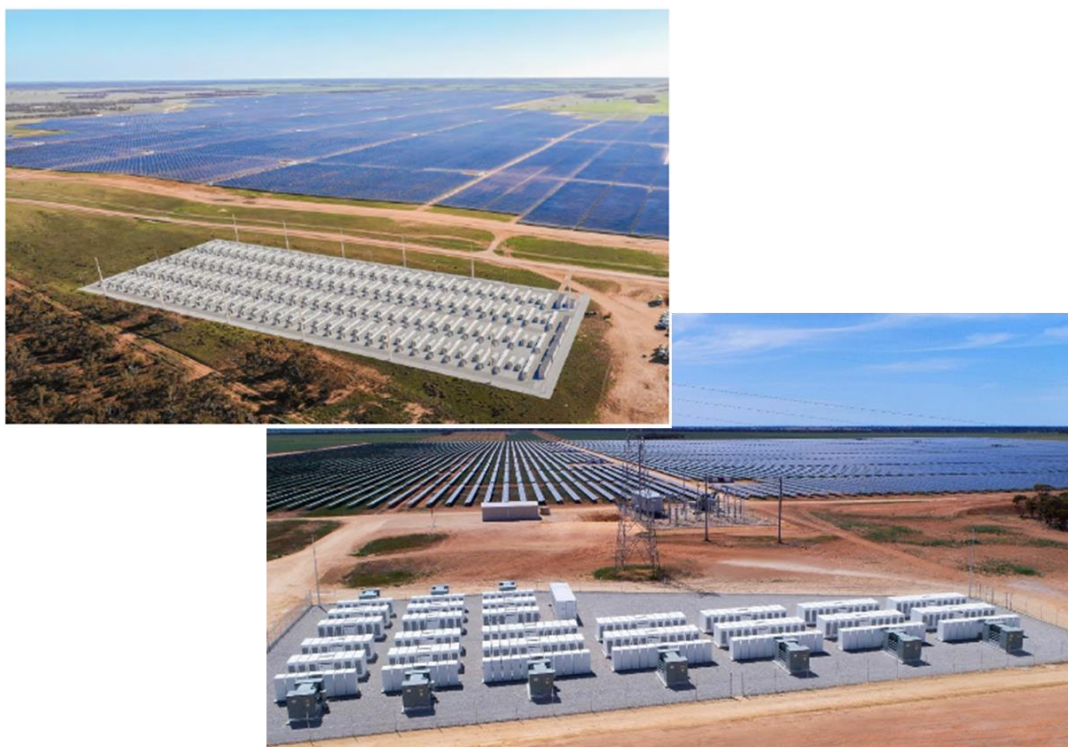
**FIGURE 2.3.1.1 – Images of Typical BESS Systems Servicing Renewable Power Farms**  
(depicted as solar but could be wind)

The solid-state batteries that are being considered are Lithium-ion or Sodium-sulphide systems. The pictures in Figure 2.3.1.1 are typical BESS installations servicing renewable power farms ( in this case depicted as solar but could be wind and arrangement of BESS would be similar). Figures 2.3.1.2 & 2.3.1.3 show typical battery modules in the BESS facility.

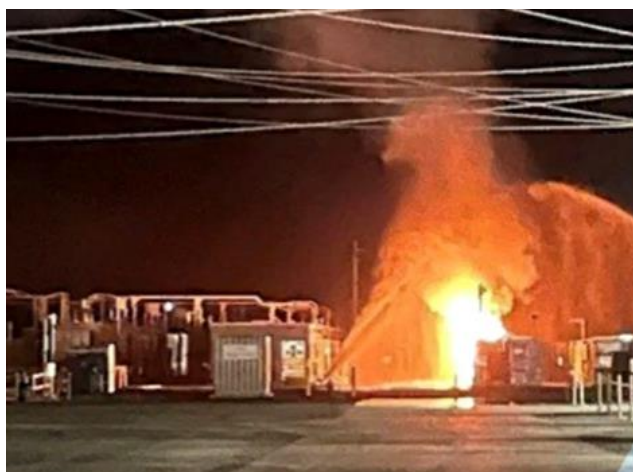
**Figure 3.4.3 – Photo of Tesla Megapack fire scene**

- There have been three incidents at the Moss Landing Power plants battery storage facility in the USA where there are 256 Tesla Mega Packs installed. The latest involved one pack which caught alight and burned out five hours later. Firefighting approach was to let the pack burn out. Near-by communities were warned to shelter-in-place and the adjacent highway shutdown due to possible toxic smoke. Only one mega pack burned out and the fire did not spread.

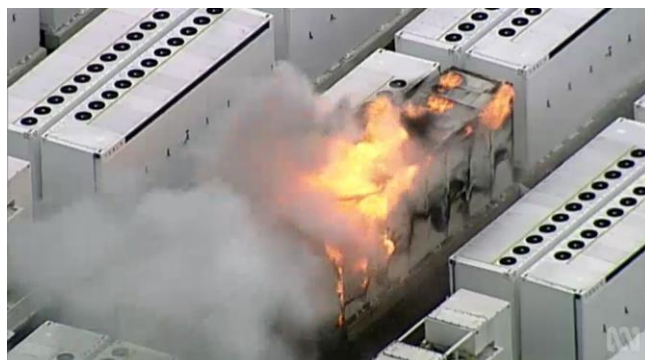
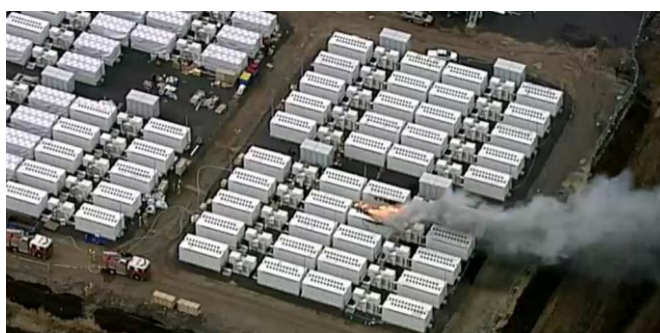
**Figure 3.4.4 – Photo of Tesla Megapack fire scene - Electric Power Research Institute**

- There was a small fire at the new Terra-Gen battery storage facility on Valley Centre Road USA. A small electrical failure produced some smoke which triggered the protection systems. Those worked exactly as planned and the failure was contained to a single battery module (meaning literally a single battery which is about the size of a DVD case). The safety systems worked exactly as planned and in addition the enclosure next to the one with the problem shut down because it also detected the smoke.
- The fire broke out during testing of a 13-tonne Tesla lithium Mega Pack at the Victorian Big Battery site near Geelong, Australia. A 13-tonne lithium battery was engulfed in flames, which then spread to an adjacent battery bank. This event indicates that if the battery pack units are not suitably separated the heat from one fire can set off an adjacent unit.
